Preliminary Engineering Report

Wellsburg Municipal Water Study
Village of Wellsburg, Chemung County, New York

February 2021
Revised July 2023

HUNT 2678-009

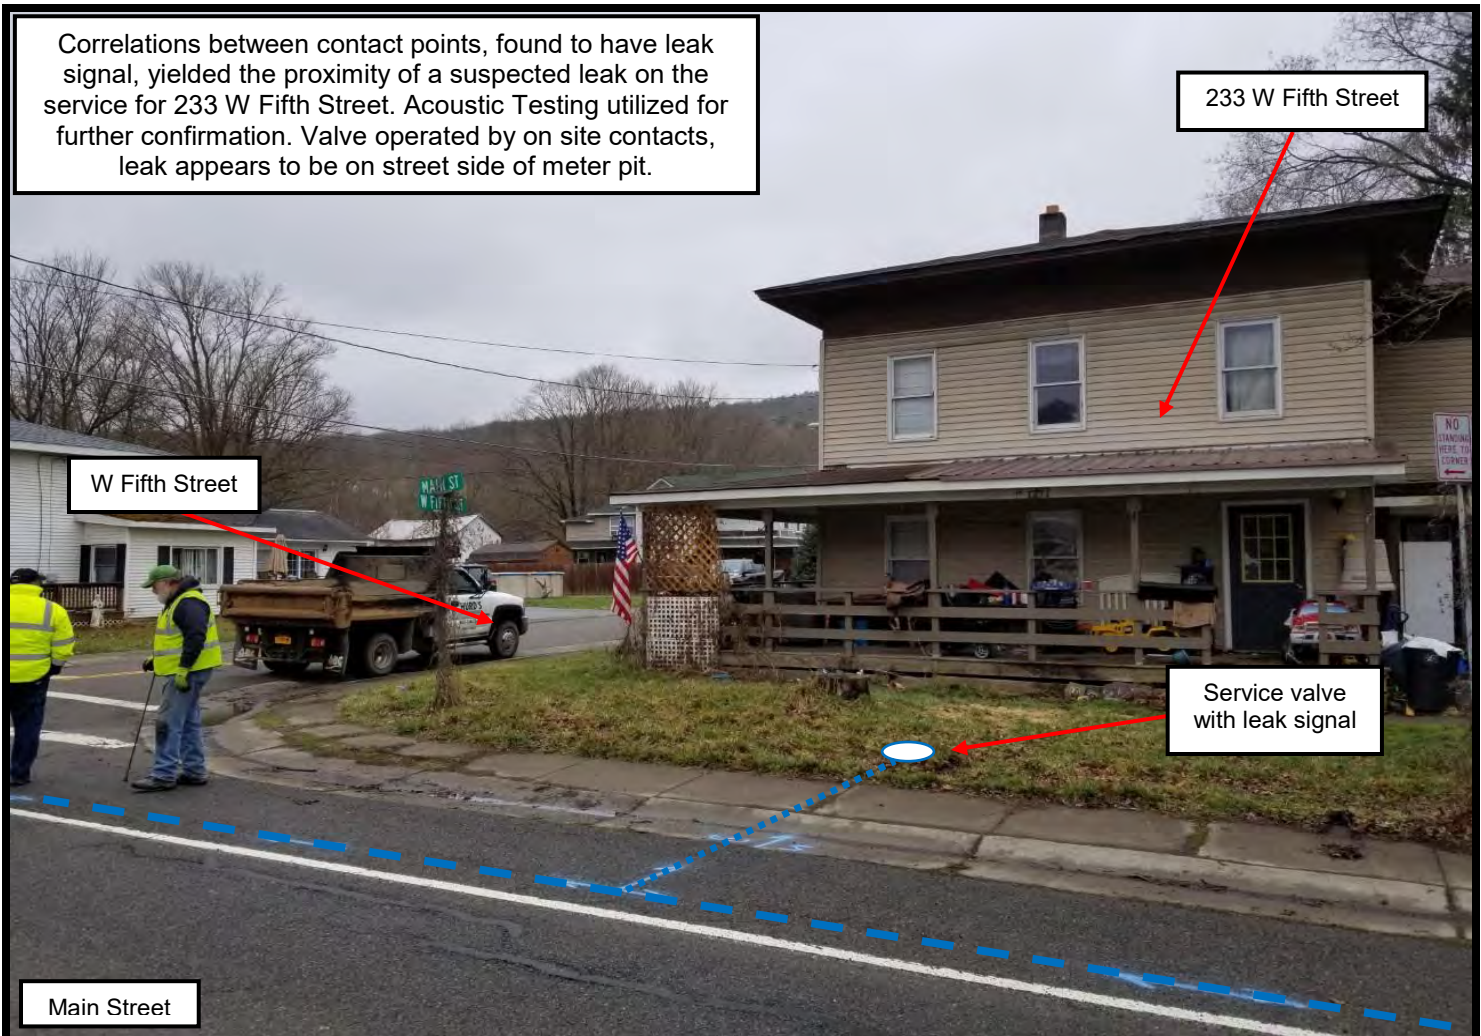
Correlations between contact points, found to have leak signal, yielded the proximity of a suspected leak on the service for 233 W Fifth Street. Acoustic Testing utilized for further confirmation. Valve operated by on site contacts, leak appears to be on street side of meter pit.

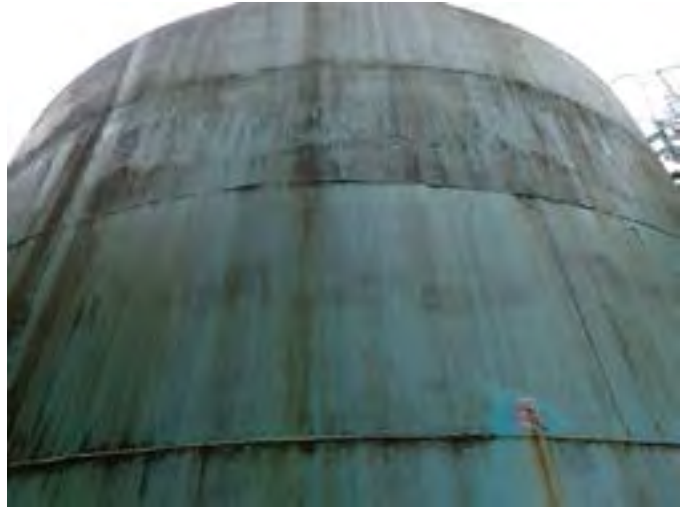
7 *Exterior Wall Having Coating Loss, Exposed Primary Coating, Exposed Steel, Corrosion And Accumulated Mildew*

8 *Exterior Wall Having Coating Loss, Exposed Primary Coating, Exposed Steel, Corrosion And Accumulated Mildew*

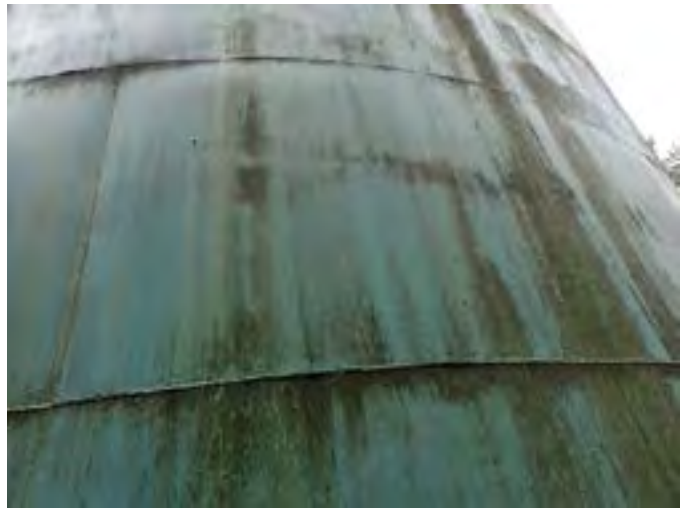
9 *Exterior Wall Having Coating Loss, Exposed Primary Coating, Exposed Steel, Corrosion And Accumulated Mildew*

10 *Exterior Wall Having Coating Loss, Exposed Steel, Corrosion And Accumulated Mildew*

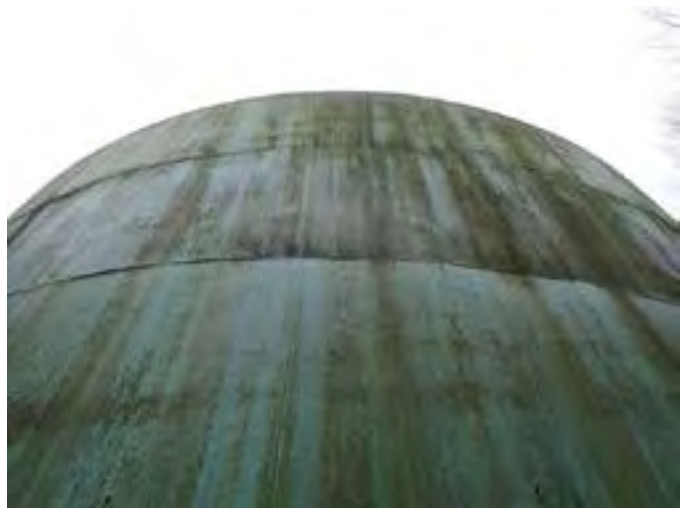
11 *Exterior Wall Having Coating Loss, Exposed Steel, Corrosion And Accumulated Mildew*

12 *Exterior Wall Having Coating Loss, Exposed Steel, Corrosion And Accumulated Mildew*

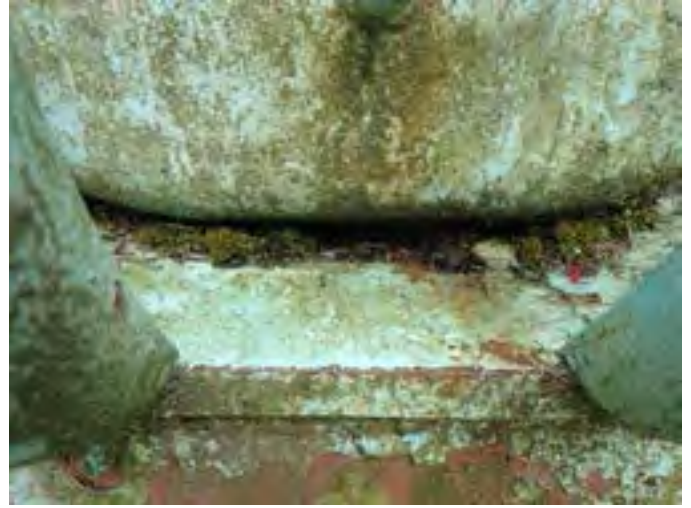
19 *Manway Having Exposed Steel And Corrosion*

20 *Manway Having Mild Leakage At Its Base*

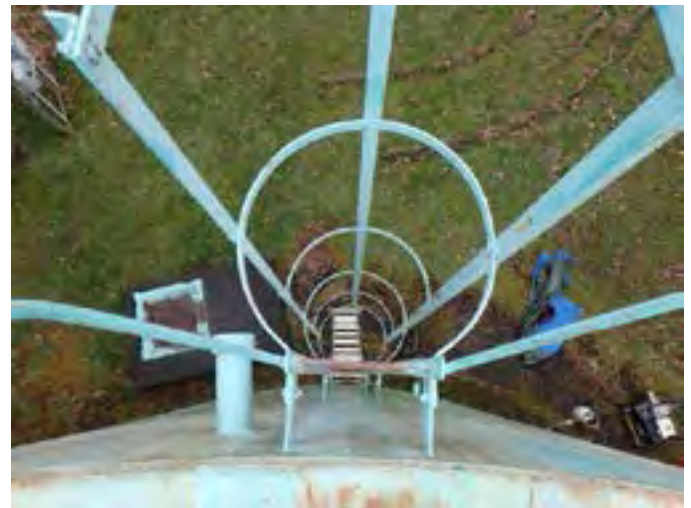
21 *Ladder And Safety Cage Having Coating Loss, Exposed Steel And Corrosion*

22 *Ladder And Safety Cage Having Coating Loss, Exposed Steel And Corrosion*

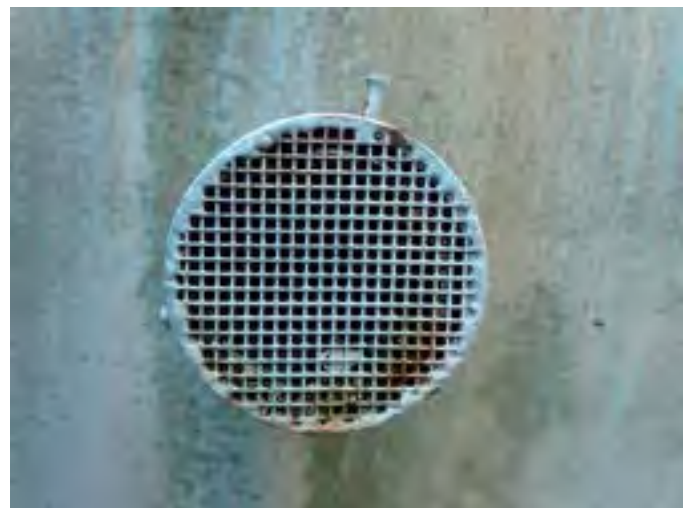
23 *Overflow Pipe Having Coating Loss, Exposed Steel And Corrosion*

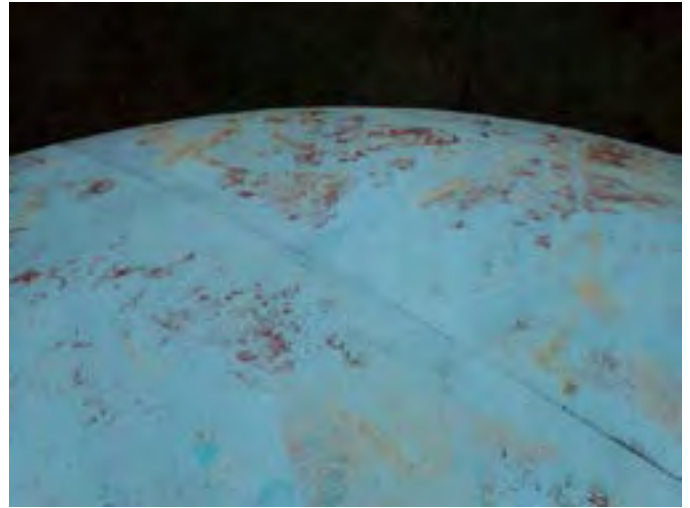
25 *Roof Having Coating Fatigue, Exposed Primary Coating, Exposed Steel And Corrosion*

26 *Roof Having Coating Fatigue, Exposed Primary Coating, Exposed Steel And Corrosion*

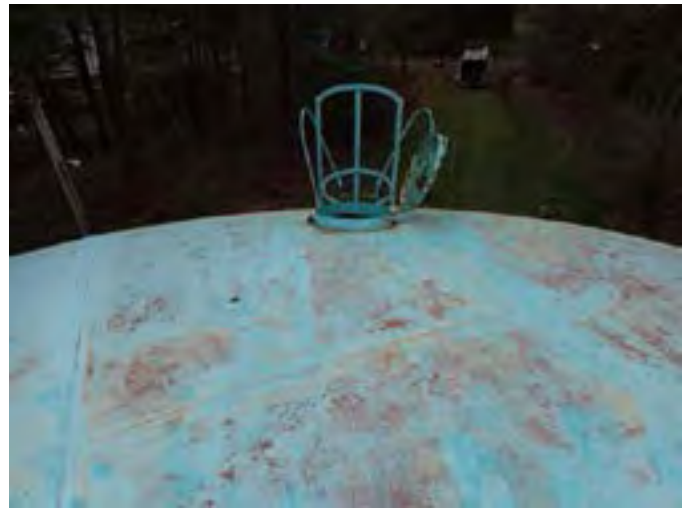
27 *Roof Having Coating Fatigue, Exposed Primary Coating, Exposed Steel And Corrosion*

28 *Roof Having Coating Fatigue, Exposed Primary Coating, Exposed Steel And Corrosion*

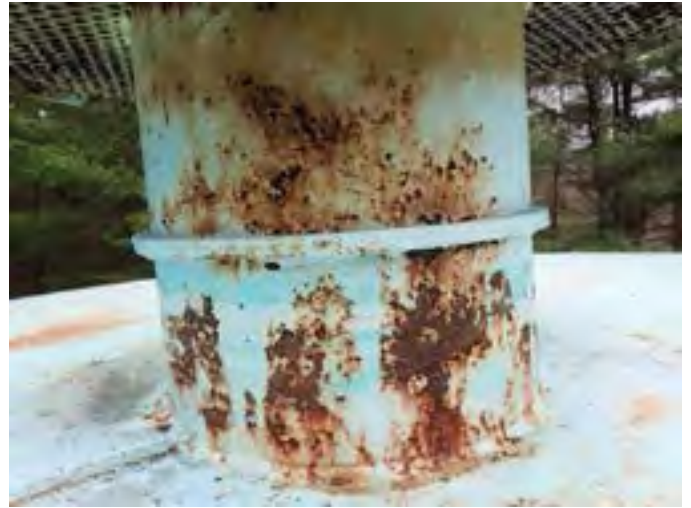
31 *Vent Assembly Having Coating Loss, Exposed Steel And Corrosion*

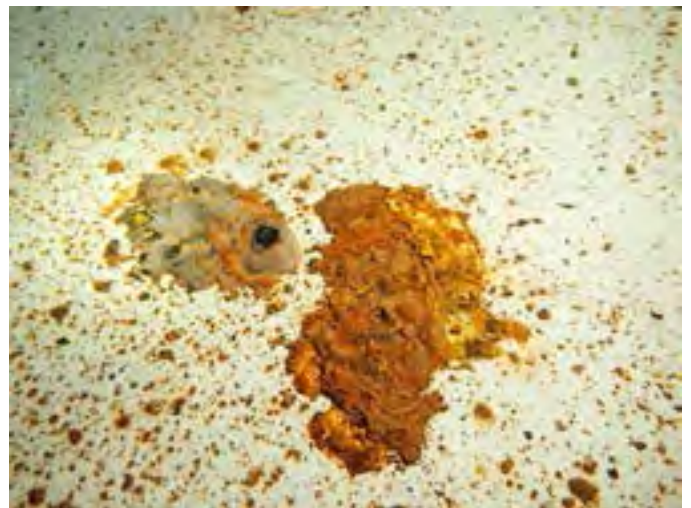
41 *Floor Having Coating Loss, Exposed Steel And Corrosion*

42 *Floor Having Coating Loss, Exposed Steel And Corrosion*

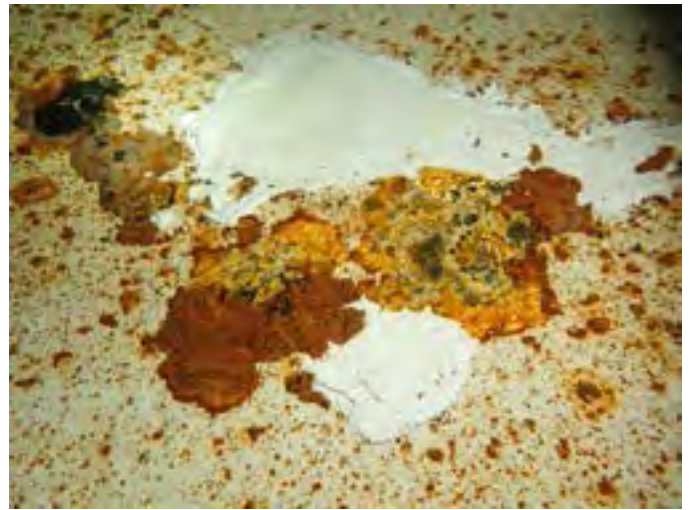
43 *Floor Having Coating Loss, Exposed Steel And Corrosion*

44 *Floor Having Coating Loss, Exposed Steel And Corrosion*

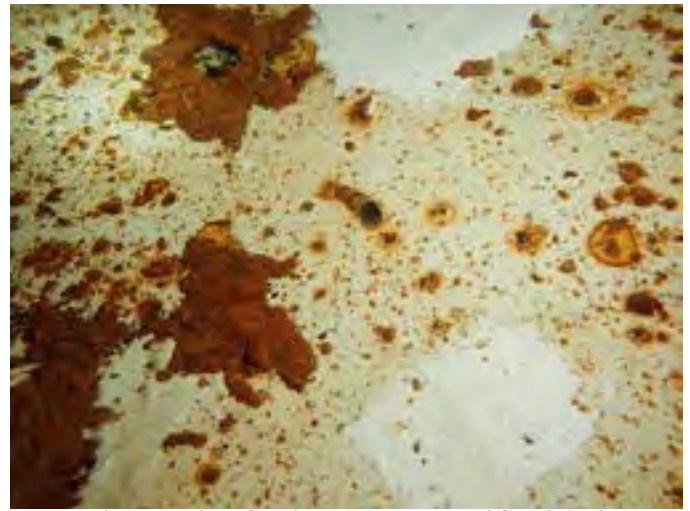
45 *Floor Having Coating Loss, Exposed Steel And Corrosion*

46 *Floor Having Coating Loss, Exposed Steel And Corrosion*

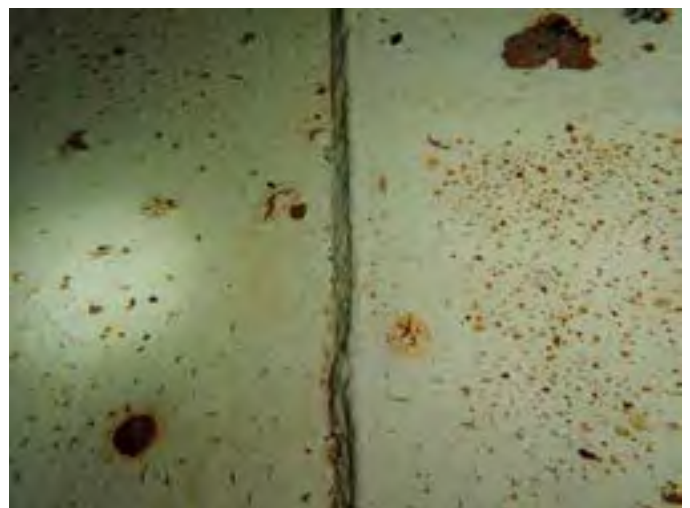
47 *Floor Having Coating Loss, Exposed Steel And Corrosion*

48 *Floor Having Coating Loss, Exposed Steel And Corrosion*

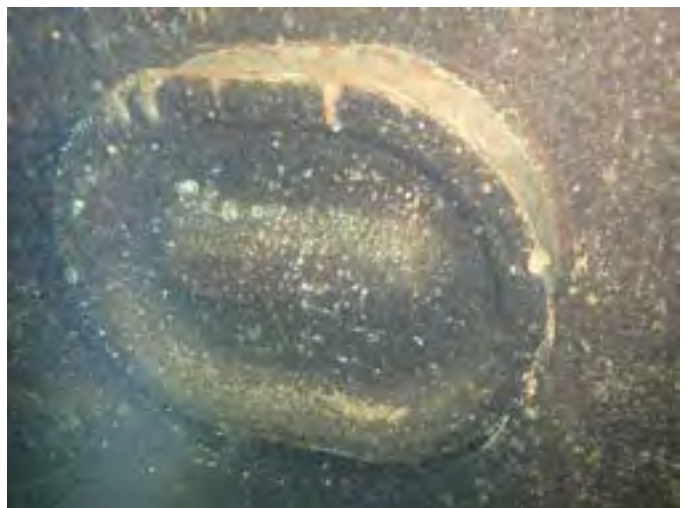
53 *Manway Having Coating Loss, Exposed Steel And Corrosion*

54 *Manway Having Coating Loss, Exposed Steel And Corrosion*

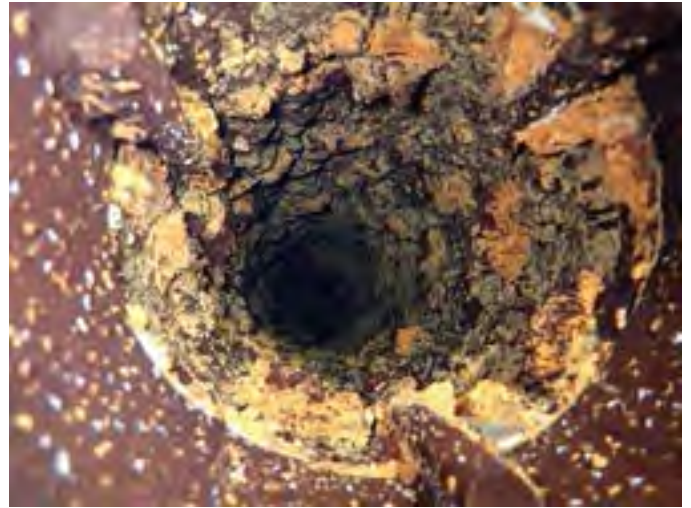
55 *Removable Silt Stop Riser Having Exposed Steel And Corrosion*

56 *Interior Of The Pipe Within The Floor Having Corrosion*

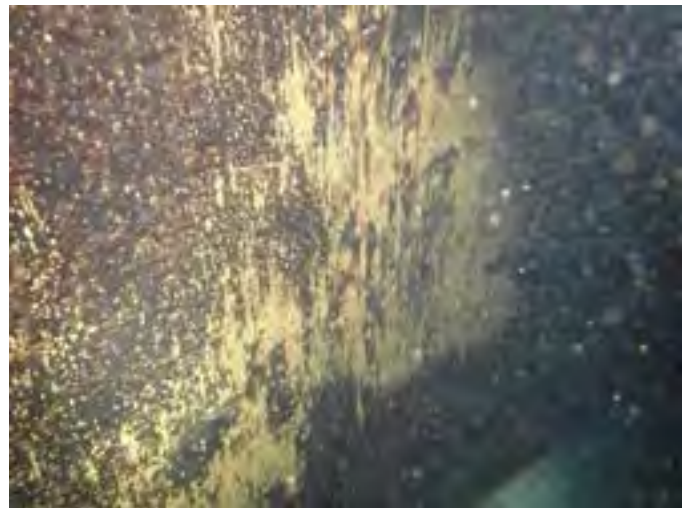
57 *Interior Wall Having Coating Loss, Exposed Steel And Corrosion*

58 *Interior Wall Having Coating Loss, Exposed Steel And Corrosion*

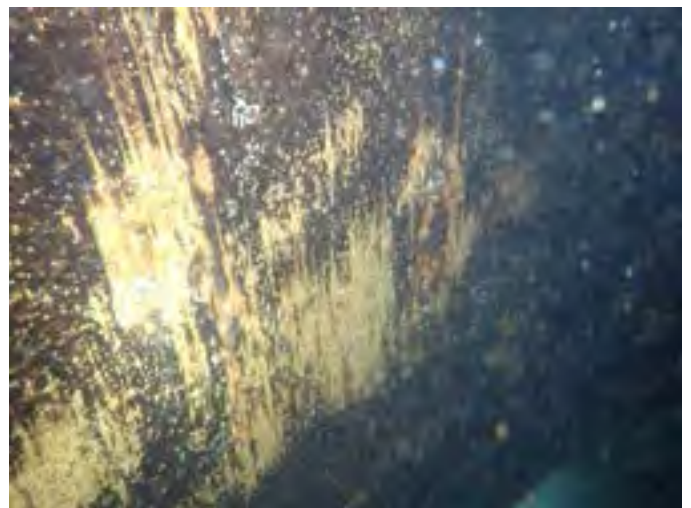
59 *Interior Wall Having Coating Loss, Exposed Steel And Corrosion*

60 *Interior Wall Having Coating Loss, Exposed Steel And Corrosion*

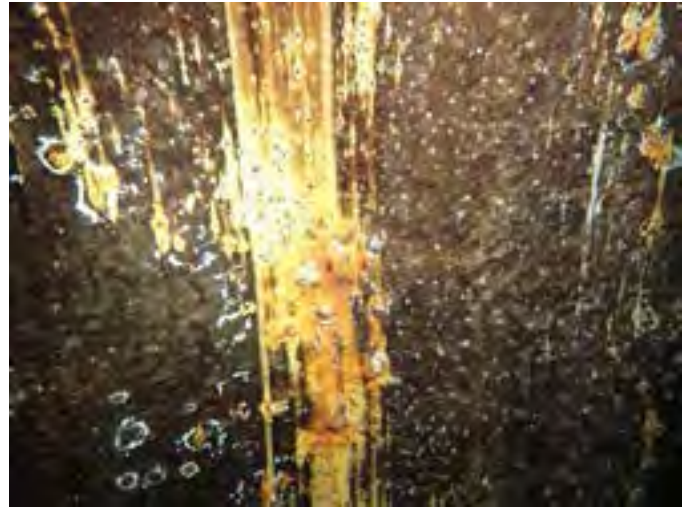
61 *Interior Wall Having Coating Loss, Exposed Steel And Corrosion*

62 *Interior Wall Having Coating Loss, Exposed Steel And Corrosion*

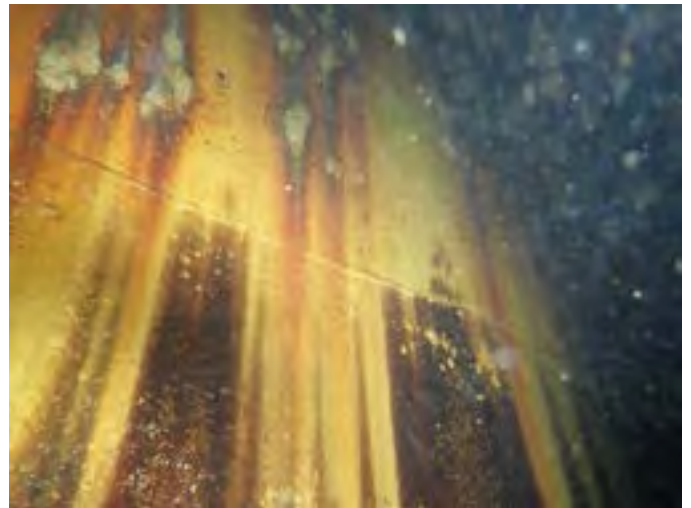
63 *Interior Wall Having Coating Loss, Exposed Steel And Corrosion*

64 *Interior Wall Having Coating Loss, Exposed Steel And Corrosion*

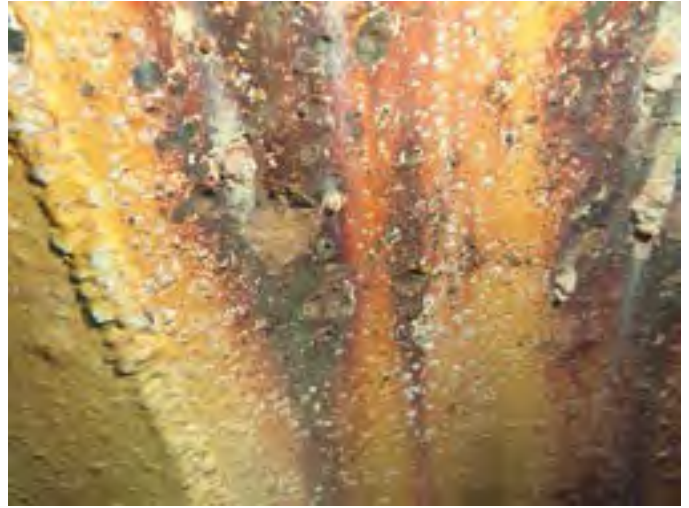
67 *Wall Panel Weld Having Deterioration*

68 *Wall Panel Having Pitting Of The Steel*

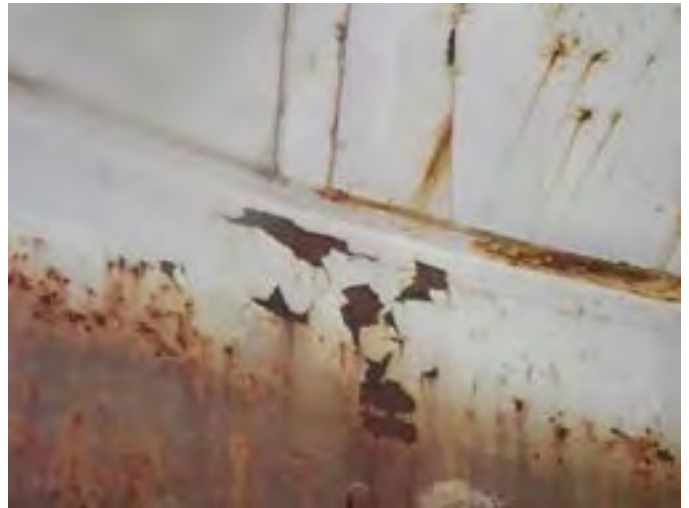
75 *Interior Wall Having Coating Loss, Exposed Steel And Corrosion*

76 *Interior Wall Having Coating Loss, Exposed Steel And Corrosion*

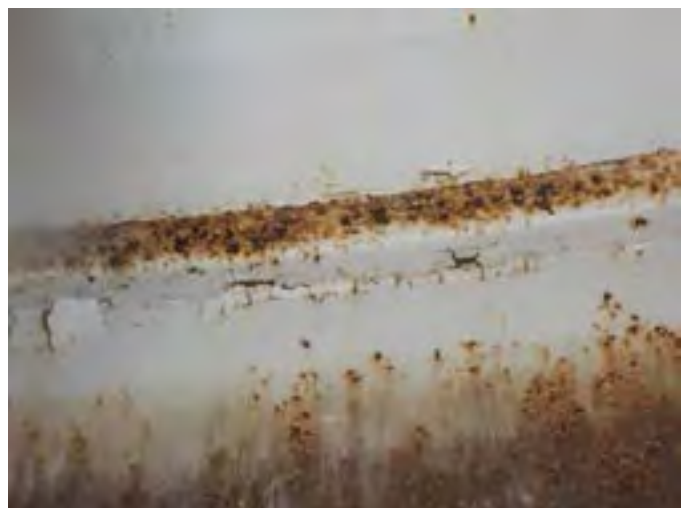
77 *Interior Wall Having Coating Loss, Exposed Steel And Corrosion*

78 *Interior Wall Having Coating Loss, Exposed Steel And Corrosion*

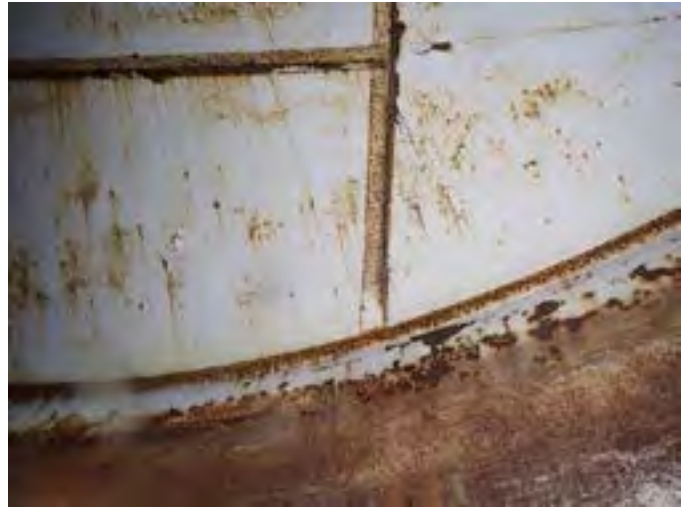
79 *Interior Wall Having Coating Loss, Exposed Steel And Corrosion*

80 *Interior Wall Having Coating Loss, Exposed Steel And Corrosion*

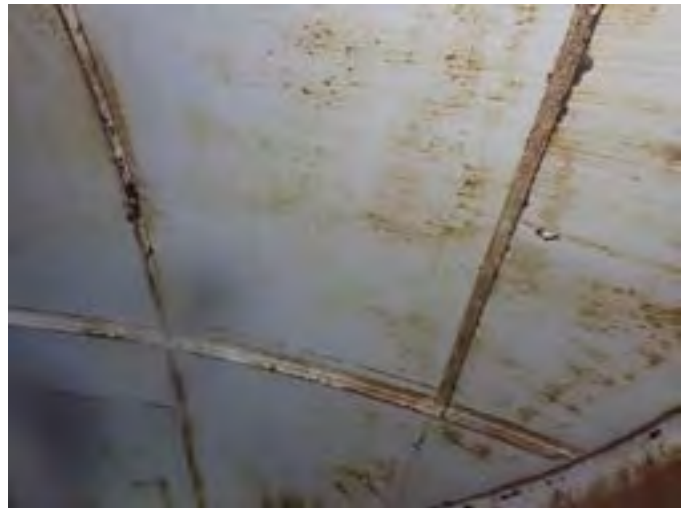
81 *Overhead Having Coating Loss, Exposed Steel And Corrosion*

82 *Overhead Having Coating Loss, Exposed Steel And Corrosion*

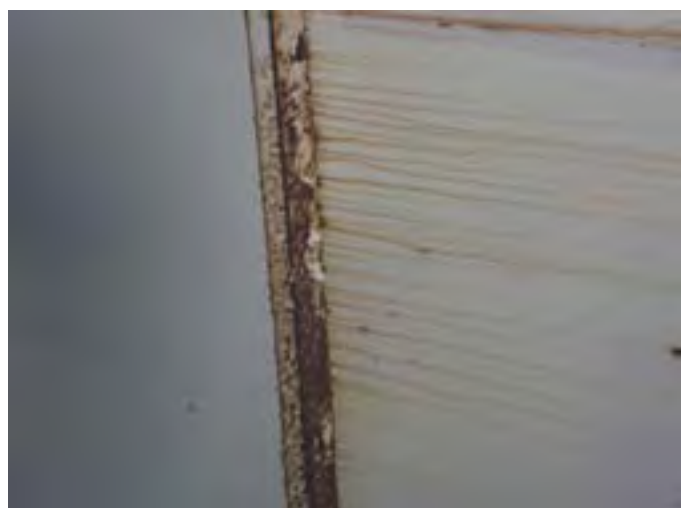
83 *Overhead Having Coating Loss, Exposed Steel And Corrosion*

84 *Overhead Having Coating Loss, Exposed Steel And Corrosion*

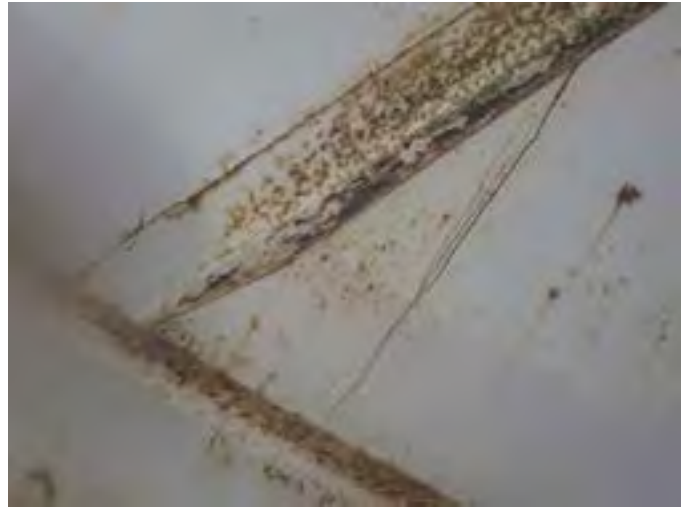
85 *Overhead Having Coating Loss, Exposed Steel And Corrosion*

86 *Overhead Having Coating Loss, Exposed Steel And Corrosion*

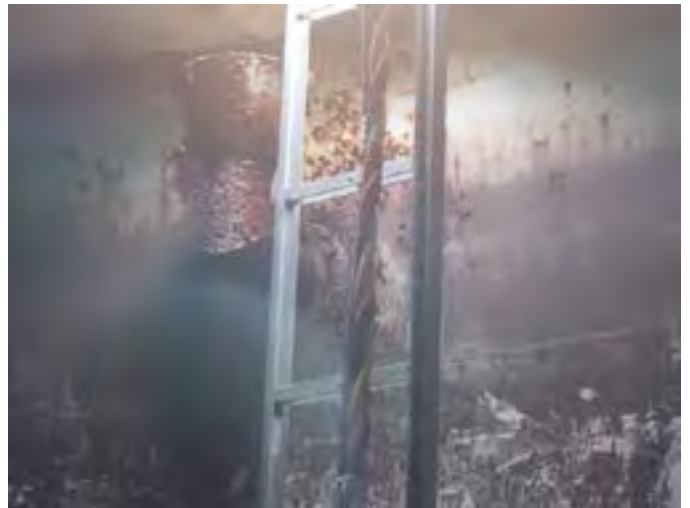
87 *Overhead Having Coating Loss, Exposed Steel And Corrosion*

88 *Overflow Pipe Having Exposed Steel And Corrosion*

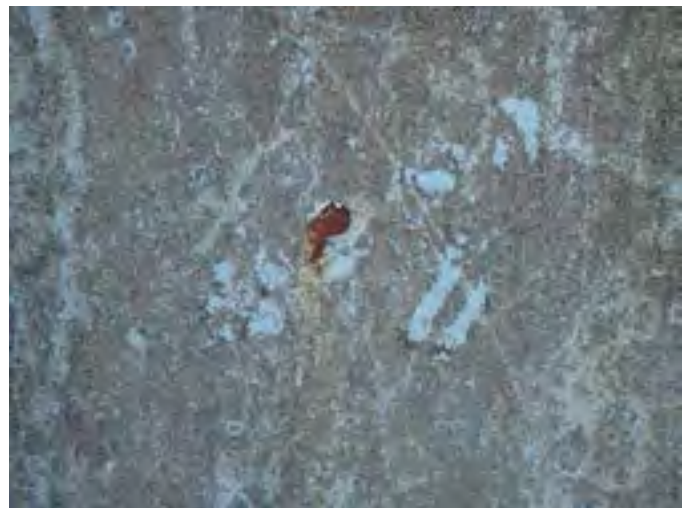
11 *Exterior Wall Having Coating Loss, Exposed Steel And Corrosion*

12 *Exterior Wall Having Coating Loss, Exposed Steel And Corrosion*

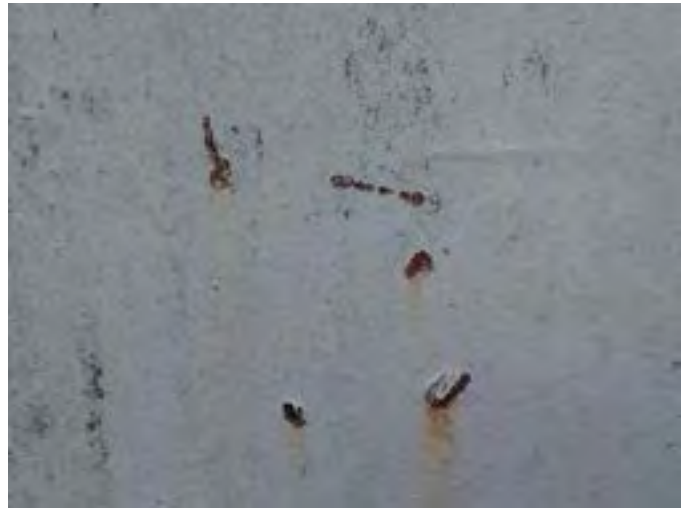
13 *Exterior Wall Having Coating Loss, Exposed Steel And Corrosion*

14 *Exterior Wall Having Coating Loss, Exposed Steel And Corrosion*

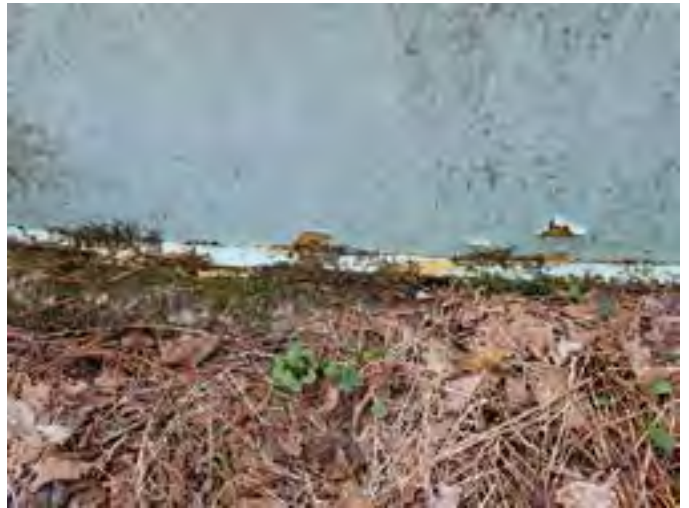
15 *Exposed Foundation Surface Found Covered With Moss And Vegetation*

16 *Exposed Foundation Surface Found Covered With Moss And Vegetation*

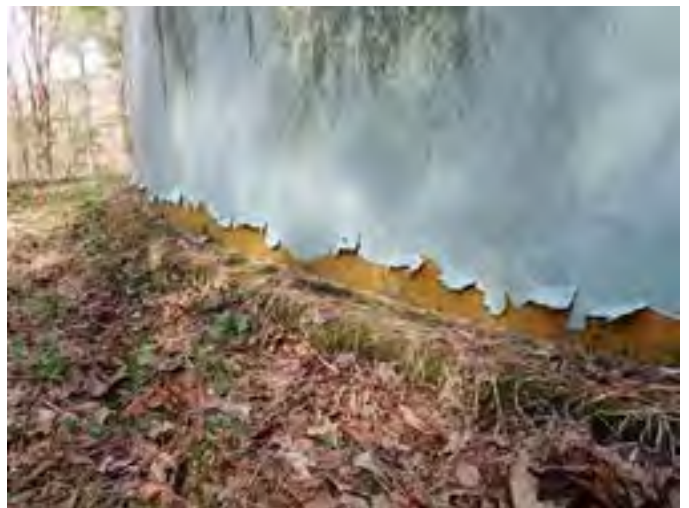
17 *Exposed Foundation Surface Found Covered With Moss And Vegetation*

18 *Exposed Foundation Surface Found Covered With Moss And Vegetation*

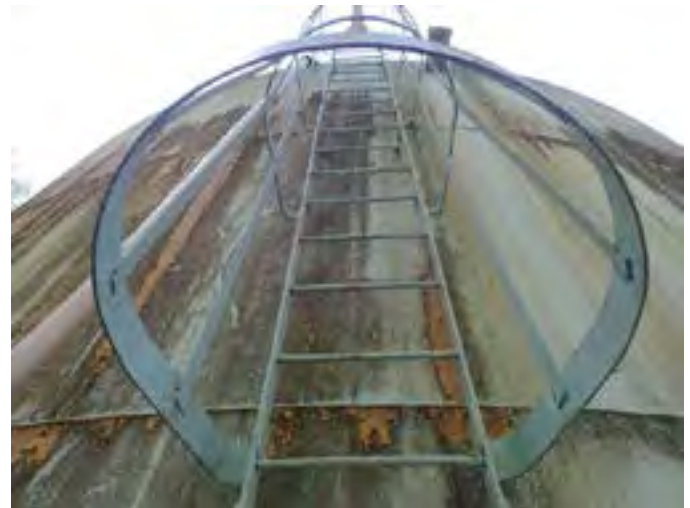
21 *Manway Having Exposed Steel And Corrosion*

22 *Ladder And Safety Cage Having Exposed Steel And Corrosion*

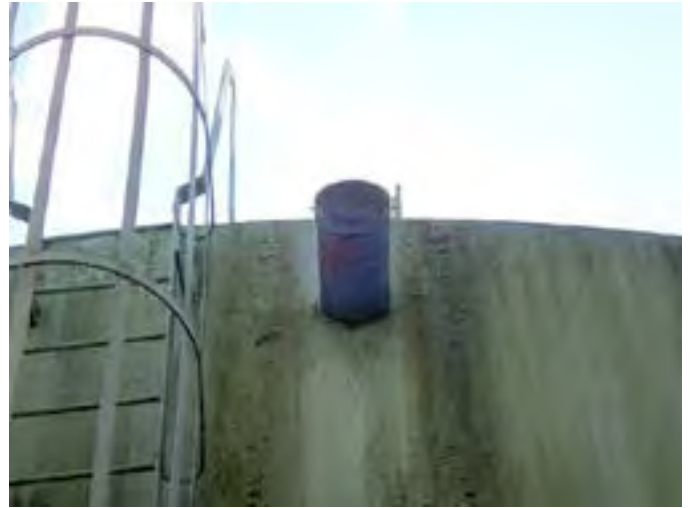
25 *Vent Access Ladder Having Exposed Steel And Corrosion*

26 *Overflow Pipe Having Exposed Primary Coating, Exposed Steel And Corrosion*

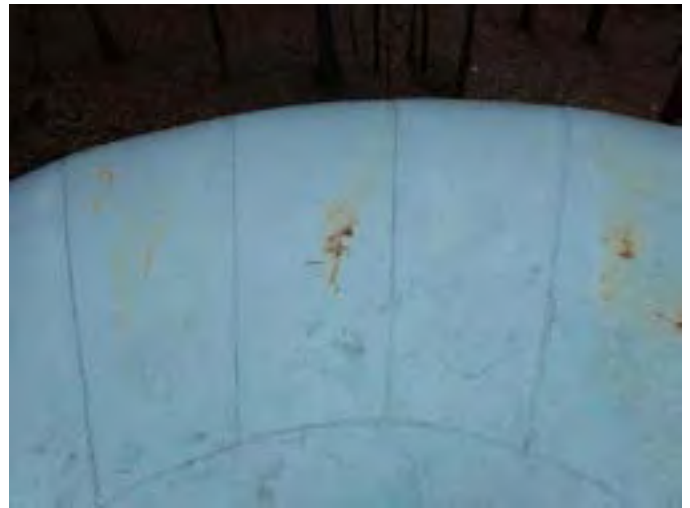
28 *Roof Having Coating Loss, Exposed Steel, Corrosion And A Non-Uniform Accumulation Of Mildew*

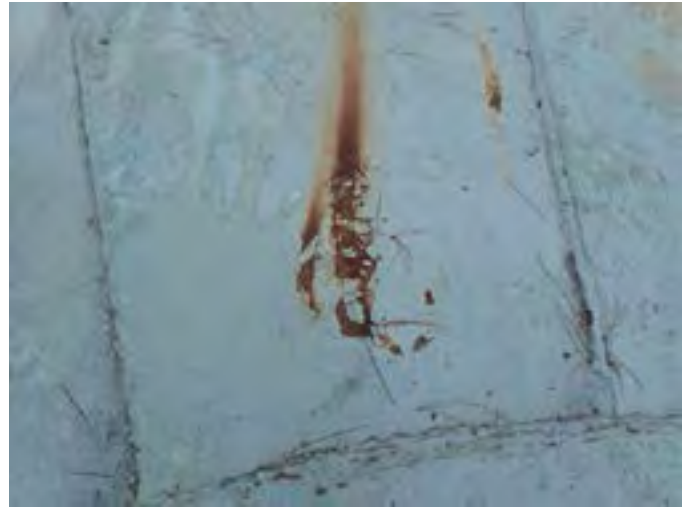
31 *Roof Having Coating Loss, Exposed Steel, Corrosion And A Non-Uniform Accumulation Of Mildew*

32 *Roof Having Coating Loss, Exposed Steel, Corrosion And A Non-Uniform Accumulation Of Mildew*

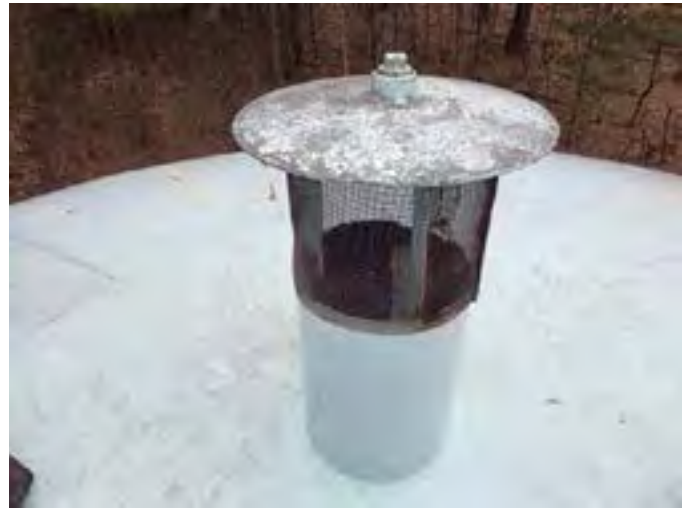
33 *Roof Having Coating Loss, Exposed Steel, Corrosion And A Non-Uniform Accumulation Of Mildew*

34 *Vent Assembly Having Exposed Steel And Corrosion*

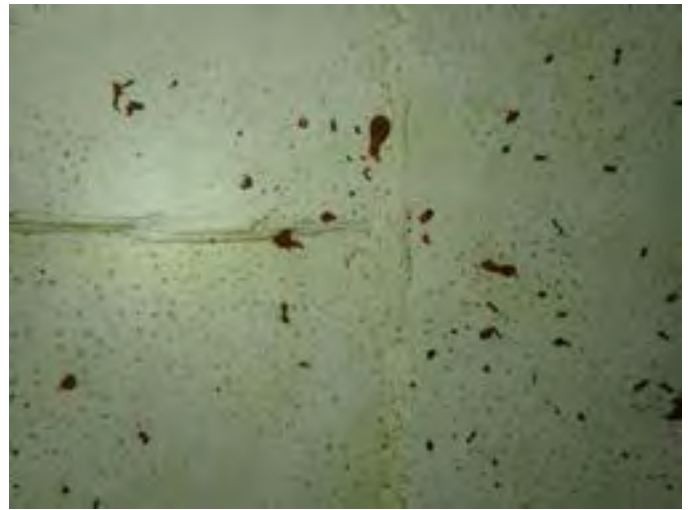
43 *Floor Having Coating Loss, Exposed Steel And Corrosion*

44 *Floor Having Coating Loss, Exposed Steel And Corrosion*

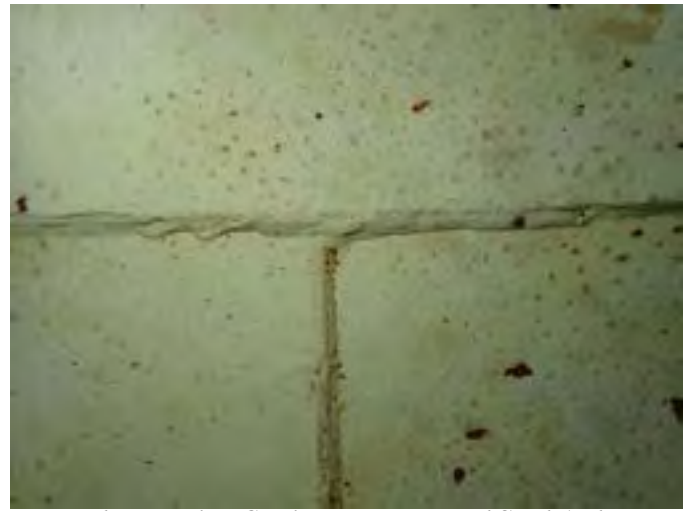
45 *Floor Having Coating Loss, Exposed Steel And Corrosion*

46 *Floor Having Coating Loss, Exposed Steel And Corrosion*

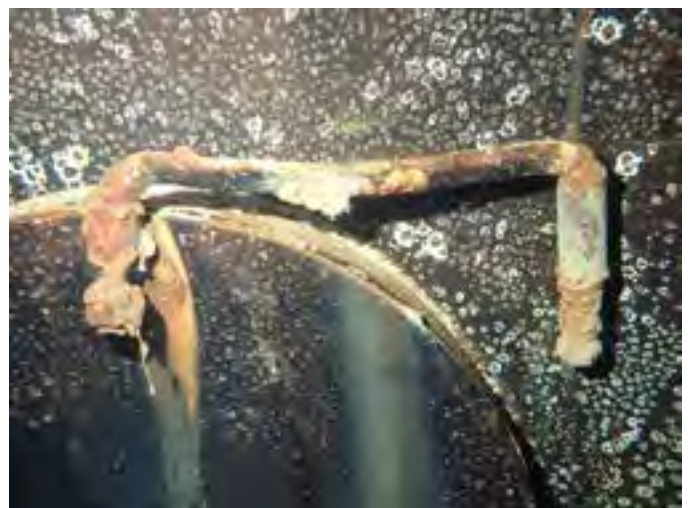
47 *Manway Having Exposed Steel And Corrosion*

48 *Manway Having Exposed Steel And Corrosion*

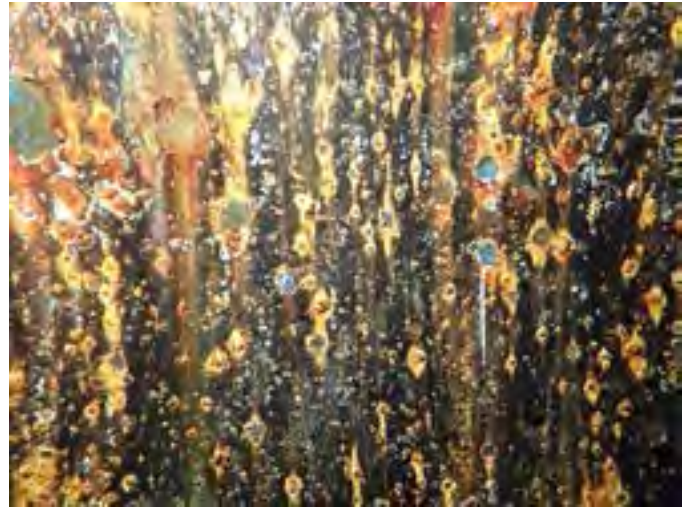
61 *Interior Wall Having Exposed Steel And Corrosion*

62 *Third Row Of Wall Panels Above The Tank Floor Having Pitting Of The Steel*

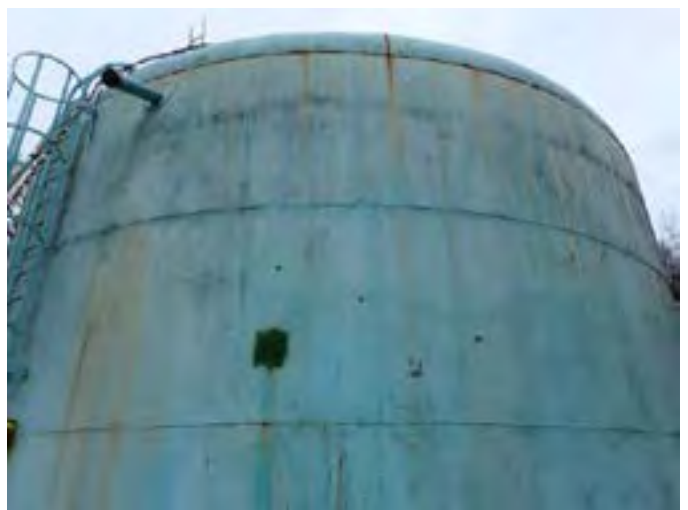
3 *Steel Patch Welded Over A Weld Found Without Leakage*

4 *Steel Patch Welded To A Wall Panel Having Minimal Leakage*

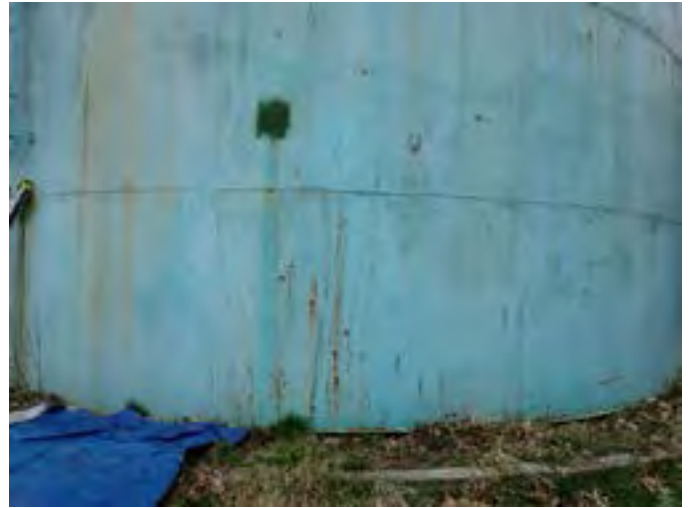
7 *Exterior Wall Having Coating Fatigue, Exposed Primary Coating, Exposed Steel And Corrosion*

8 *Exterior Wall Having Coating Fatigue, Exposed Primary Coating, Exposed Steel And Corrosion*

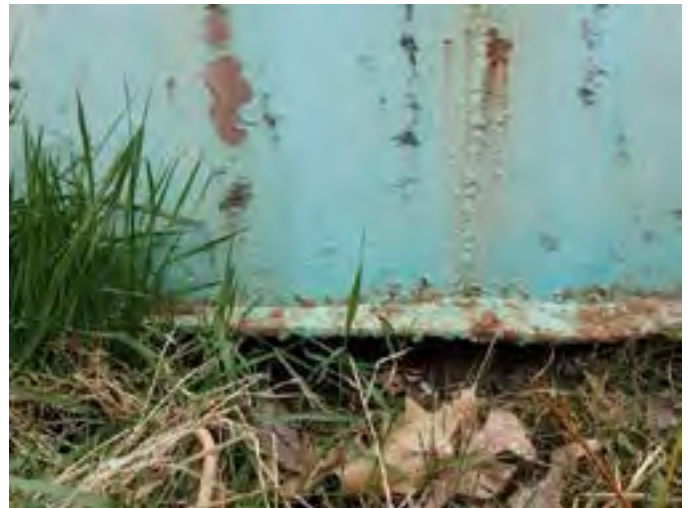
9 *Exterior Wall Having Coating Fatigue, Exposed Primary Coating, Exposed Steel And Corrosion*

10 *Exterior Wall Having Coating Fatigue, Exposed Primary Coating, Exposed Steel And Corrosion*

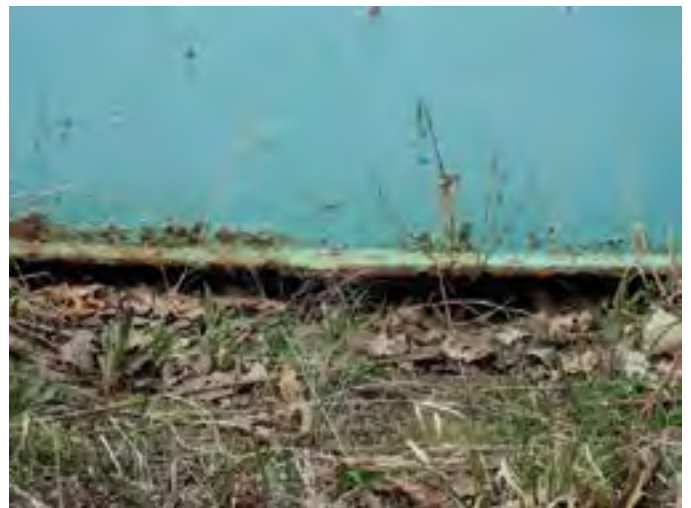
11 *Exterior Wall Having Coating Fatigue, Exposed Primary Coating, Exposed Steel And Corrosion*

12 *Exterior Wall Having Coating Fatigue, Exposed Primary Coating, Exposed Steel And Corrosion*

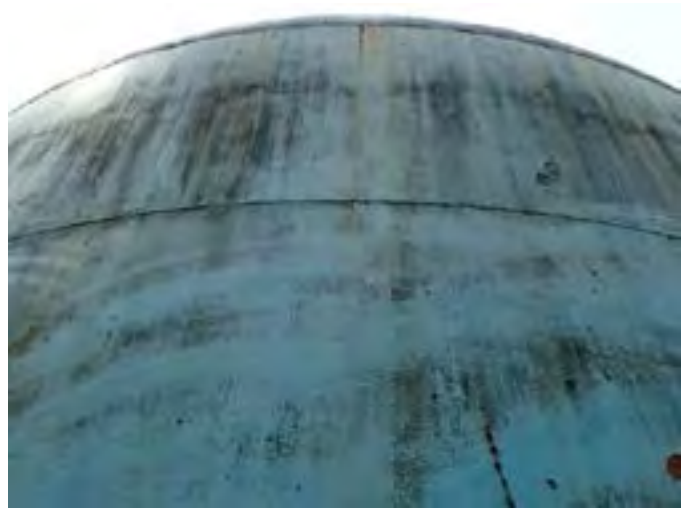
13 *Exterior Wall Having Coating Fatigue, Exposed Primary Coating, Exposed Steel And Corrosion*

14 *Exterior Wall Having Coating Fatigue, Exposed Primary Coating, Exposed Steel And Corrosion*

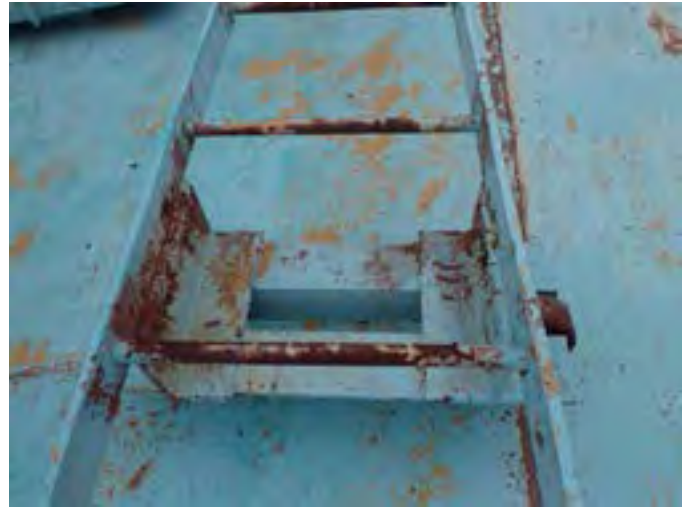
19 *Ladder Extending From The Vent Having Exposed Steel And Corrosion*

20 *Ladder Extending From The Vent Having Exposed Steel And Corrosion*

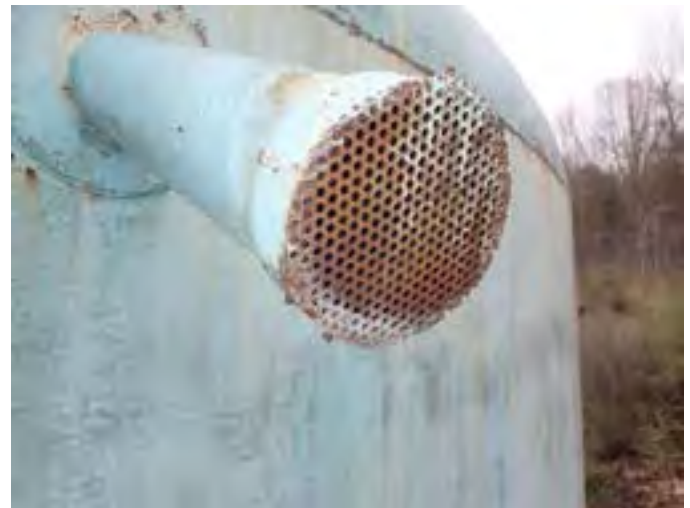
21 *Overflow Pipe Having Exposed Primary Coating, Exposed Steel And Corrosion*

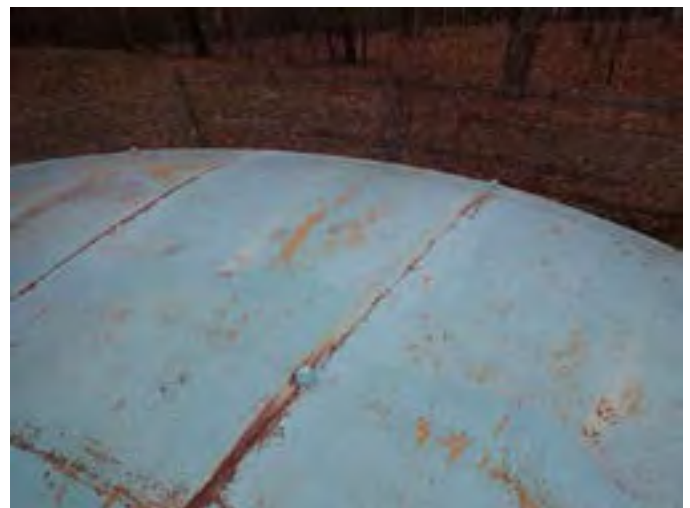
23 *Roof Having Exposed Primary Coating, Exposed Steel And Corrosion*

24 *Roof Having Exposed Primary Coating, Exposed Steel And Corrosion*

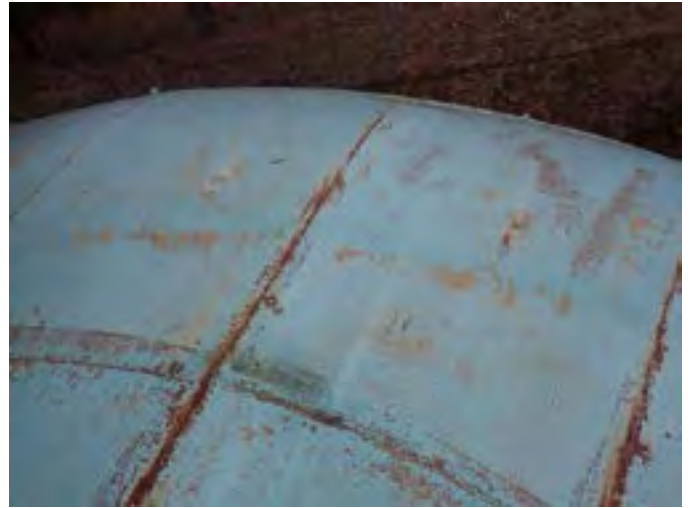
25 *Roof Having Exposed Primary Coating, Exposed Steel And Corrosion*

26 *Roof Having Exposed Primary Coating, Exposed Steel And Corrosion*

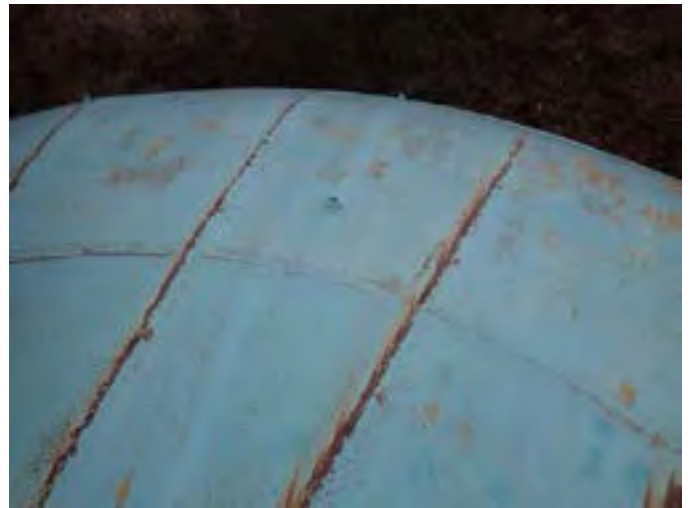
27 *Roof Having Exposed Primary Coating, Exposed Steel And Corrosion*

28 *Roof Having Exposed Primary Coating, Exposed Steel And Corrosion*

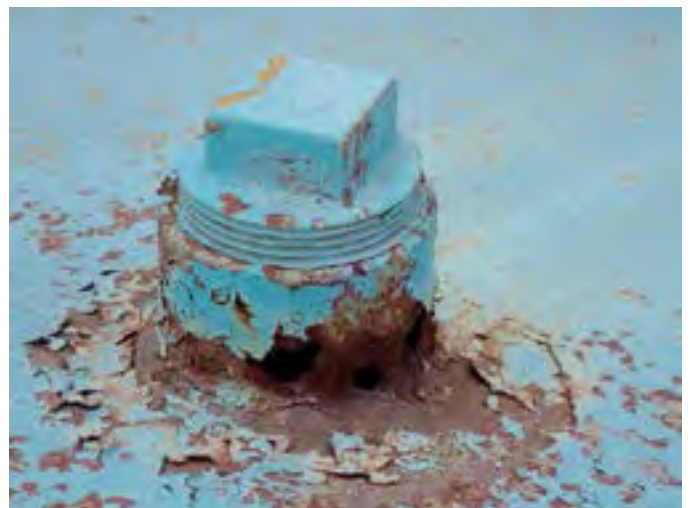
30 *Deteriorating Rigging Hole Coupling*

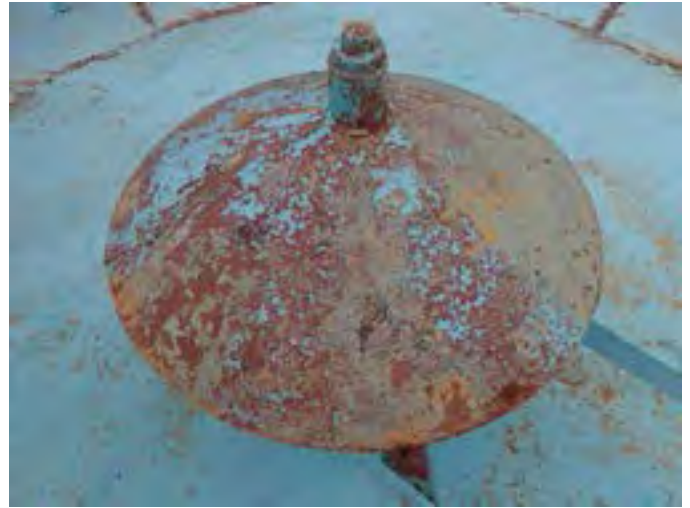
31 *Open Rigging Hole Penetration Within The Roof*

32 *Vent Assembly Having Exposed Primary Coating, Exposed Steel And Corrosion*

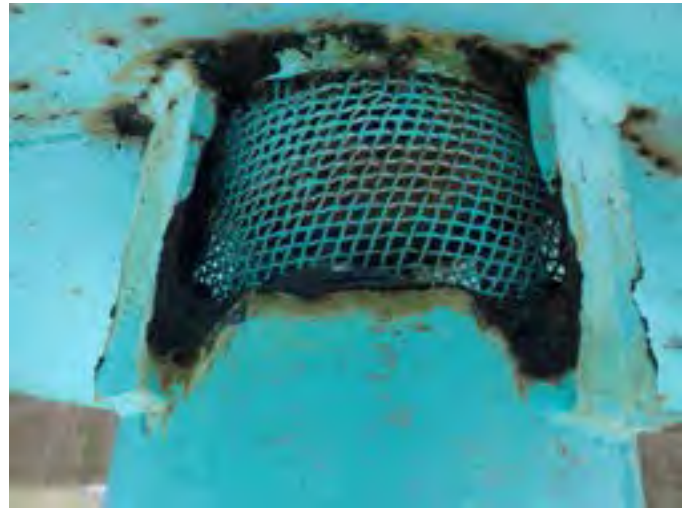
33 *Vent Assembly Having Exposed Primary Coating, Exposed Steel And Corrosion*

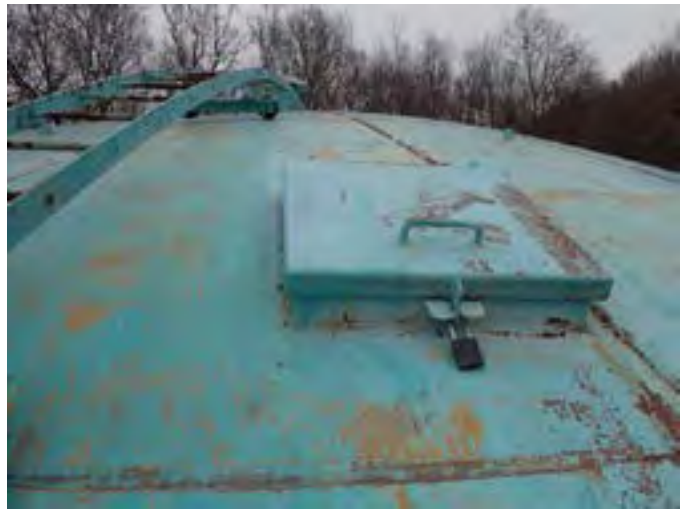
37 *Exterior Of The Hatch Cover Having Exposed Primary Coating, Exposed Steel And Corrosion*

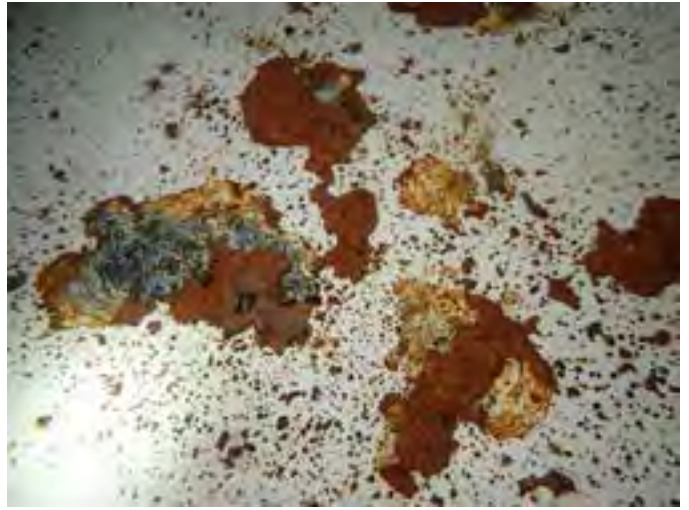
43 *Floor Having Coating Loss, Exposed Steel And Corrosion*

44 *Floor Having Coating Loss, Exposed Steel And Corrosion*
