Preliminary Engineering Report

Wellsburg Municipal Water Study
Village of Wellsburg, Chemung County, New York

February 2021
Revised July 2023

HUNT 2678-009

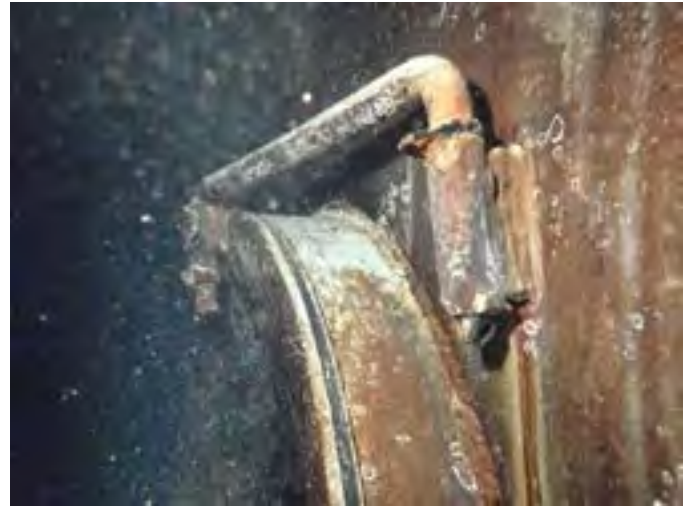
49 *Manway Davit Hinge Assembly Exposed Steel, Corrosion And Deterioration Of The Steel*

50 *Manway Davit Hinge Assembly Exposed Steel, Corrosion And Deterioration Of The Steel*

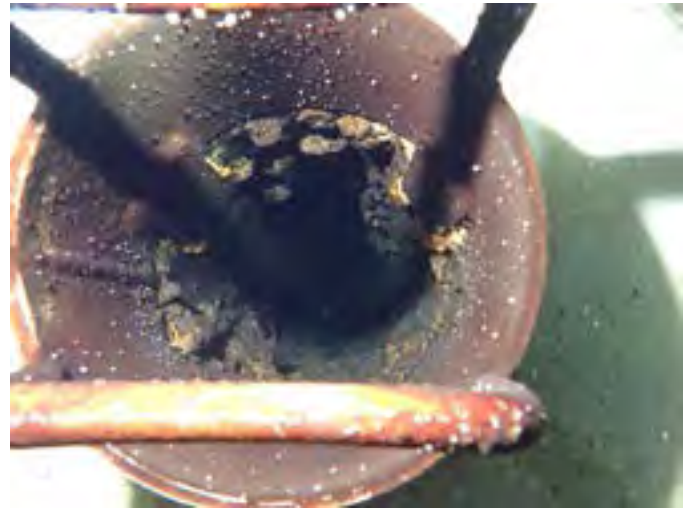
51 *Removable Slit Stop Riser Having Exposed Steel And Corrosion*

52 *Interior Of The Pipe Within The Floor Having Corrosion*

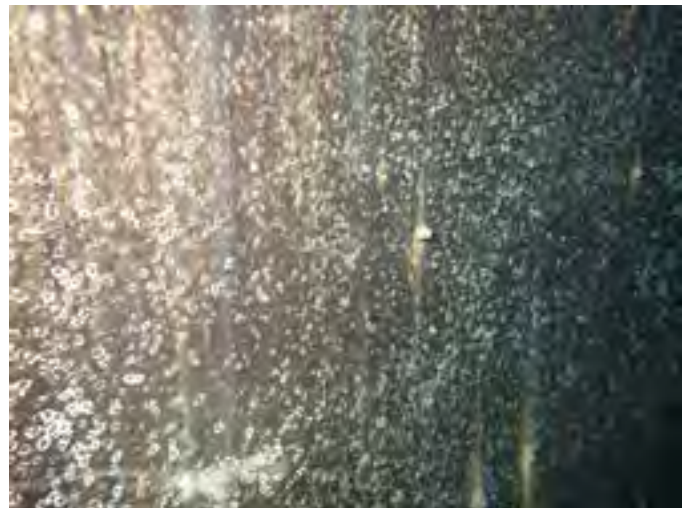
53 *Interior Wall Having Coating Fatigue, Exposed Steel And Corrosion*

54 *Interior Wall Having Coating Fatigue, Exposed Steel And Corrosion*

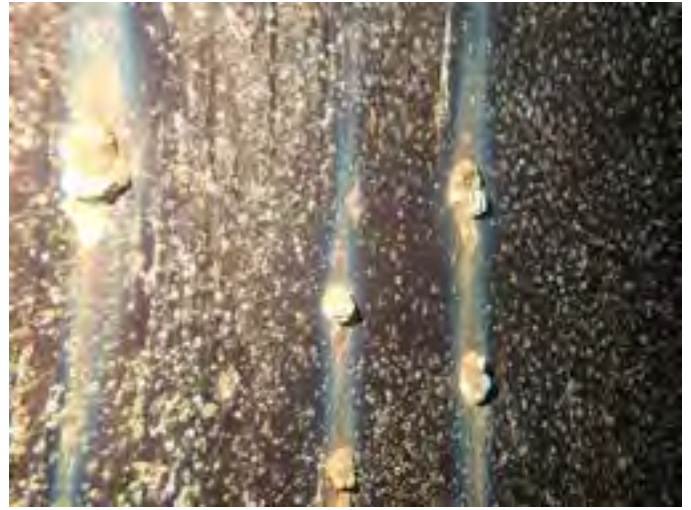
55 *Interior Wall Having Coating Fatigue, Exposed Steel And Corrosion*

56 *Interior Wall Having Coating Fatigue, Exposed Steel And Corrosion*

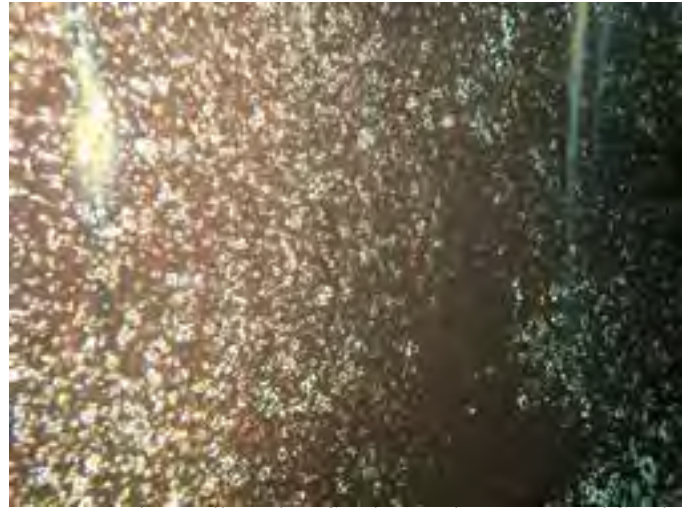
57 *Interior Wall Having Coating Fatigue, Exposed Steel And Corrosion*

58 *Interior Wall Having Coating Fatigue, Exposed Steel And Corrosion*

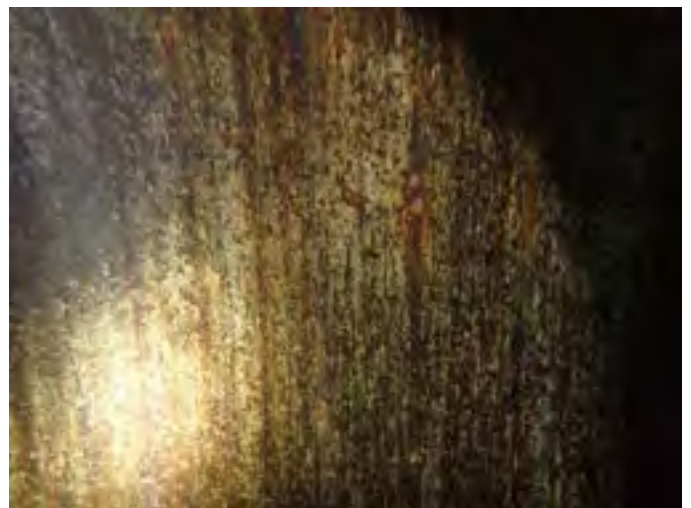
59 *Interior Wall Having Coating Fatigue, Exposed Steel And Corrosion*

60 *Interior Wall Having Coating Fatigue, Exposed Steel And Corrosion*

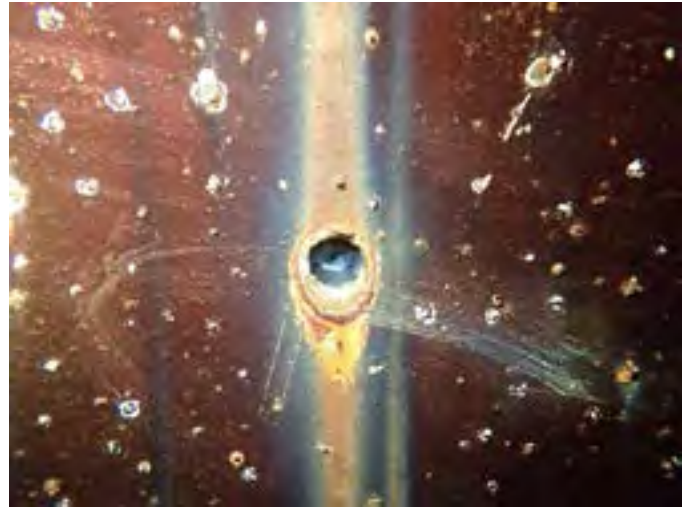
61 *Interior Wall Having Coating Fatigue, Exposed Steel And Corrosion*

62 *Interior Wall Having Pitting Of The Steel*

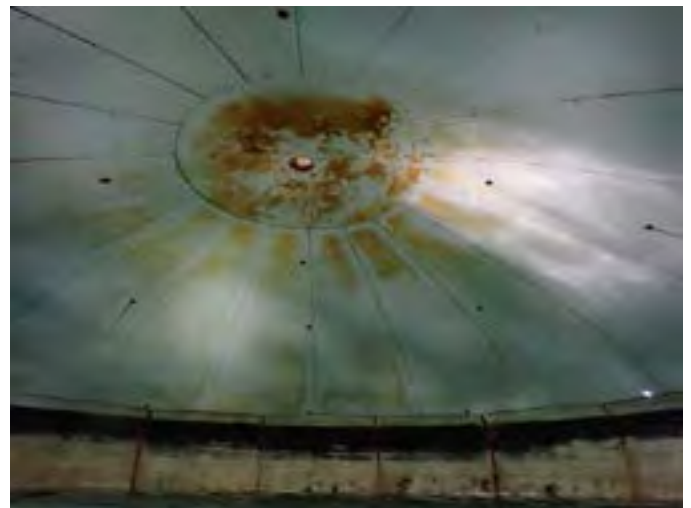
65 *Interior Wall Having Pitting Of The Steel*

66 *Overhead Having Surface Corrosion Showing Through The Coating*

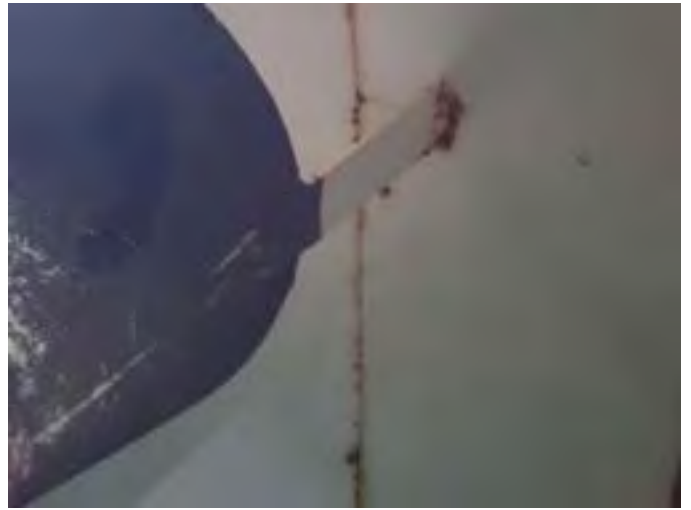
73 *Overflow Pipe Having Exposed Steel And Corrosion*
