Preliminary Engineering Report

Wellsburg Municipal Water Study
Village of Wellsburg, Chemung County, New York

February 2021
Revised July 2023

HUNT 2678-009

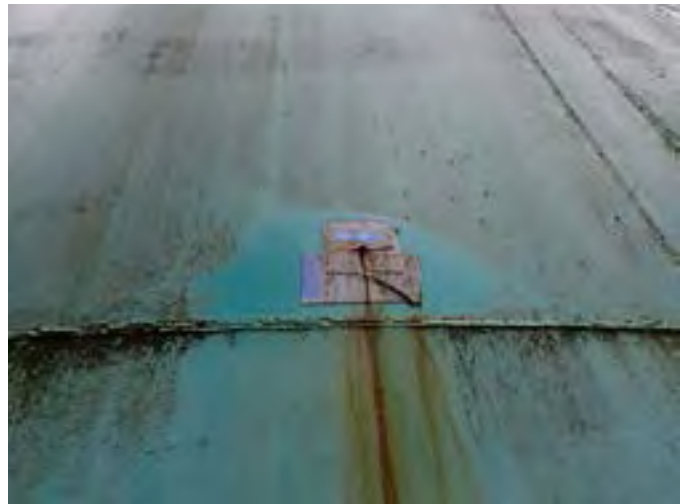
2 *Wood Dowel And Patch Temporarily Sealing A Penetration In The Second Wall Panel On The Southernmost Side Of The Tank*

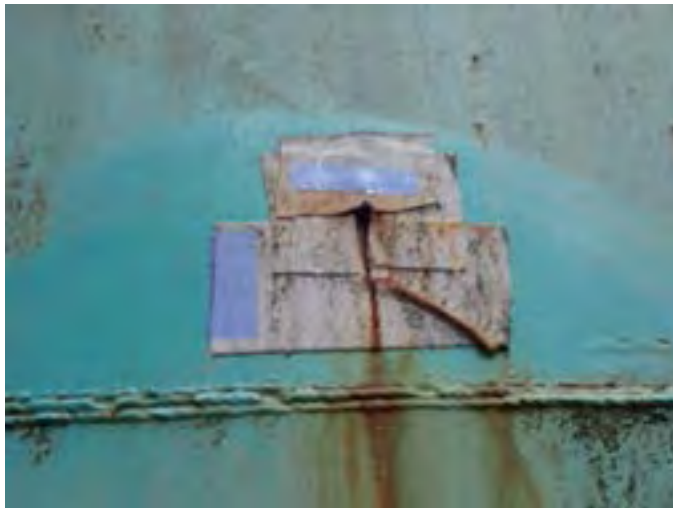
3 *Wood Dowel And Patch Temporarily Sealing A Penetration In The Second Wall Panel On The Southernmost Side Of The Tank*

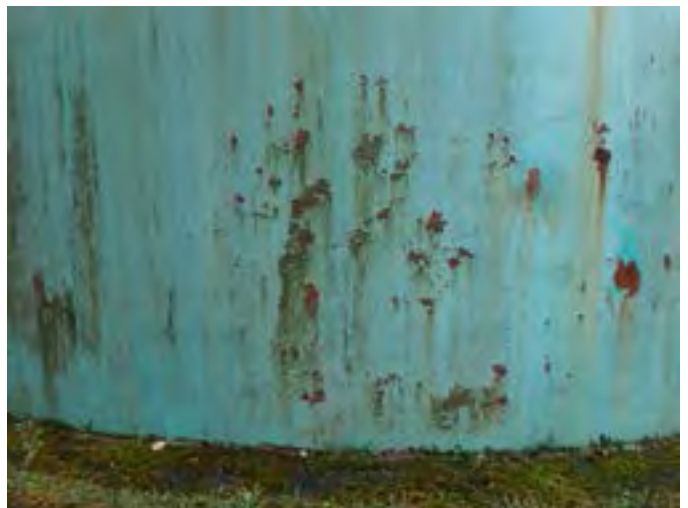
4 *Exterior Wall Having Coating Loss, Exposed Primary Coating, Exposed Steel, Corrosion And Accumulated Mildew*

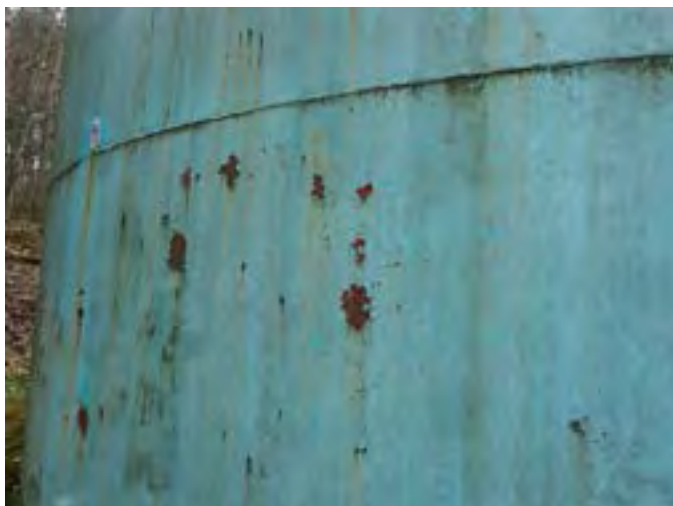
5 *Exterior Wall Having Coating Loss, Exposed Primary Coating, Exposed Steel, Corrosion And Accumulated Mildew*

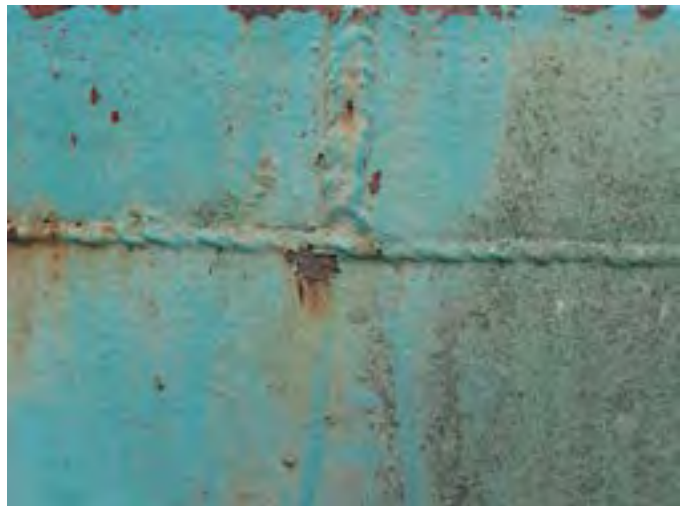
6 *Exterior Wall Having Coating Loss, Exposed Primary Coating, Exposed Steel, Corrosion And Accumulated Mildew*

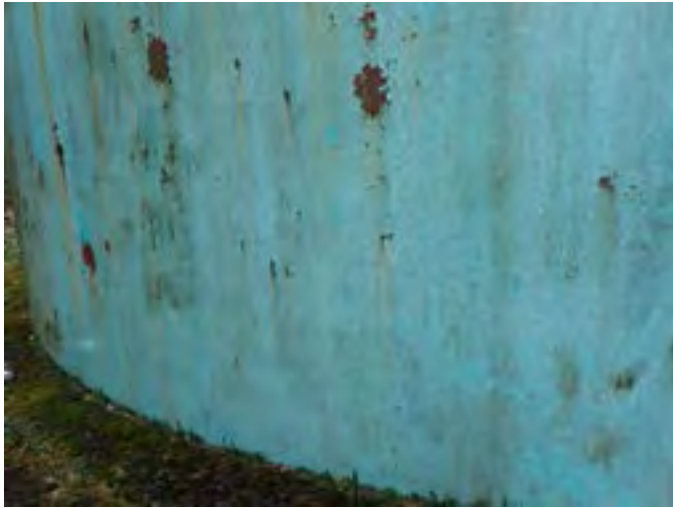
7 *Exterior Wall Having Coating Loss, Exposed Primary Coating, Exposed Steel, Corrosion And Accumulated Mildew*

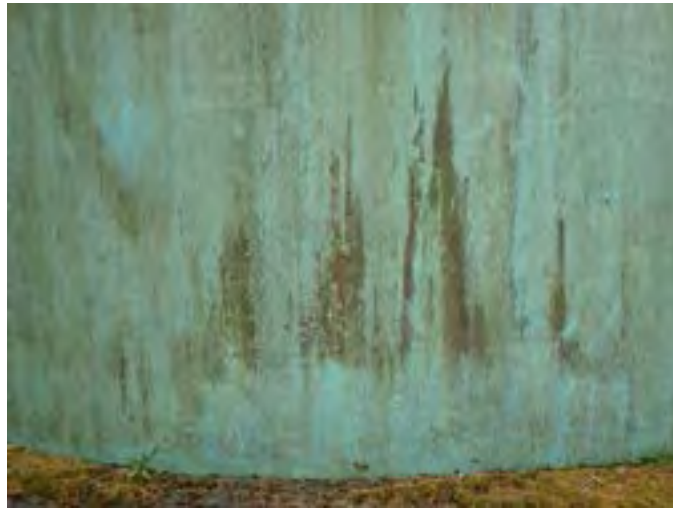
9 *Exterior Wall Having Coating Loss, Exposed Primary Coating, Exposed Steel, Corrosion And Accumulated Mildew*

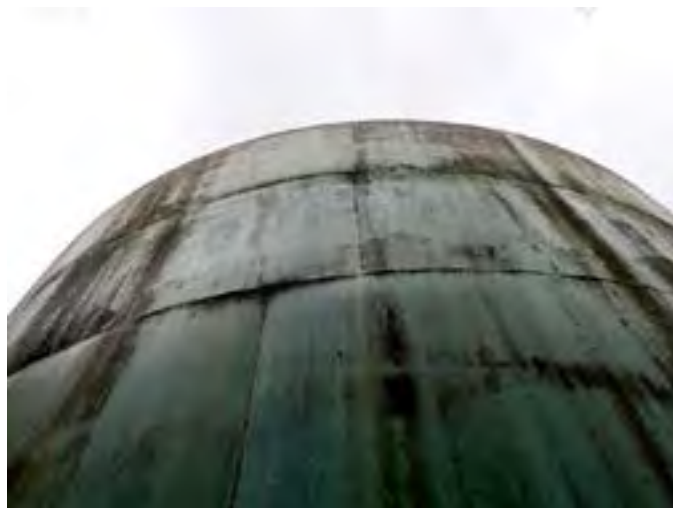
11 *Exterior Wall Having Coating Loss, Exposed Steel, Corrosion And Accumulated Mildew*

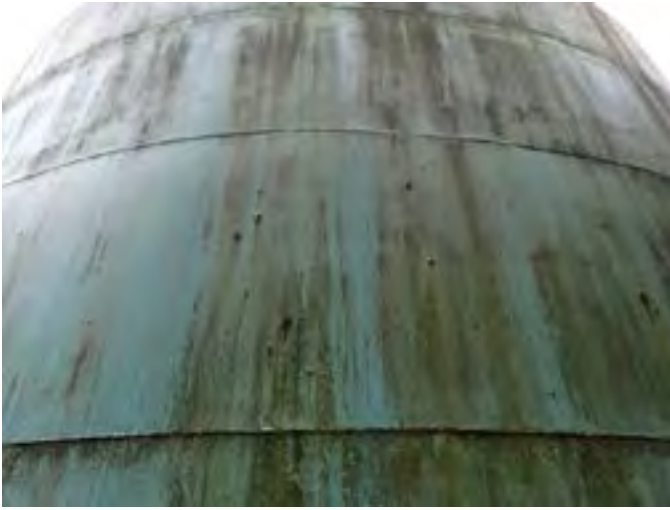
13 *Exterior Wall Having Coating Loss, Exposed Steel, Corrosion And Accumulated Mildew*

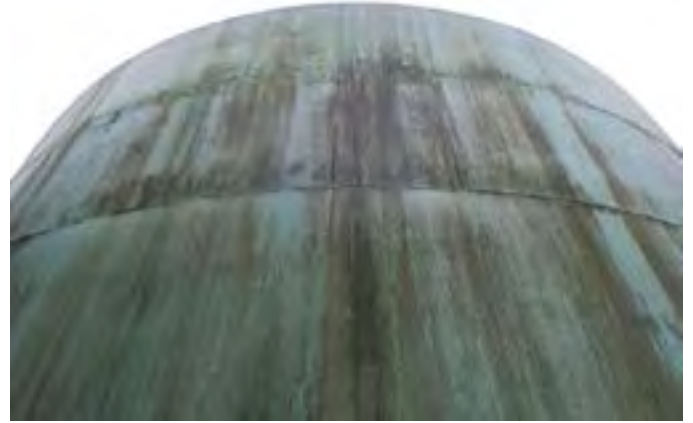
14 *Exterior Wall Having Coating Loss, Exposed Steel, Corrosion And Accumulated Mildew*

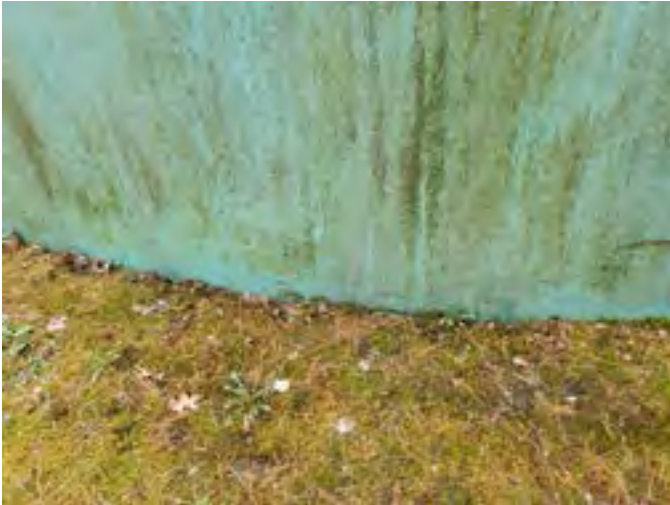
15 *Foundation Found Below Grade And Covered With Moss And Vegetation*

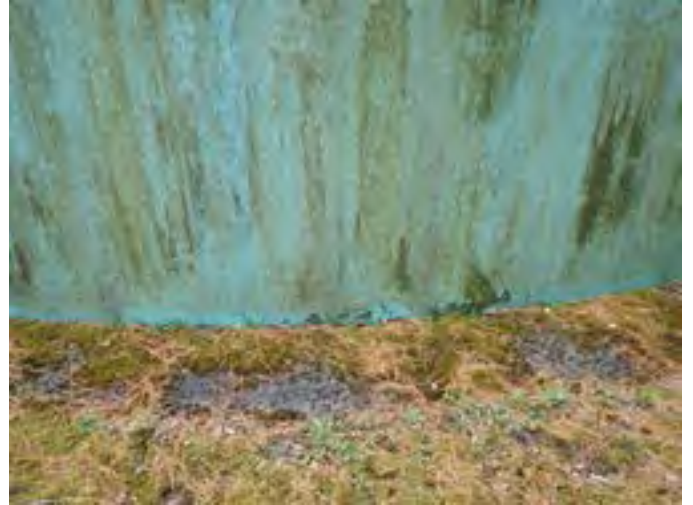
16 *Foundation Found Below Grade And Covered With Moss And Vegetation*

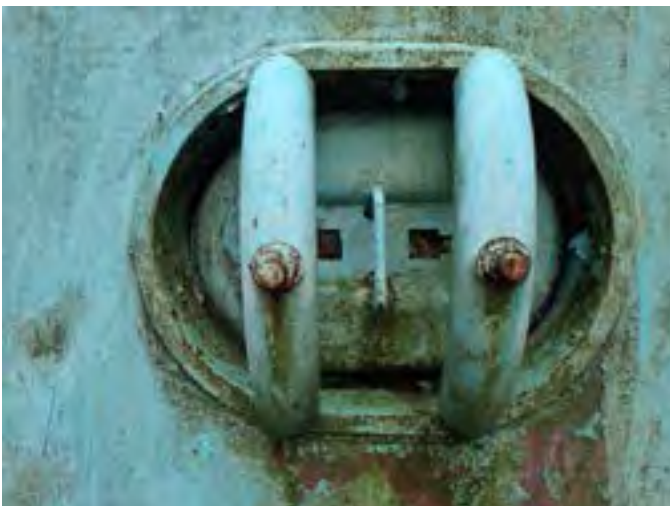
17 *Manway Having Coating Fatigue*

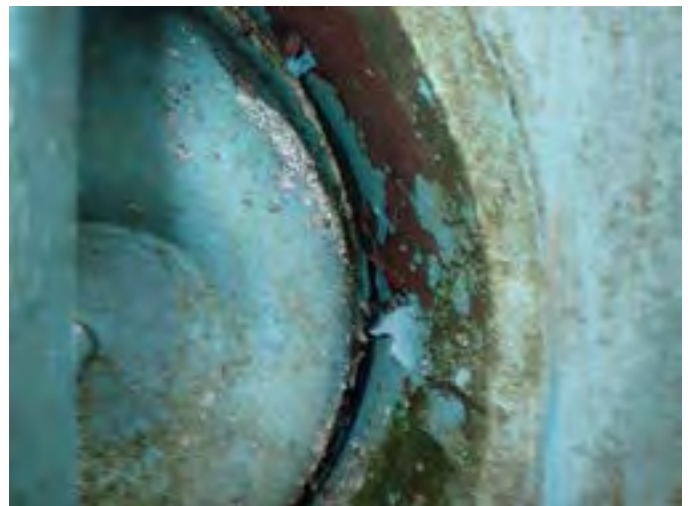
18 *Manway Having Exposed Primary Coating*

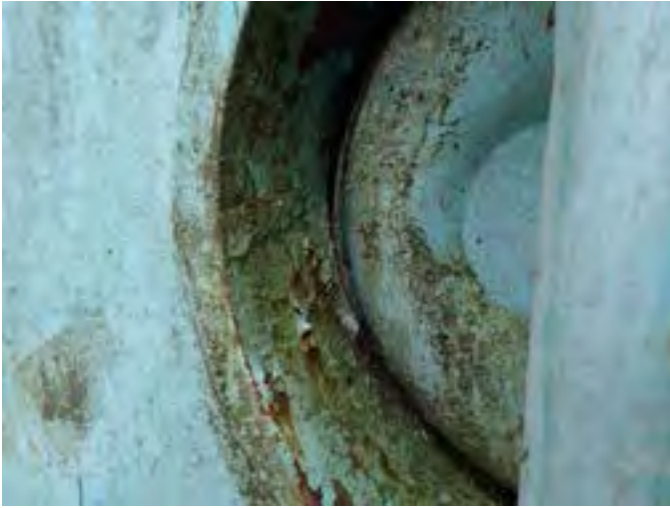
19 *Manway Having Exposed Steel And Corrosion*

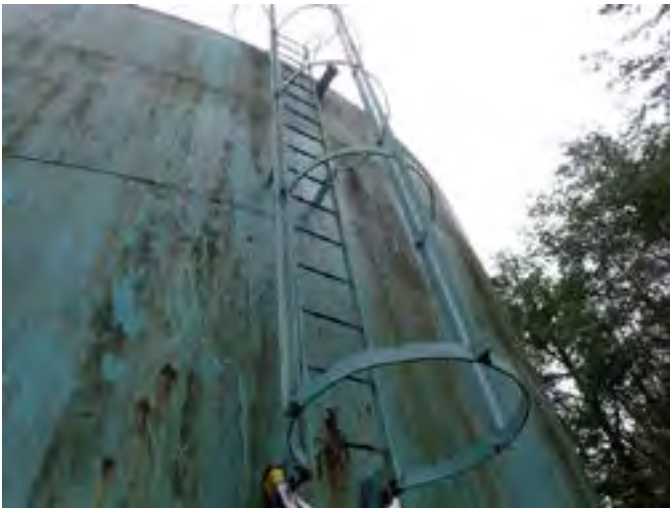
21 *Ladder And Safety Cage Having Coating Loss, Exposed Steel And Corrosion*

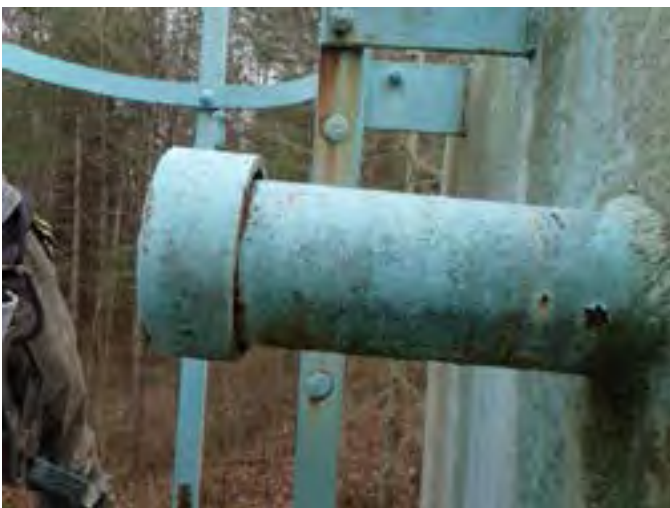
23 *Overflow Pipe Having Coating Loss, Exposed Steel And Corrosion*

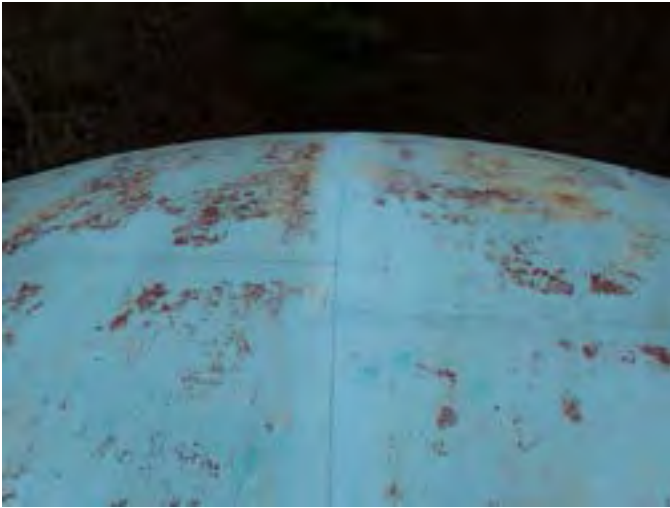
25 *Roof Having Coating Fatigue, Exposed Primary Coating, Exposed Steel And Corrosion*

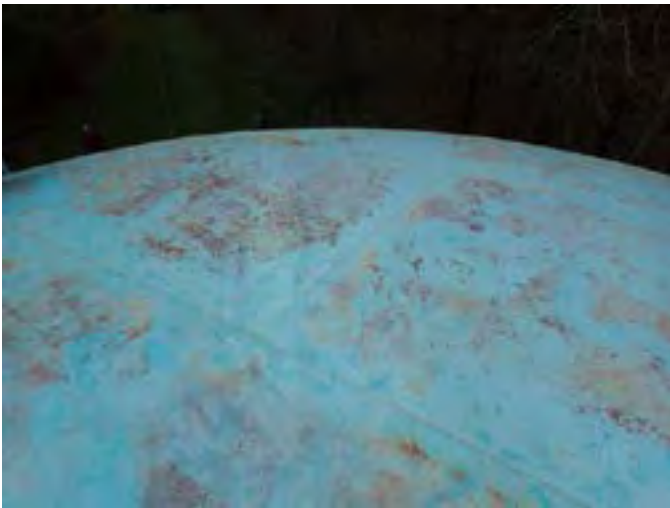
27 *Roof Having Coating Fatigue, Exposed Primary Coating, Exposed Steel And Corrosion*

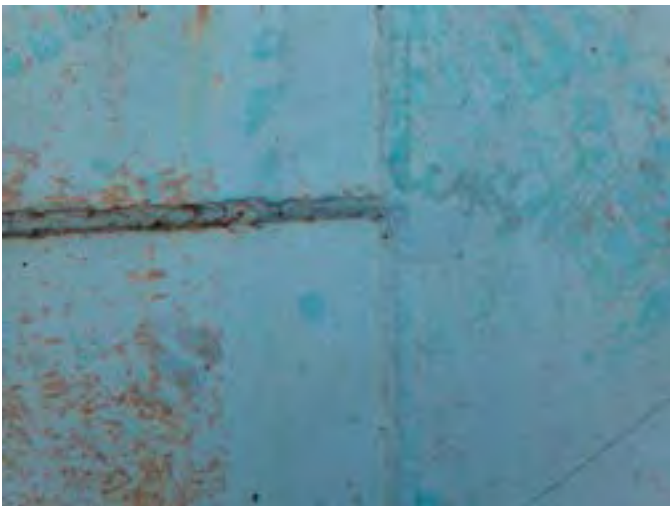
29 *Roof Having Coating Fatigue, Exposed Primary Coating, Exposed Steel And Corrosion*

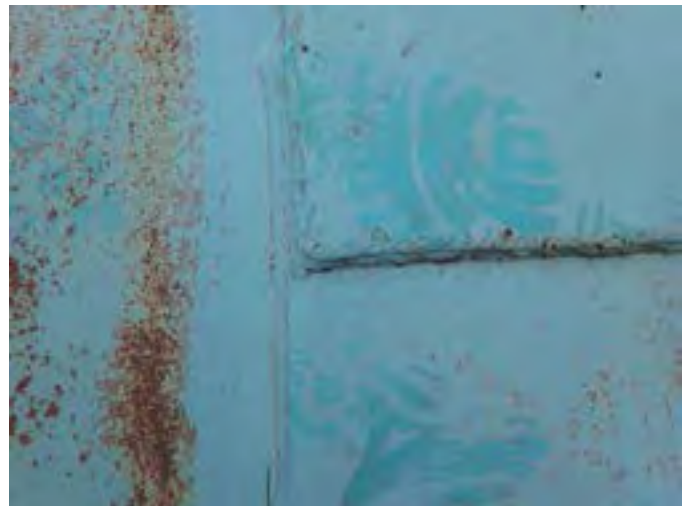
30 *Roof Having Coating Fatigue, Exposed Primary Coating, Exposed Steel And Corrosion*

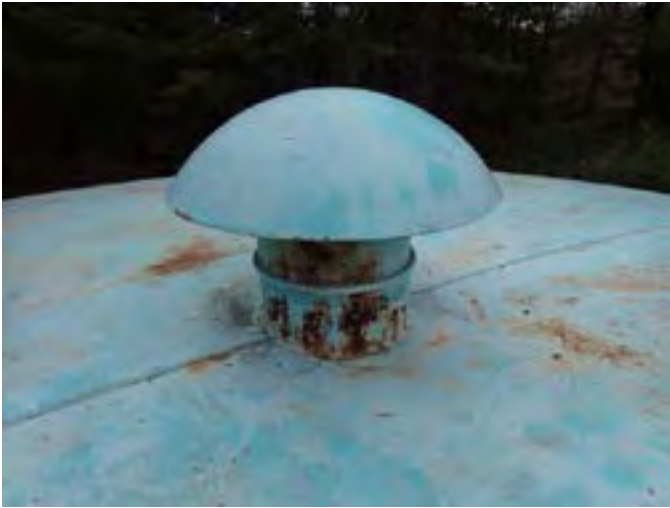
31 *Vent Assembly Having Coating Loss, Exposed Steel And Corrosion*

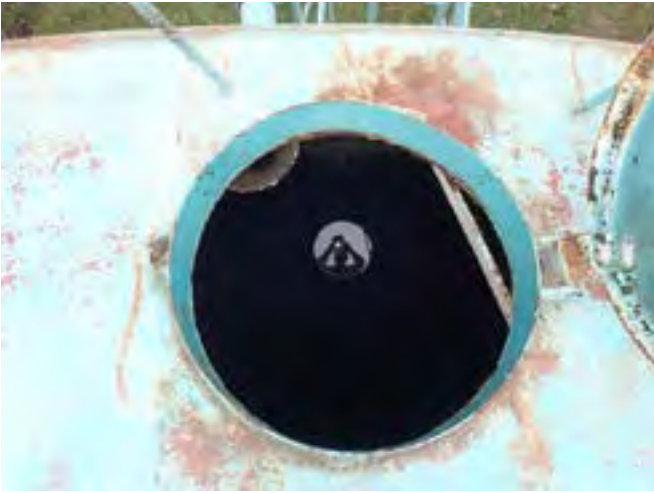
37 *Interior Of The Hatch Trunk Having Exposed Steel And Corrosion*

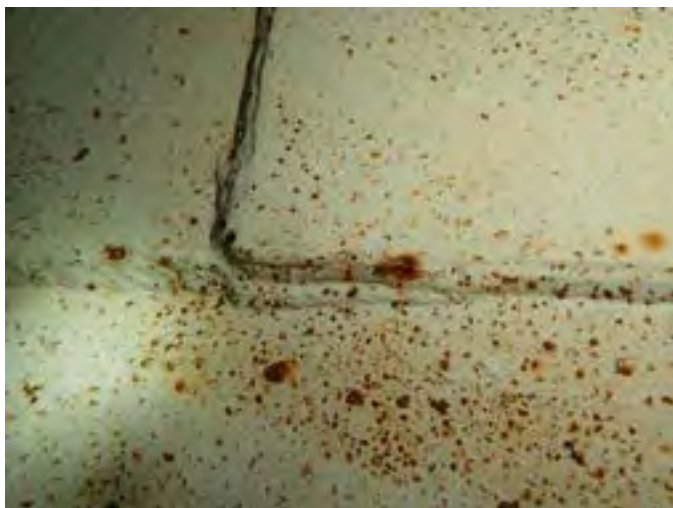
47 *Floor Having Coating Loss, Exposed Steel And Corrosion*

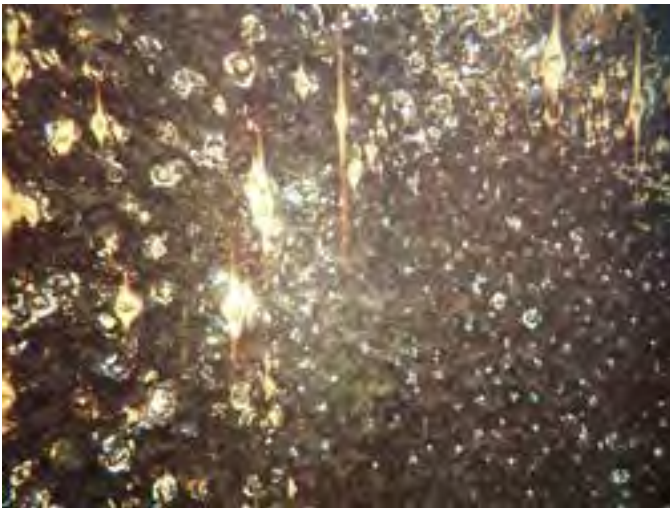
57 *Interior Wall Having Coating Loss, Exposed Steel And Corrosion*

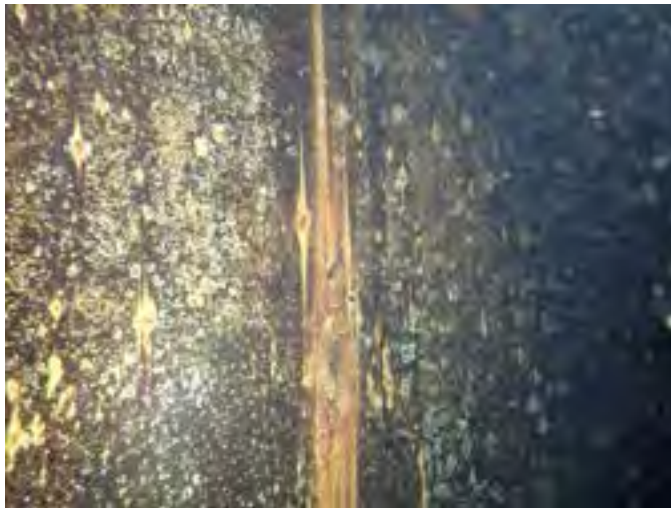
63 *Interior Wall Having Coating Loss, Exposed Steel And Corrosion*

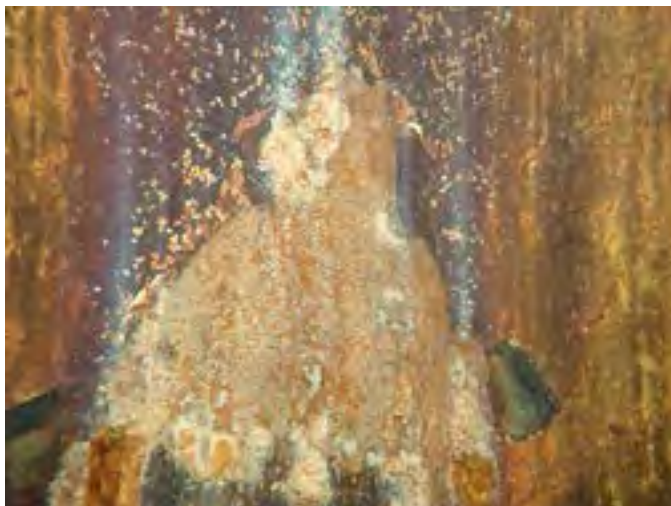
65 *Interior Wall Having Coating Loss, Exposed Steel And Corrosion*

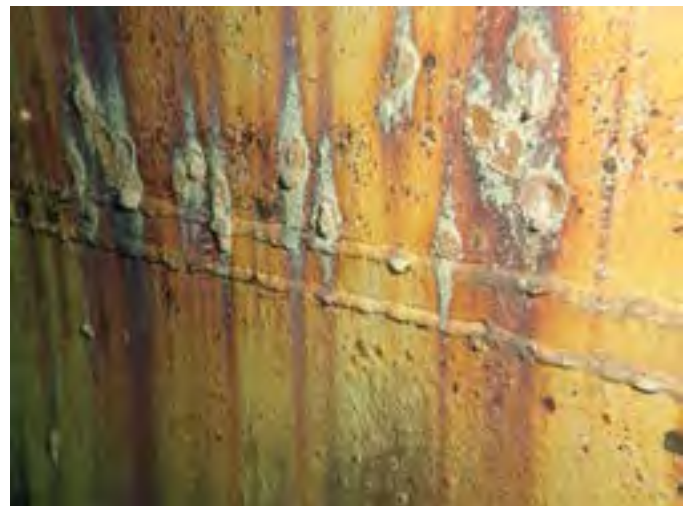
66 *Interior Wall Having Coating Loss, Exposed Steel And Corrosion*

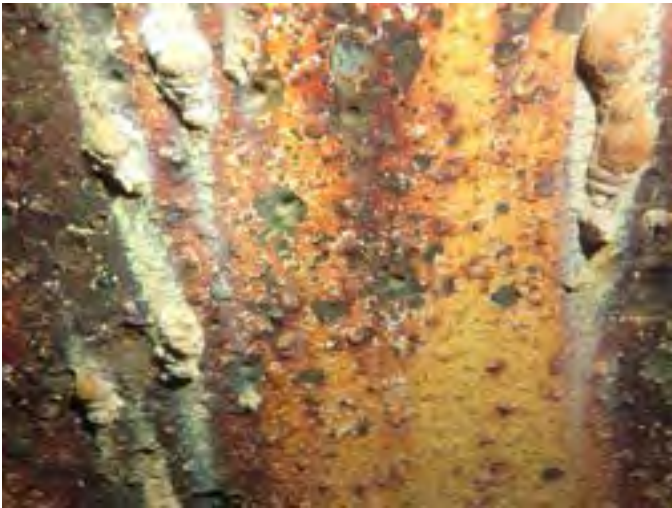
69 *Wall Panel Having Pitting Of The Steel*

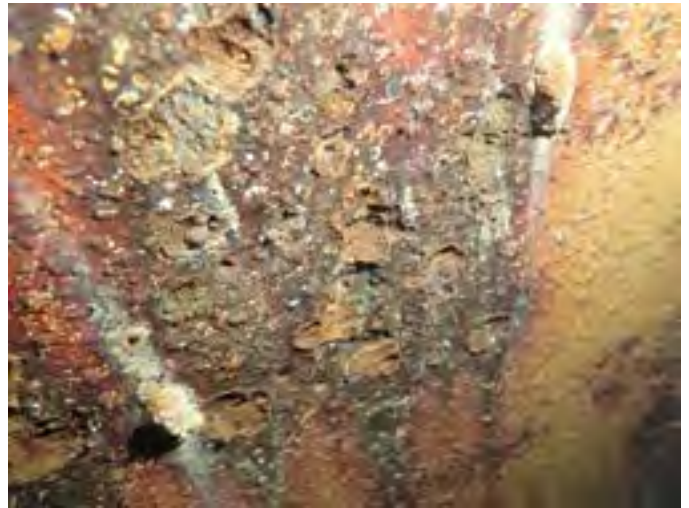
70 *Wall Panel Having Pitting Of The Steel*

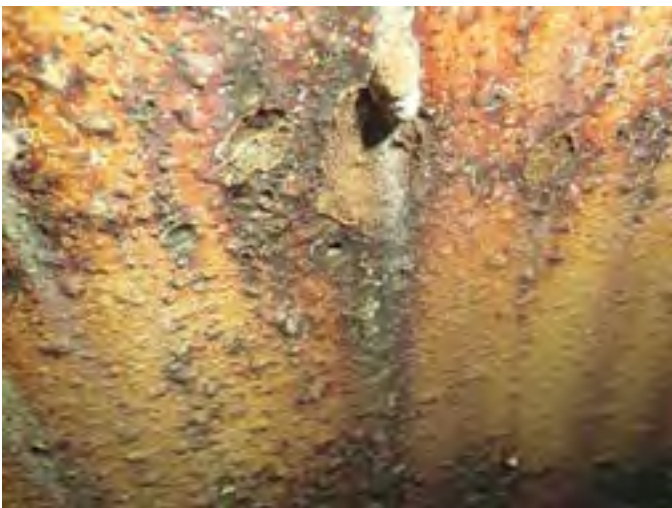
71 *Wall Panel Having Pitting Of The Steel*

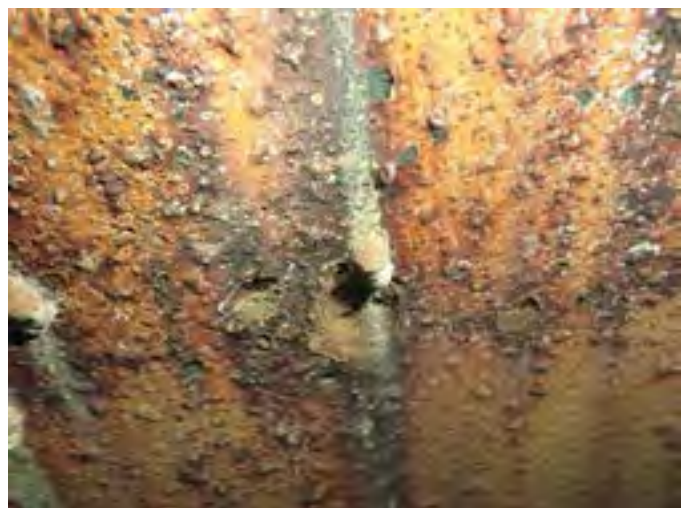
72 *Wall Panel Having Pitting Of The Steel*

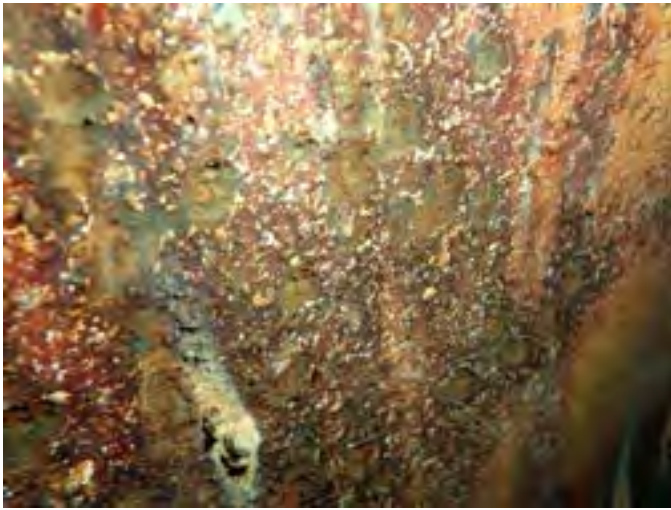
73 *Wall Panel Having Pitting Of The Steel*

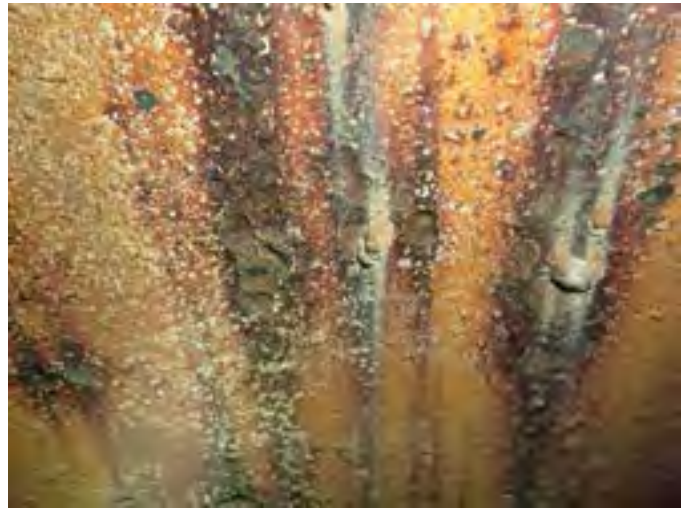
74 *Wall Panel Having Pitting Of The Steel*

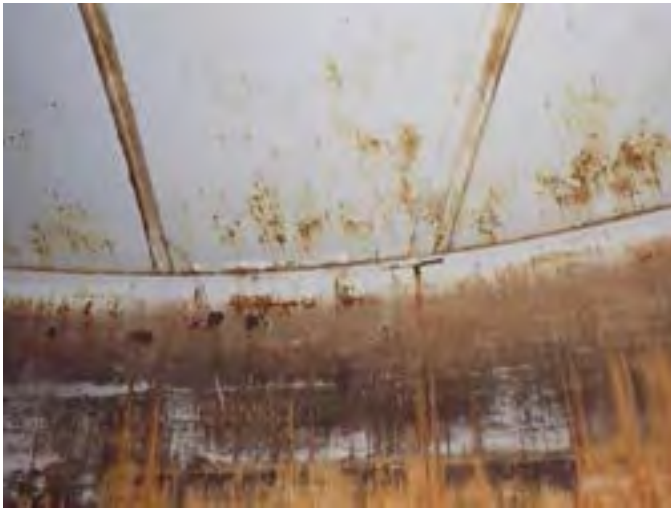
75 *Interior Wall Having Coating Loss, Exposed Steel And Corrosion*

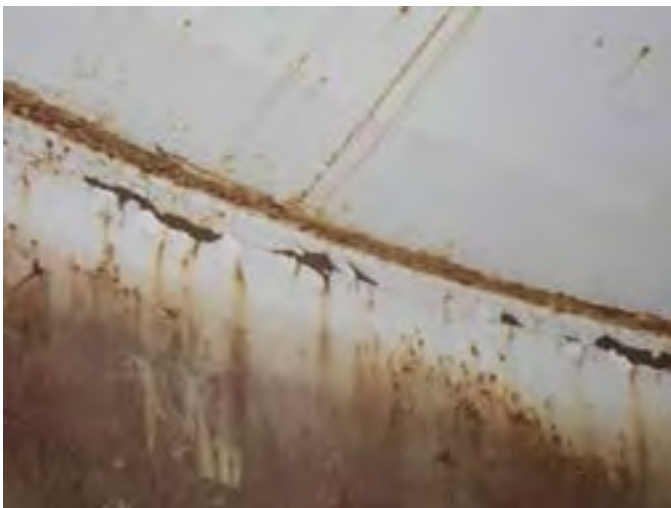
77 *Interior Wall Having Coating Loss, Exposed Steel And Corrosion*

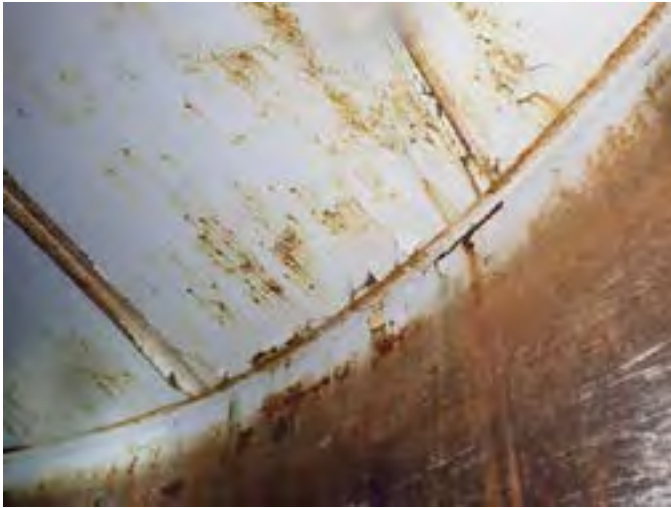
79 *Interior Wall Having Coating Loss, Exposed Steel And Corrosion*

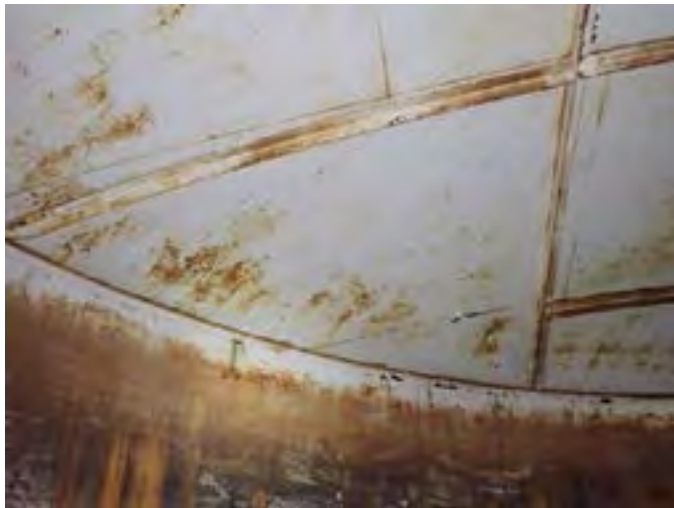
81 *Overhead Having Coating Loss, Exposed Steel And Corrosion*

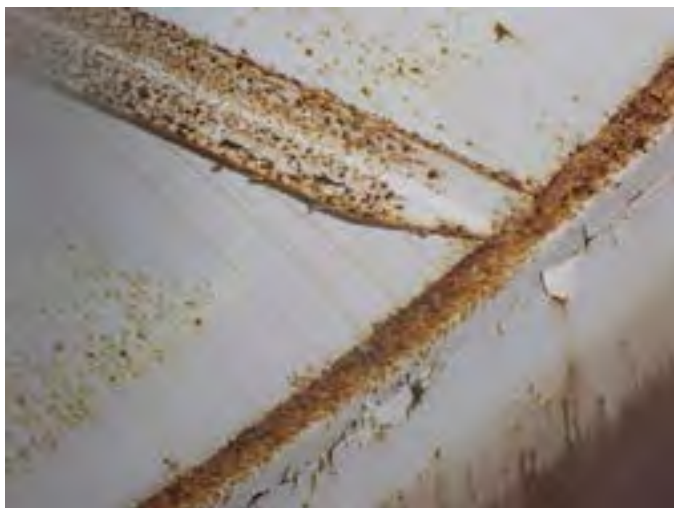
83 *Overhead Having Coating Loss, Exposed Steel And Corrosion*

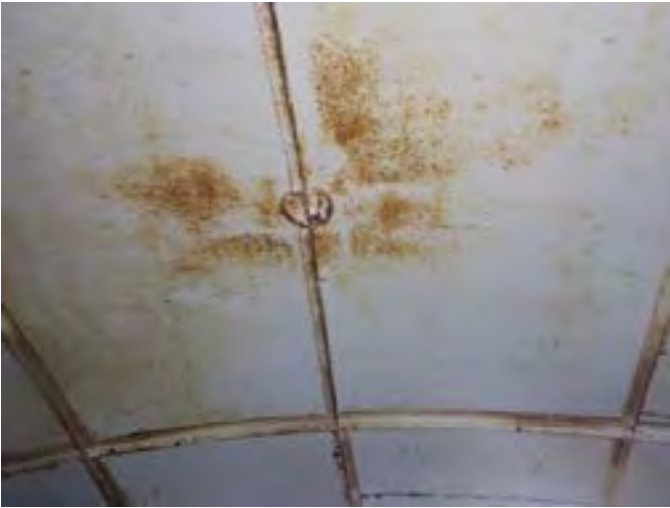
85 *Overhead Having Coating Loss, Exposed Steel And Corrosion*

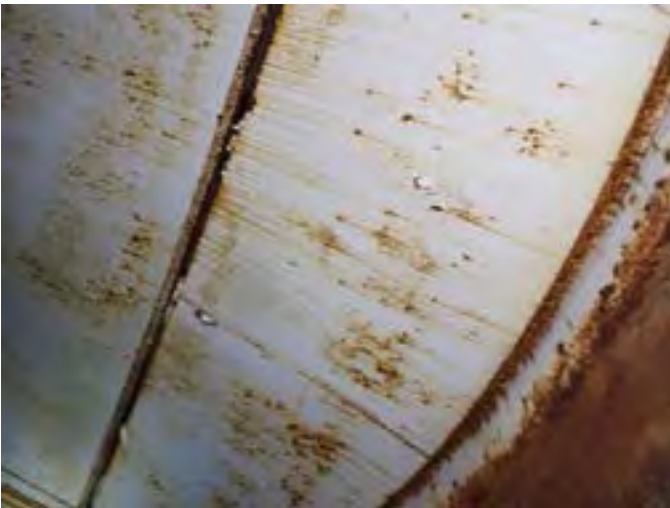
87 *Overhead Having Coating Loss, Exposed Steel And Corrosion*

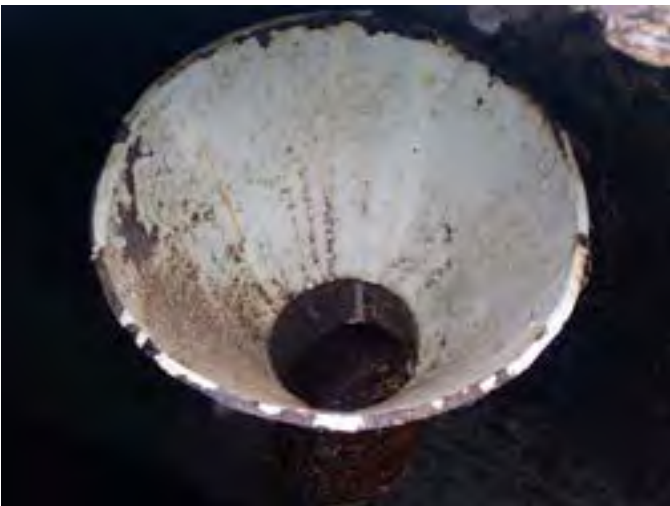
89 *Unobstructed Overflow Pipe*

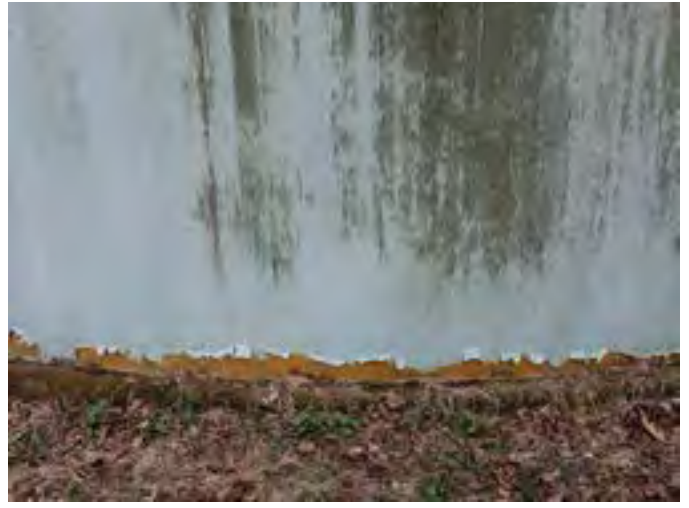
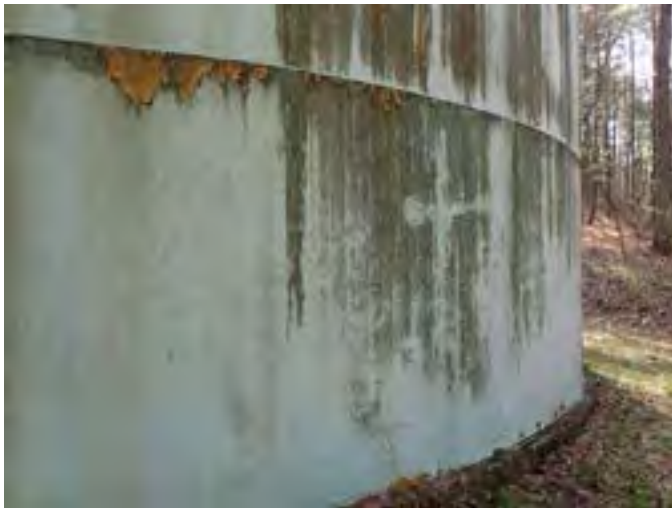
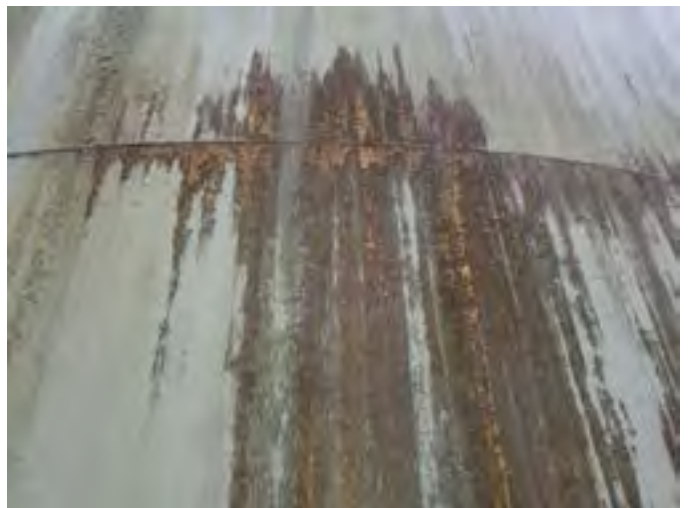
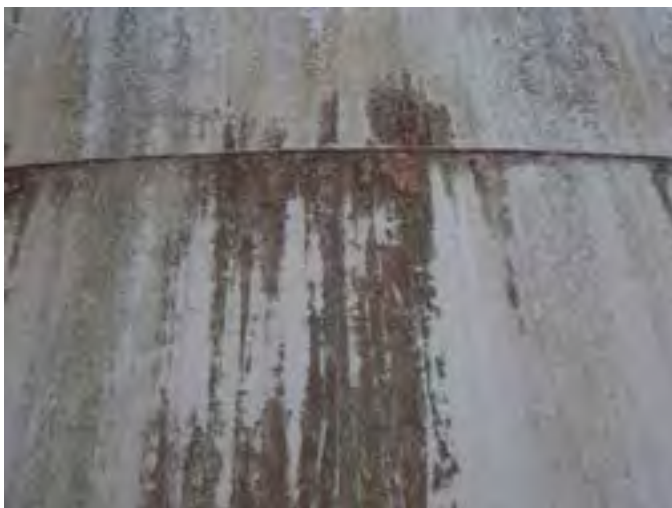
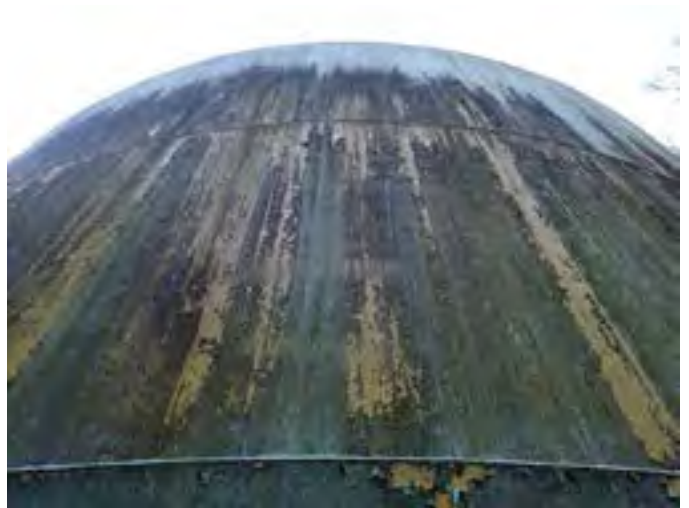
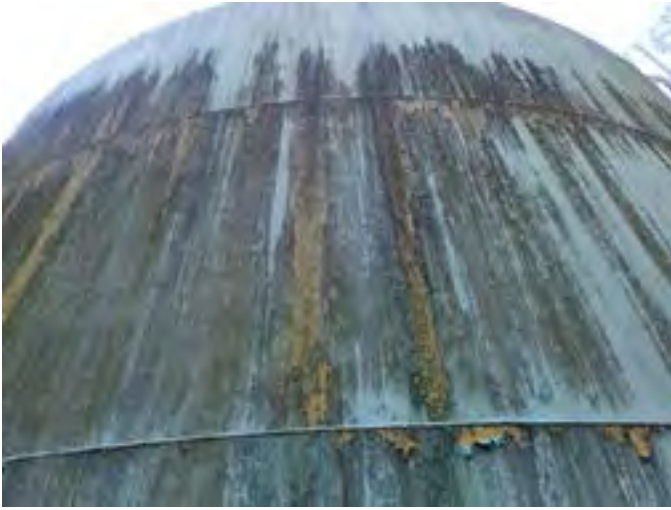
The protective coating on the exterior wall surfaces appeared to have been applied uniformly, however was found having fair adhesion value at this time.

Adhesion loss (lifting/peeling) of the coating was observed throughout approximately 25% of the exterior wall surfaces, resulting in exposure of the primary coating. The primary coating within these areas of exposure appeared to have good adhesion value at this time.

2 *Exterior Wall Having Coating Loss, Exposed Primary Coating And Accumulated Mildew*

RECOMMENDATION(S): It is our recommendation to pressure-wash the exterior wall surfaces at 4,500 P.S.I. using an oscillating tip to remove the accumulated mildew from these surfaces and to remove any and all coating that has lost adhesion from the tank.

It is also our recommendation to re-coat the exterior walls using a protective coating formulated for exterior exposure and to be applied in accordance with the product manufacturer's surface preparation and application recommendations in an effort to halt corrosion, prevent steel fatigue/deterioration and to provide good protection for the exterior welded steel wall surfaces.

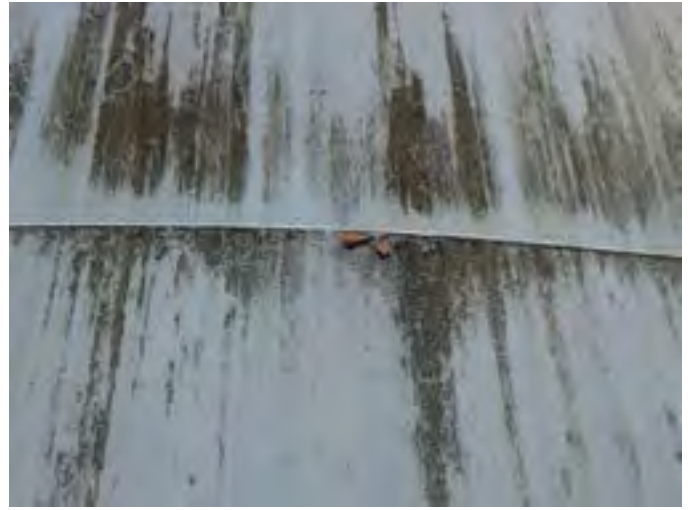
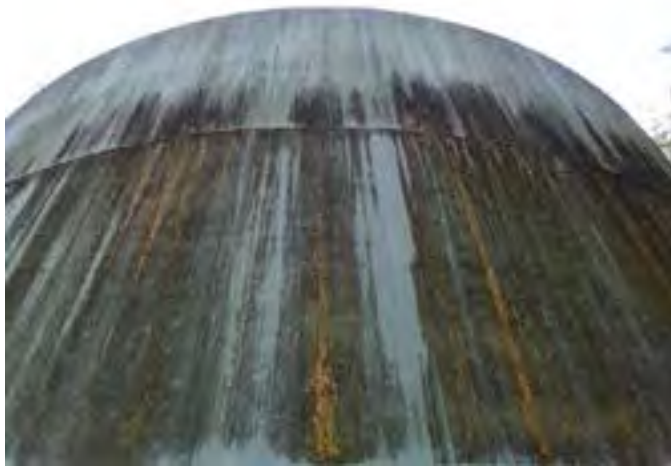
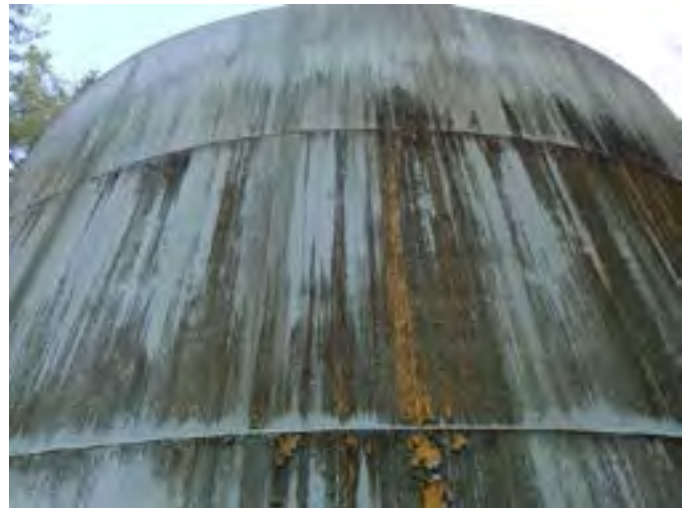
8 *Exterior Wall Having Coating Loss, Exposed Primary Coating And Accumulated Mildew*

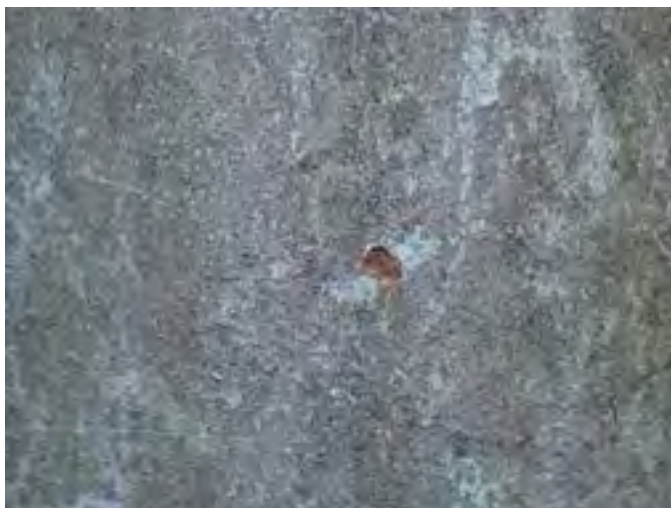
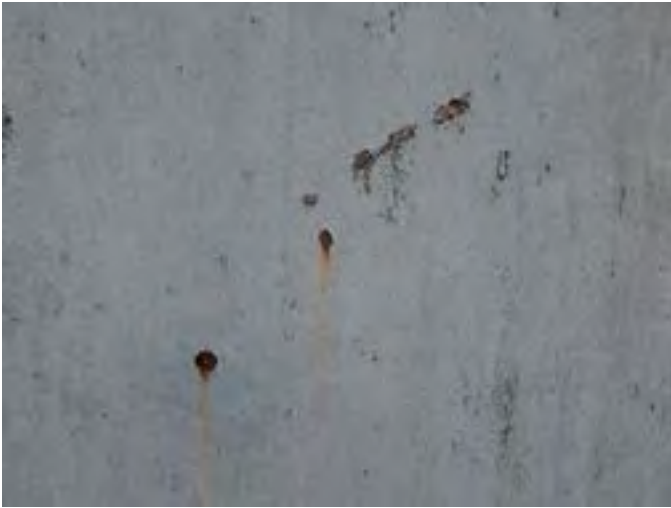
No obvious fatigue (pitting) of the steel was evident within these areas of steel exposure, rather mild corrosion exists at this time.

11 *Exterior Wall Having Coating Loss, Exposed Steel And Corrosion*

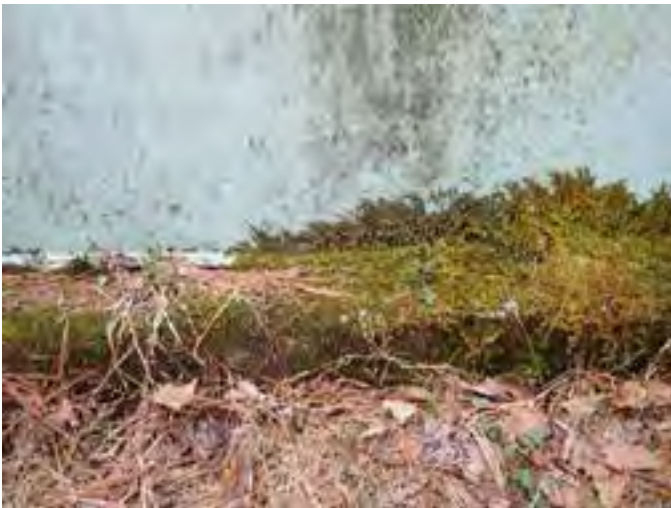
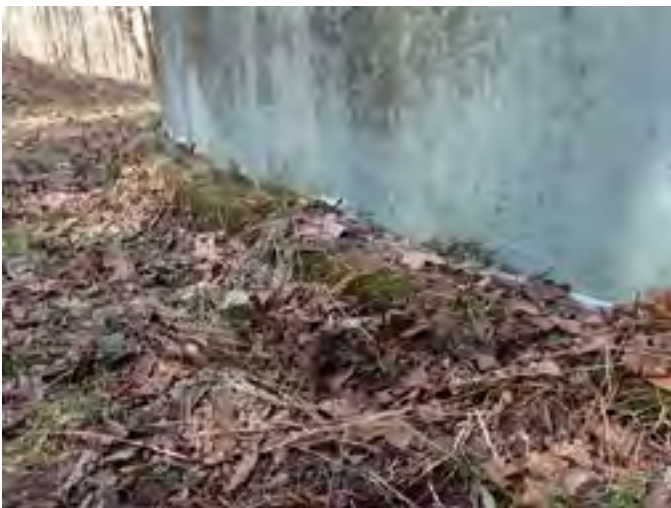
The exposed surfaces of the 5” wide by 3” tall concrete foundation were found covered with moss/vegetation, preventing an inspection of the concrete.

15 *Exposed Foundation Surface Found Covered With Moss And Vegetation*

RECOMMENDATION(S): It is our recommendation that when the exterior walls are pressure-washed to also pressure-wash the exposed surfaces of the foundation to remove the moss and vegetation. Upon removing the vegetation, we recommend inspecting the concrete to determine the integrity of its surfaces.

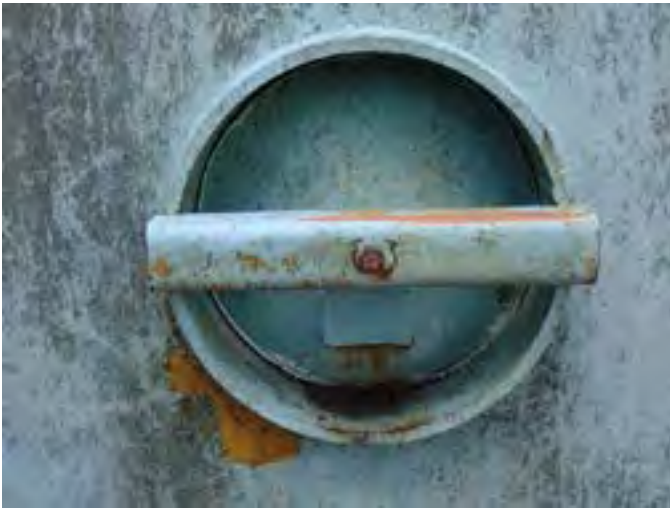
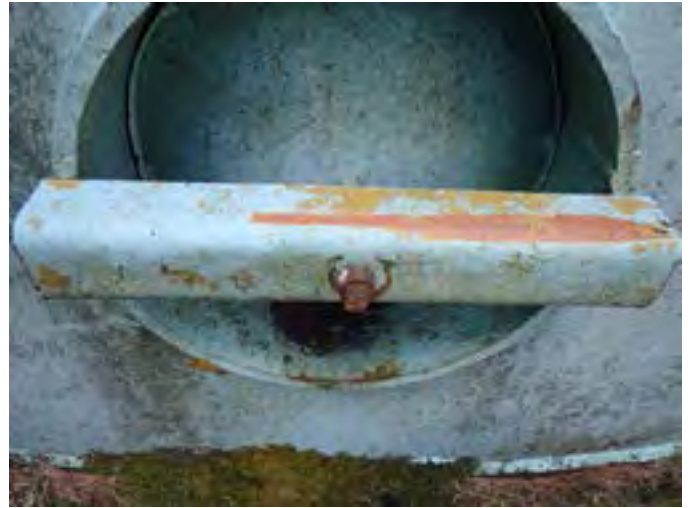
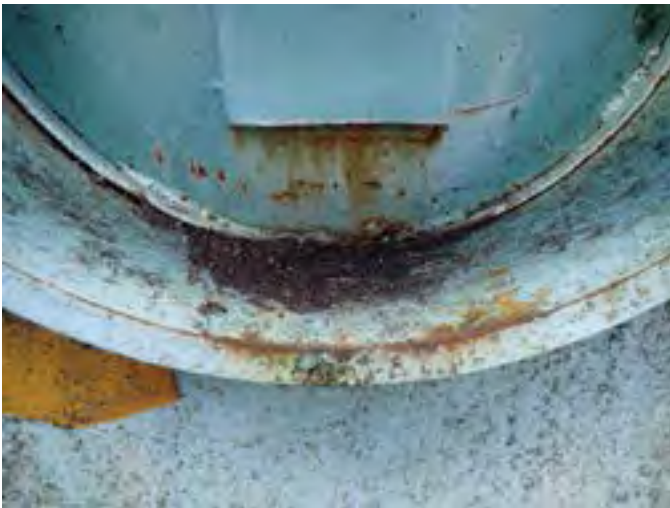
Secondary coating adhesion loss was observed throughout less than 5% of these surfaces, resulting in exposure of the primary coating. Coating loss throughout less than 5% of these surfaces has resulted in exposure of the underlying steel.

No obvious fatigue/deterioration of the steel was evident within these areas of exposure, rather mild corrosion exists at this time. The primary coating within these areas of exposure appeared to have good adhesion value at this time.

19 *Manway Having Coating Loss*

RECOMMENDATION(S): It is our recommendation to pressure-wash the exterior surfaces of the manway at 4,500 P.S.I. using an oscillating tip to remove the accumulated mildew from these surfaces and to remove any and all coating that has lost adhesion.

It is also our recommendation to re-coat the exterior surfaces of the manway using a protective coating formulated for exterior exposure and to be applied in accordance with the product manufacturer's surface preparation and application recommendations in an effort to halt corrosion, prevent steel fatigue/deterioration and to provide good protection for the exterior surfaces of the manway.

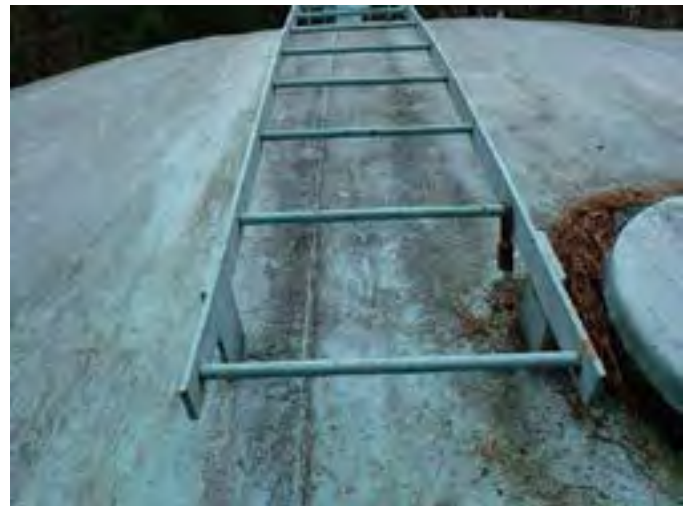
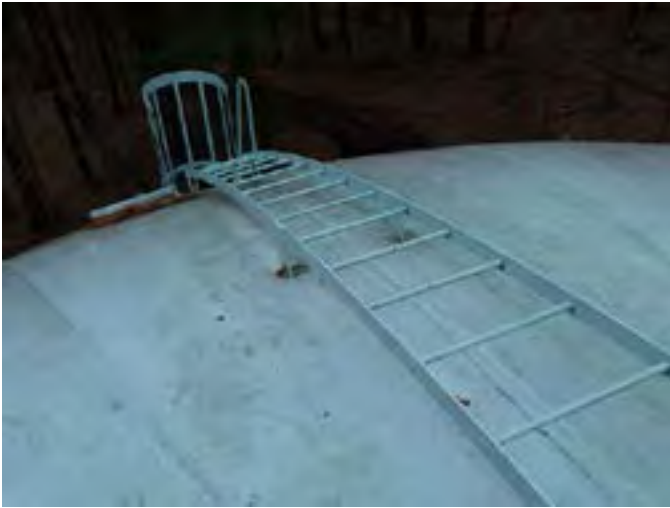
Secondary coating loss was observed throughout less than 5% of the ladder and safety cage, resulting in exposure of the primary coating. The primary coating within these areas of exposure appeared to have good adhesion value at this time.

No obvious fatigue/deterioration of the ladder and safety cage were evident within these areas of steel exposure, rather mild corrosion exists at this time.

23 *Ladder Having Exposed Steel And Corrosion*

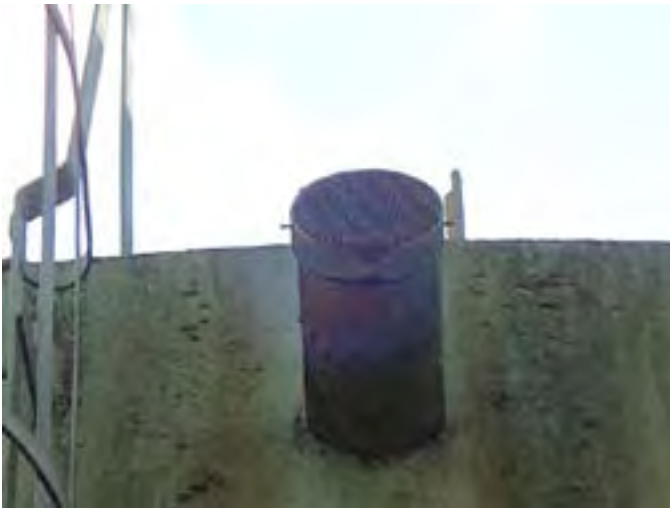
27 *Unobstructed And Screened Overflow Pipe*
