Preliminary Engineering Report

Wellsburg Municipal Water Study
Village of Wellsburg, Chemung County, New York

February 2021
Revised July 2023

HUNT 2678-009

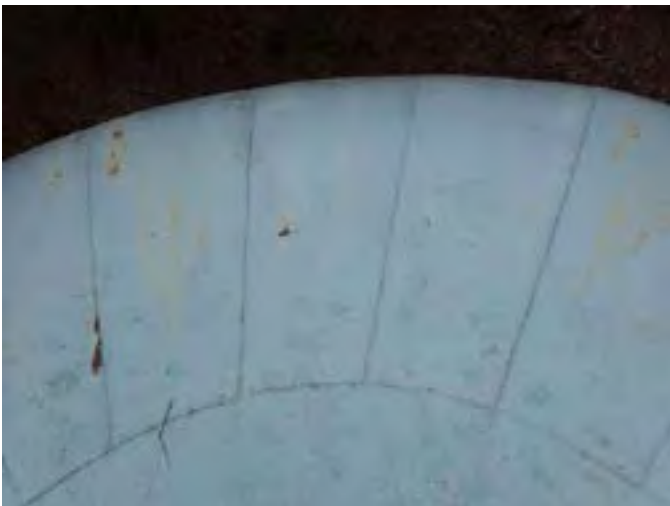
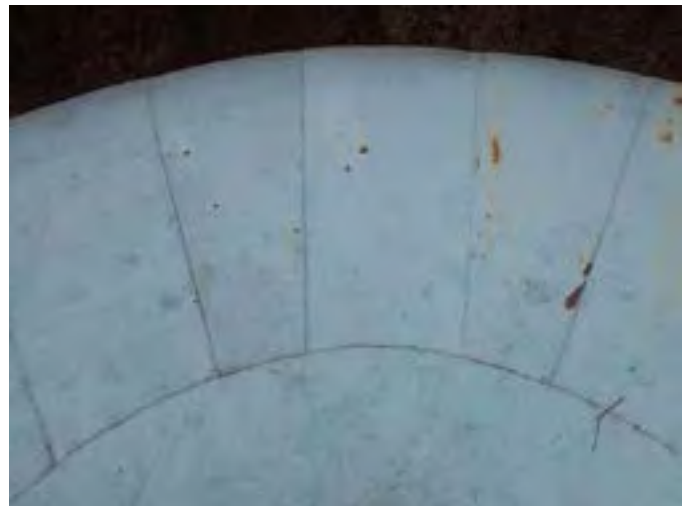
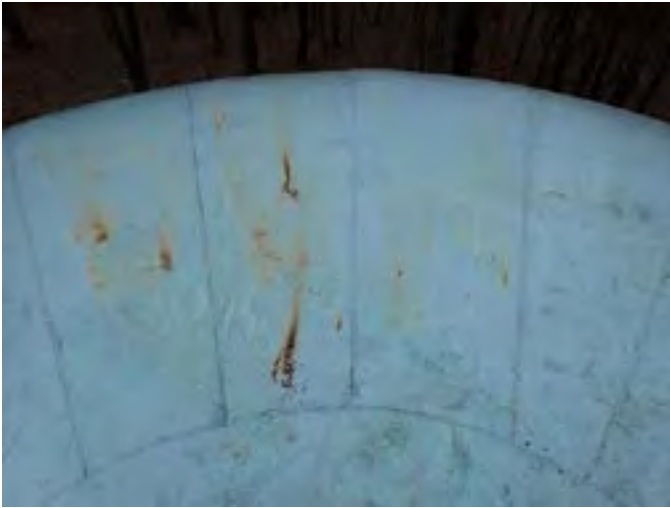
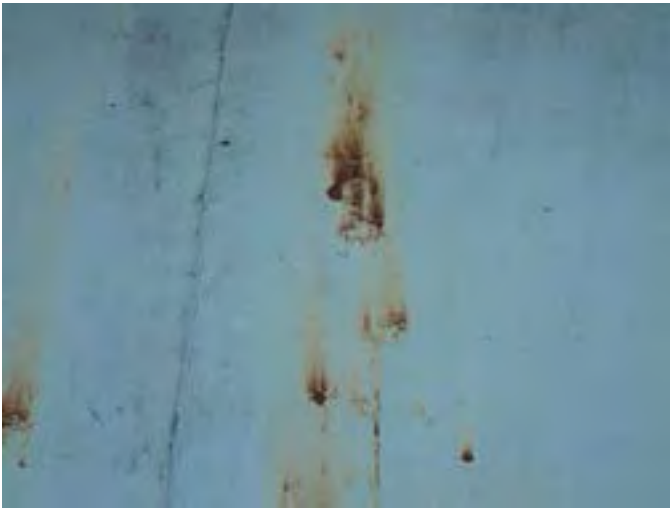
29 *Roof Having Coating Loss, Exposed Steel, Corrosion And A Non-Uniform Accumulation Of Mildew*

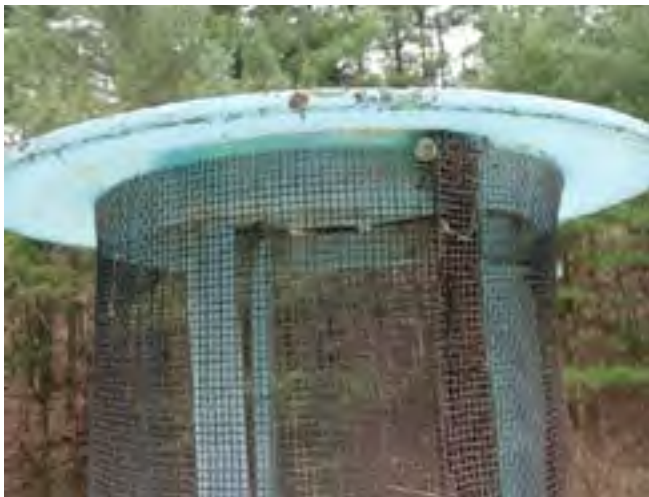
35 *Vent Assembly Having Exposed Steel And Corrosion*

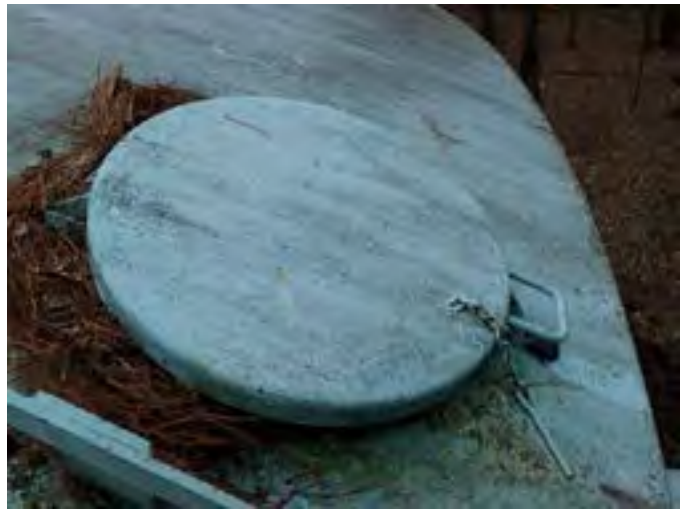
38 *Hatch Closed And Secured With A Lock*

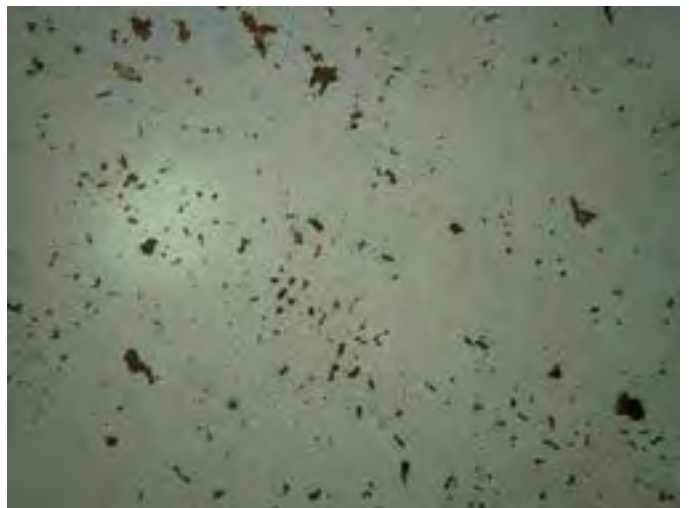
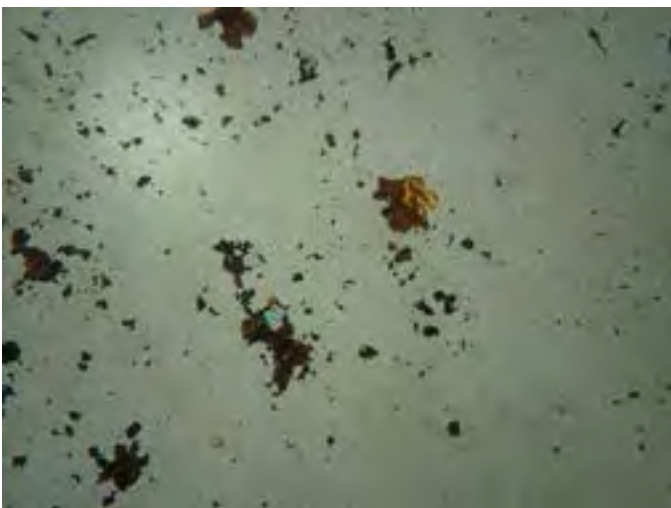
40 *Floor Having Coating Loss, Exposed Steel And Corrosion*

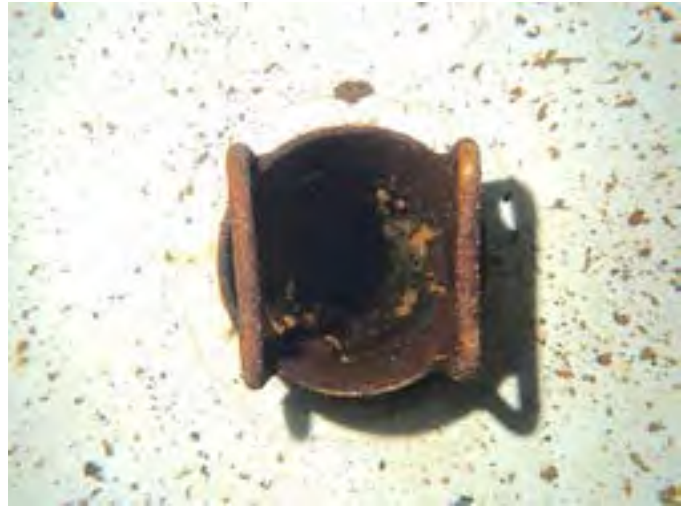
50 *Interior Of The Pipe Within The Floor Having Corrosion*

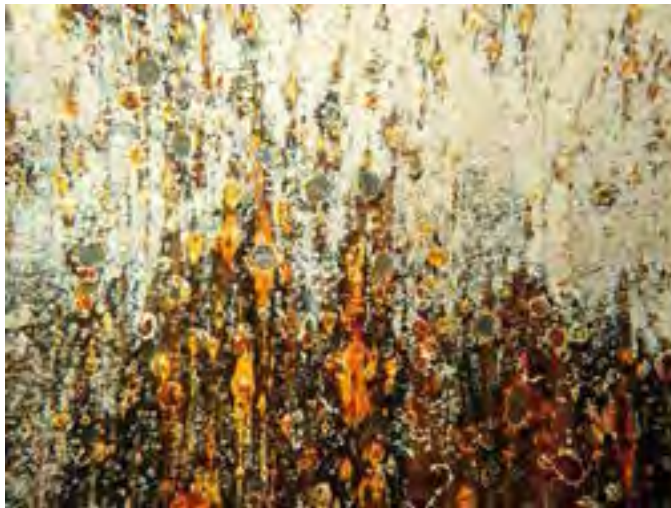
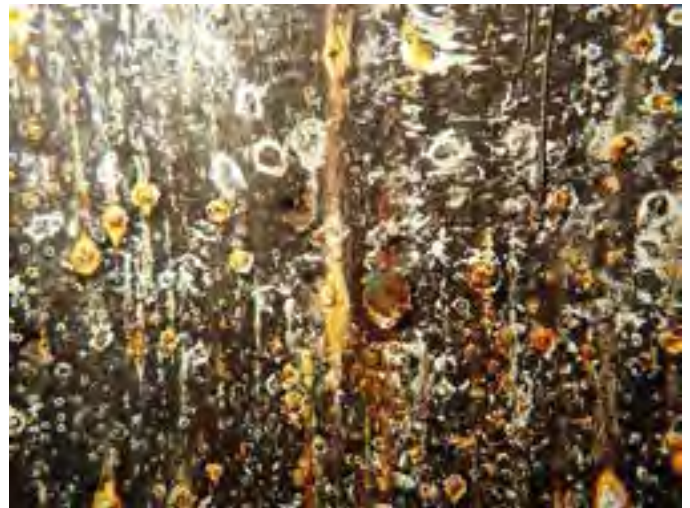
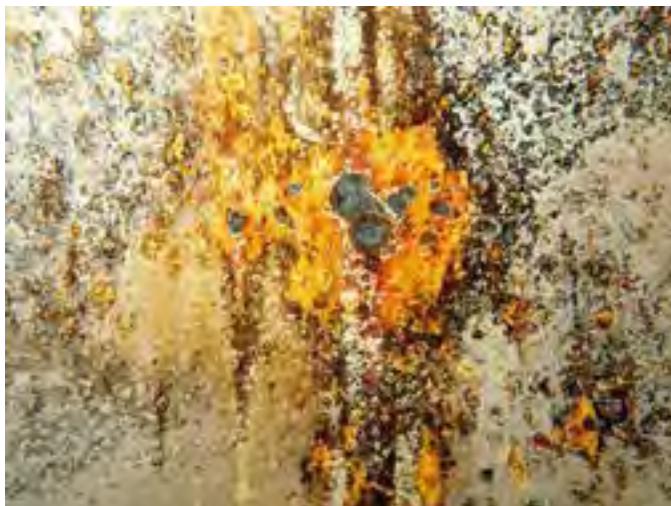
63 *Third Row Of Wall Panels Above The Tank Floor Having Pitting Of The Steel*

64 *Third Row Of Wall Panels Above The Tank Floor Having Pitting Of The Steel*

65 *Third Row Of Wall Panels Above The Tank Floor Having Pitting Of The Steel*

RECOMMENDATION(S): It is our recommendation to complete the interior rehabilitation prior to completing an exterior rehabilitation, allowing all areas of steel fatigue (pitting) found throughout the interior walls to be re-surfaced/sealed.

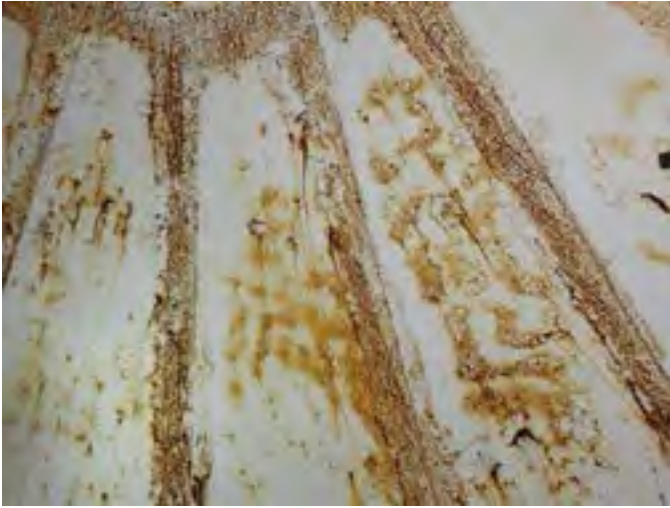
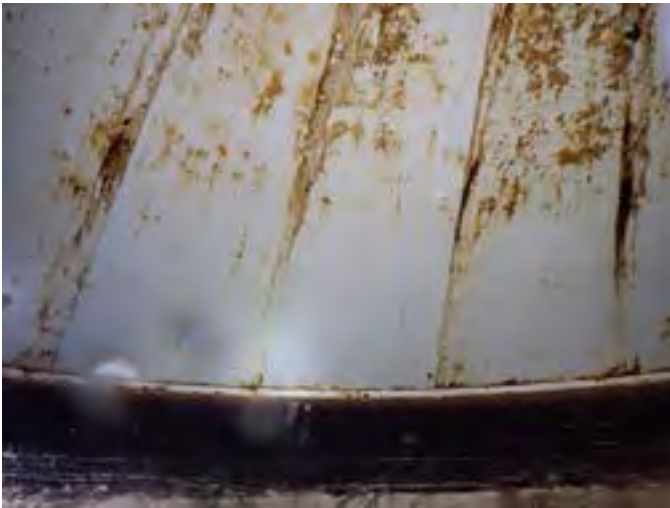
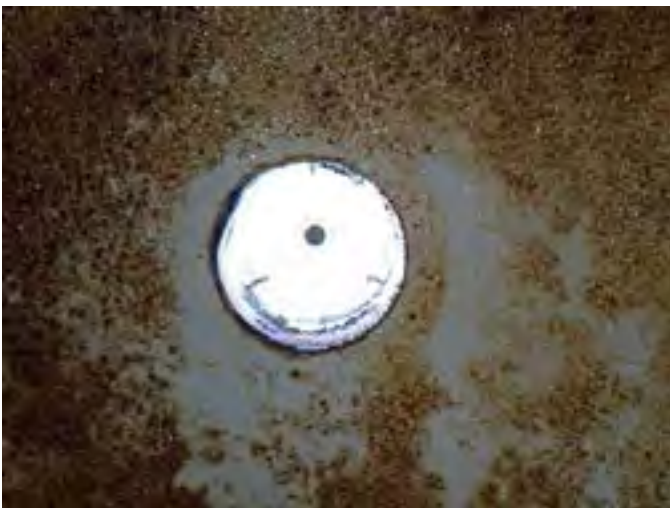
67 *Overhead Having Coating Loss, Exposed Steel And Corrosion*

68 *Overhead Having Coating Loss, Exposed Steel And Corrosion*

69 *Overhead Having Coating Loss, Exposed Steel And Corrosion*

70 *Overhead Having Coating Loss, Exposed Steel And Corrosion*

71 *Overhead Having Coating Loss, Exposed Steel And Corrosion*

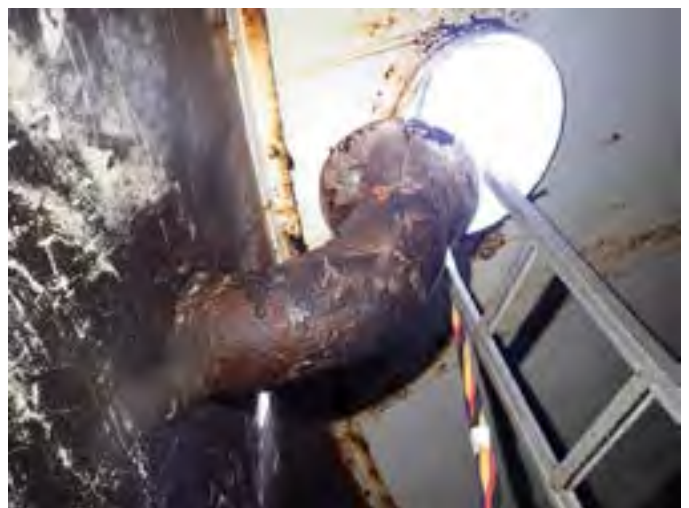
72 *Overflow Pipe Having Exposed Steel And Corrosion*

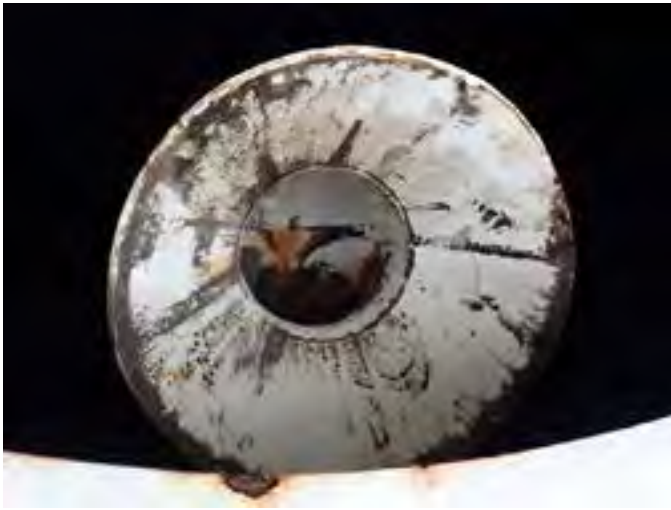
73 *Unobstructed Overflow Pipe*

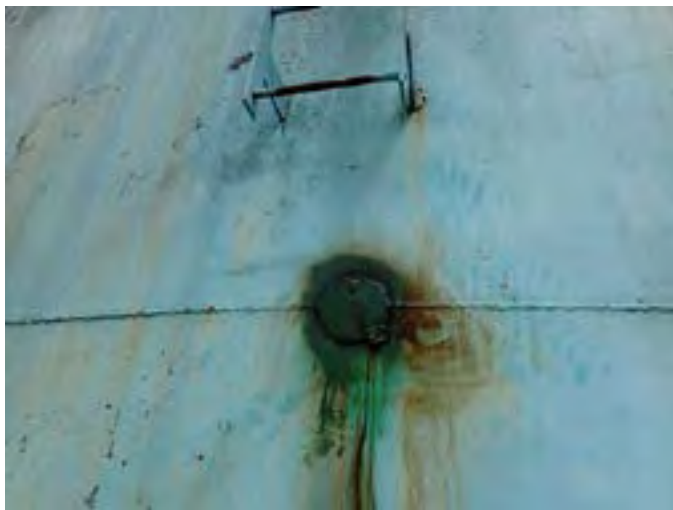
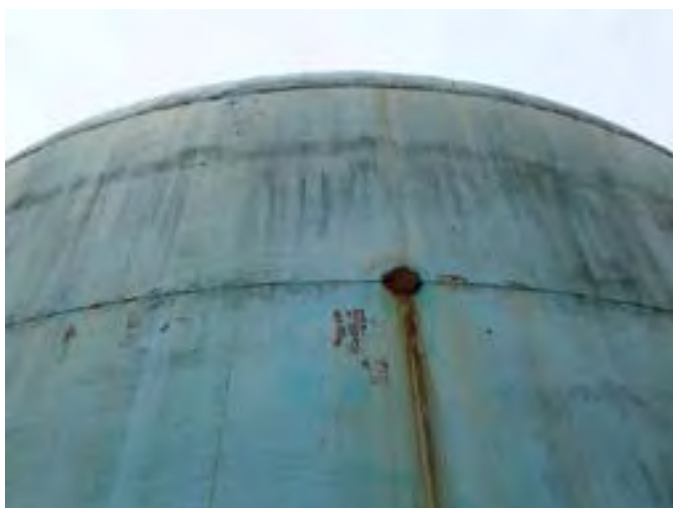
The exterior steel wall panels and associated welds were inspected and appeared sound, however three steel patches were observed welded to the exterior wall surfaces at the time of this inspection.

3 *Steel Patch Welded Over A Weld Found Without Leakage*

5 *Steel Patch Welded Over A Weld Found Without Leakage*

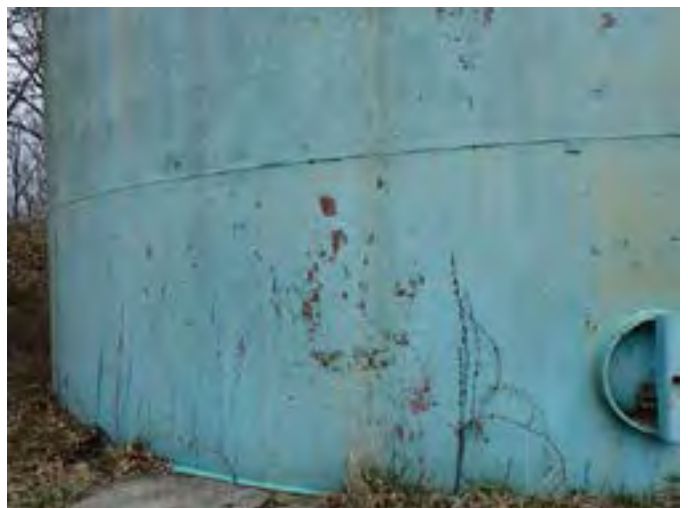
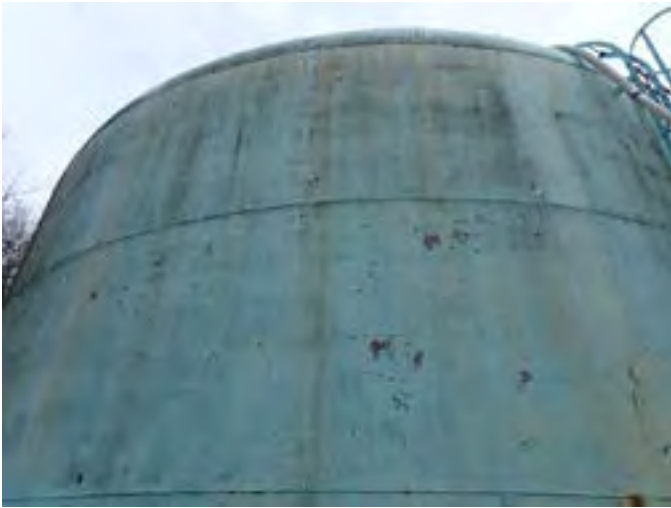
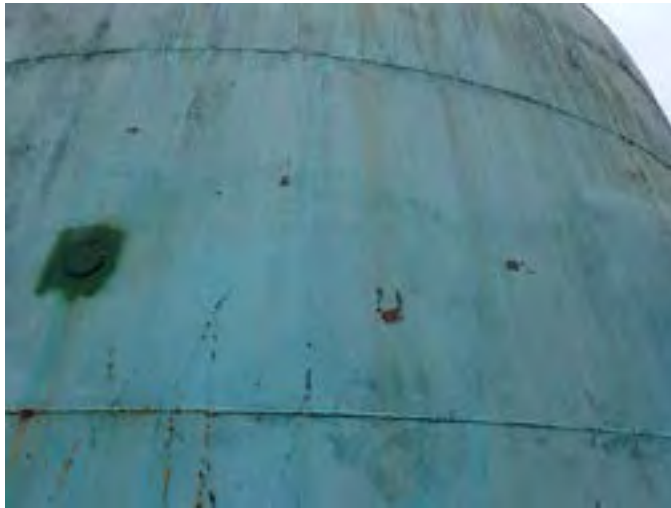
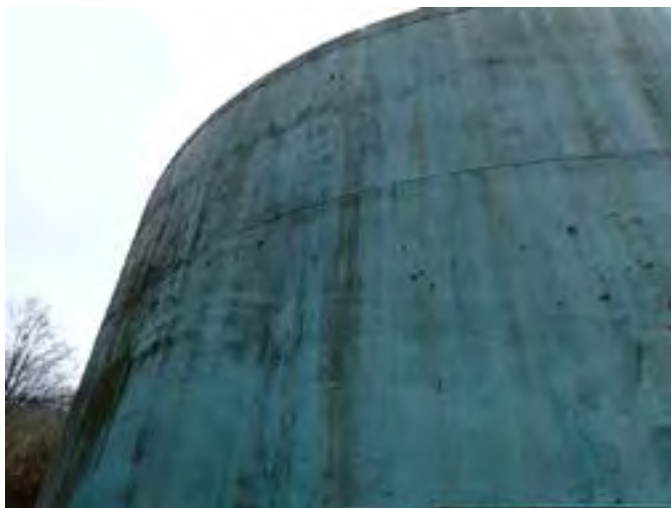
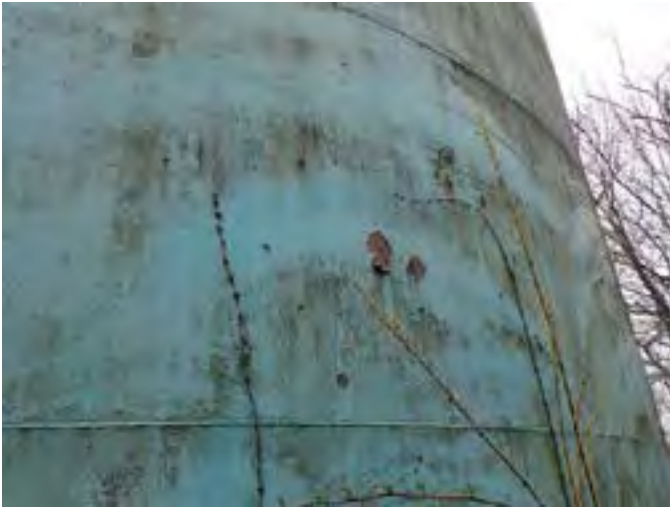
Adhesion loss (lifting/peeling) of the coating was observed throughout approximately 30% of the exterior wall surfaces, resulting in exposure of the primary coating. The primary coating within these areas of exposure appeared to have good adhesion value at this time.

No obvious fatigue (pitting) of the steel was evident within these areas of steel exposure, rather mild corrosion exist at this time.

6 *Exterior Wall Having Coating Fatigue, Exposed Primary Coating, Exposed Steel And Corrosion*

7 *Exterior Wall Having Coating Fatigue, Exposed Primary Coating, Exposed Steel And Corrosion*

9 *Exterior Wall Having Coating Fatigue, Exposed Primary Coating, Exposed Steel And Corrosion*

11 *Exterior Wall Having Coating Fatigue, Exposed Primary Coating, Exposed Steel And Corrosion*

13 *Exterior Wall Having Coating Fatigue, Exposed Primary Coating, Exposed Steel And Corrosion*

It is our recommendation to pressure-wash the exterior wall surfaces at 4,500 P.S.I. using an oscillating tip to remove the accumulated mildew from these surfaces and to remove any and all coating that has lost adhesion from the tank.

It is also our recommendation to re-coat the exterior walls using a protective coating formulated for exterior exposure and to be applied in accordance with the product manufacturer's surface preparation and application recommendations in an effort to halt corrosion, prevent steel fatigue/deterioration and to provide good protection for the exterior welded steel wall surfaces.

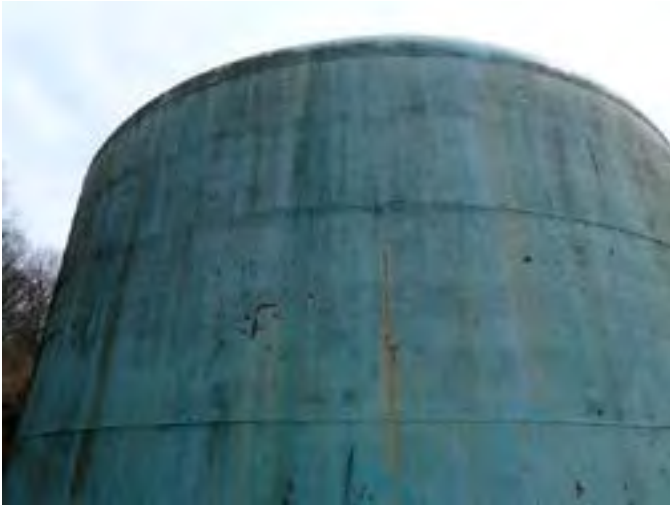
15 *Tank Exterior Having Accumulated Mildew*

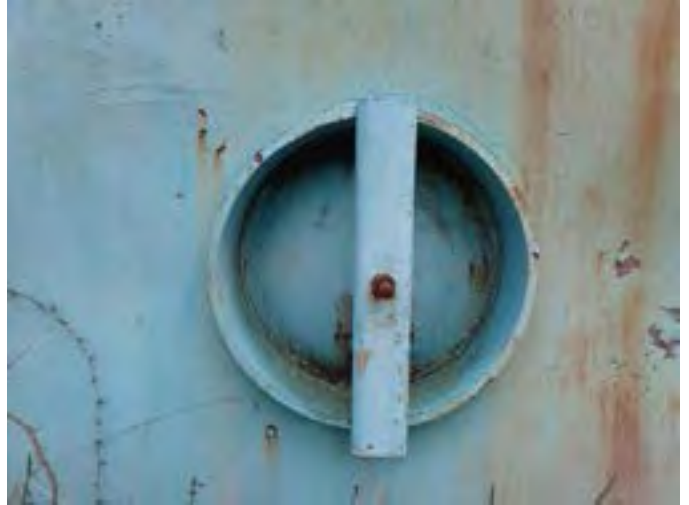
16 *Manway Having Exposed Primary Coating, Exposed Steel And Corrosion*

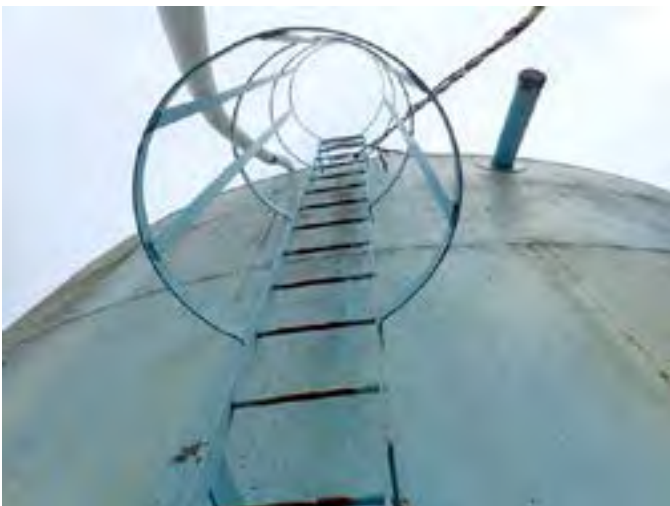
17 *Ladder And Safety Cage Having Exposed Primary Coating, Exposed Steel And Corrosion*

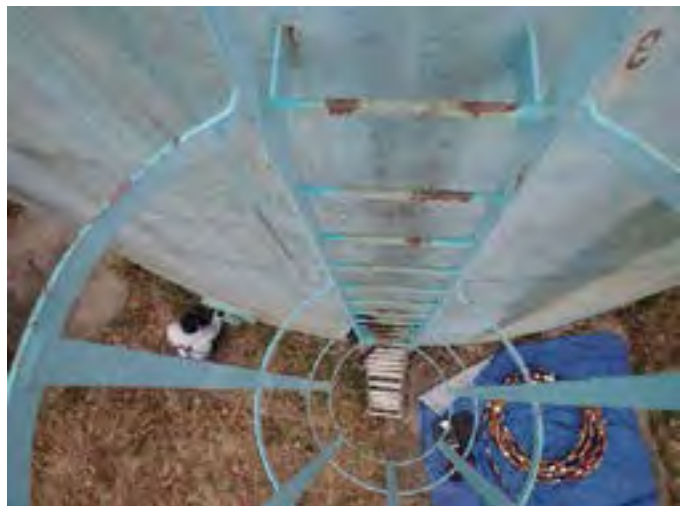
18 *Ladder And Safety Cage Having Exposed Primary Coating, Exposed Steel And Corrosion*

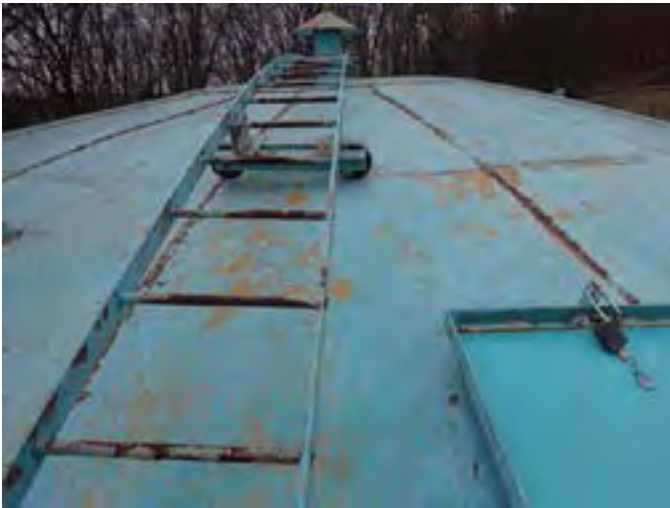
19 *Ladder Extending From The Vent Having Exposed Steel And Corrosion*

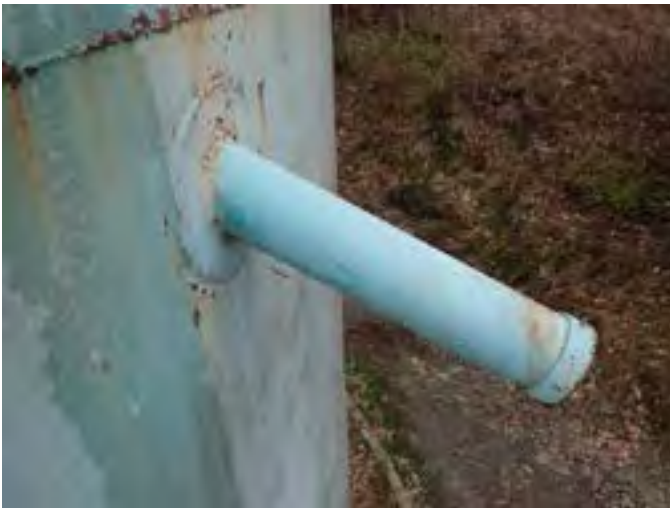
21 *Overflow Pipe Having Exposed Primary Coating, Exposed Steel And Corrosion*

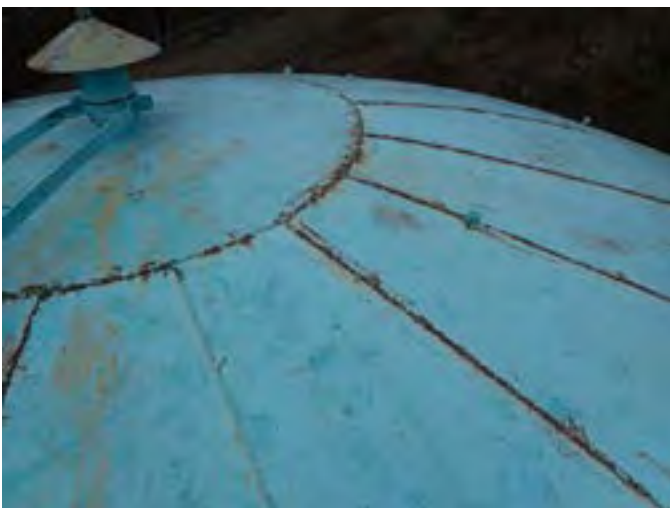
23 *Roof Having Exposed Primary Coating, Exposed Steel And Corrosion*

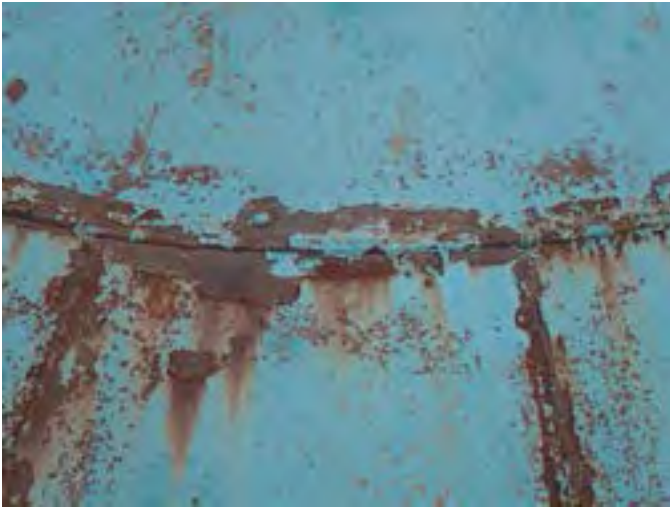
25 *Roof Having Exposed Primary Coating, Exposed Steel And Corrosion*

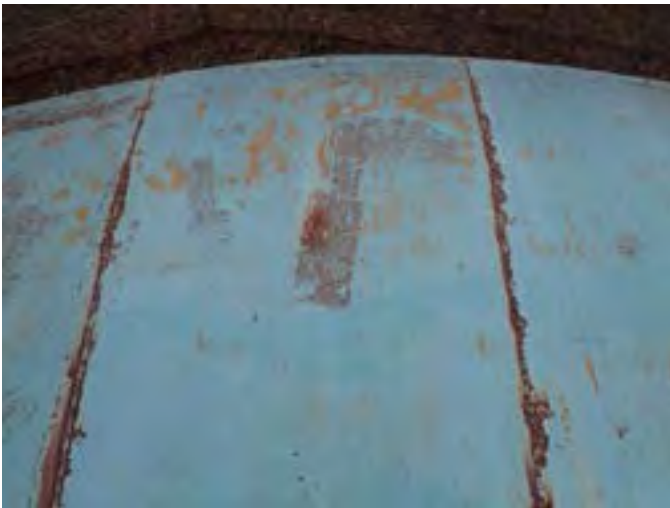
27 *Roof Having Exposed Primary Coating, Exposed Steel And Corrosion*

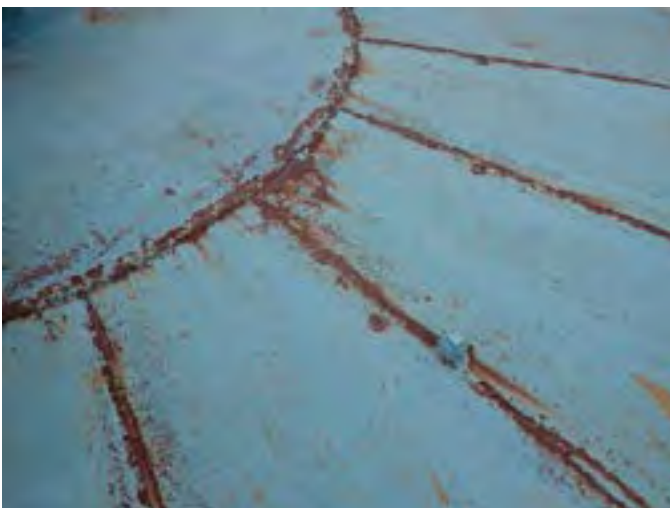
29 *Rigging Hole Penetration Sealed With A Threaded Plug*

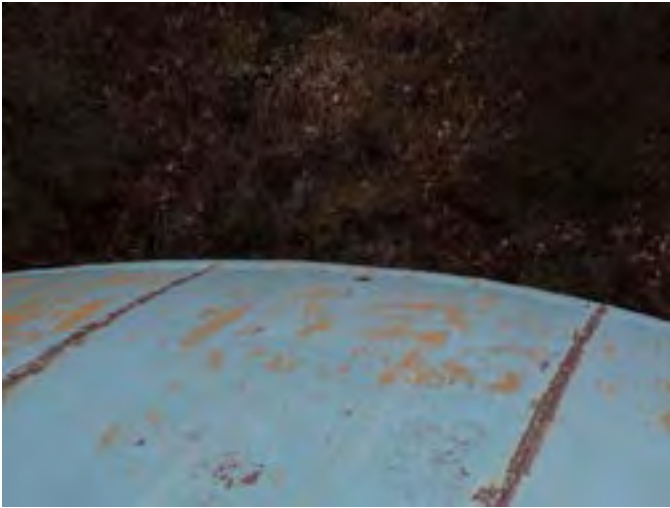
It is the opinion of Underwater Solutions Inc. that this welded steel potable water storage tank appeared mostly sound, however minimal leakage was occurring through a patch welded to an exterior wall panel. Open rigging hole penetrations throughout the roof allow rainwater run-off to enter the tank at this time.

31 *Open Rigging Hole Penetration Within The Roof*

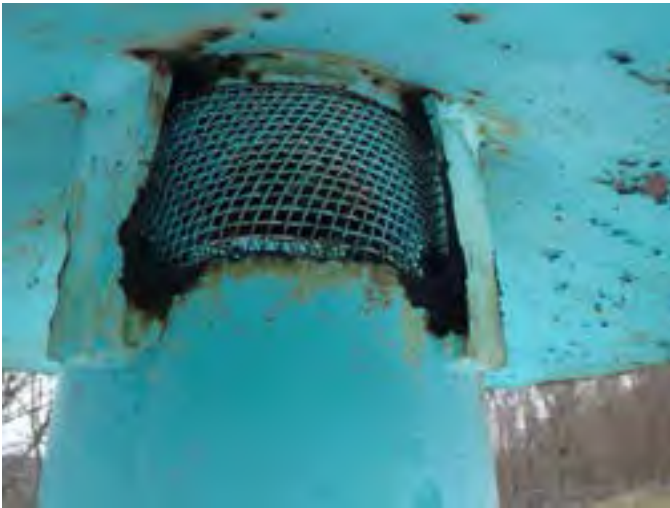
33 *Vent Assembly Having Exposed Primary Coating, Exposed Steel And Corrosion*

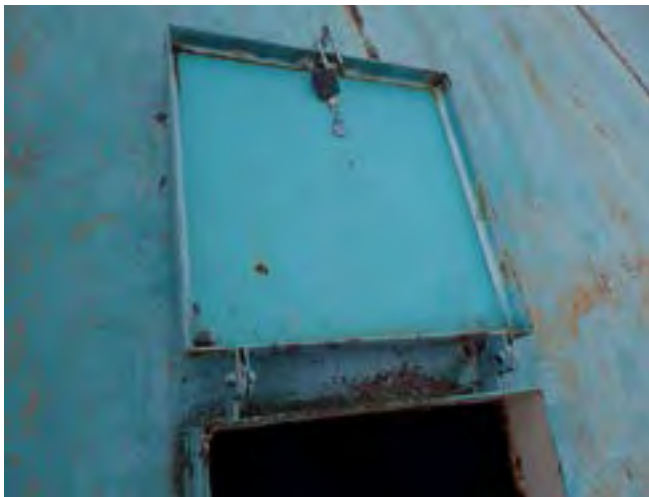
35 *Interior Of The Hatch Cover Having Exposed Steel And Corrosion*

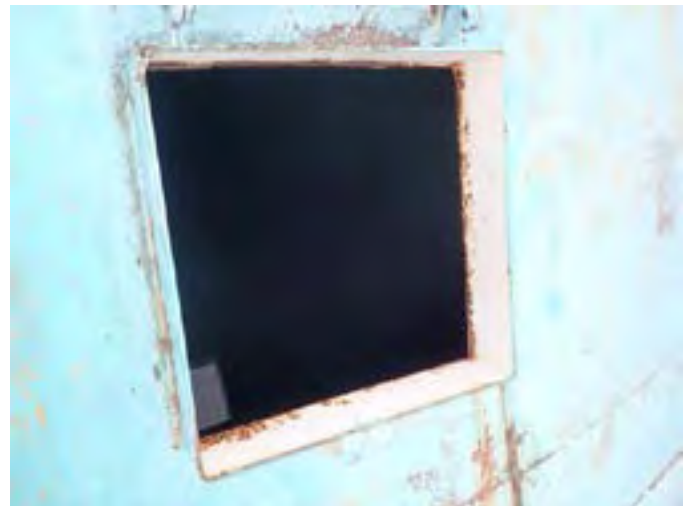
36 *Interior Of The Hatch Trunk Having Exposed Steel And Corrosion*

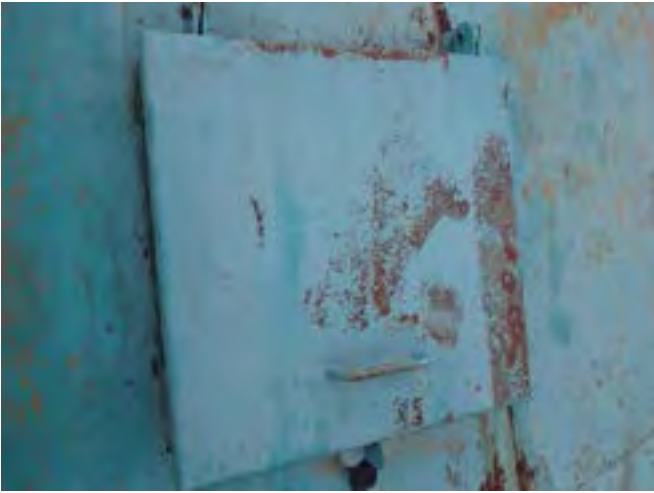
37 *Exterior Of The Hatch Cover Having Exposed Primary Coating, Exposed Steel And Corrosion*

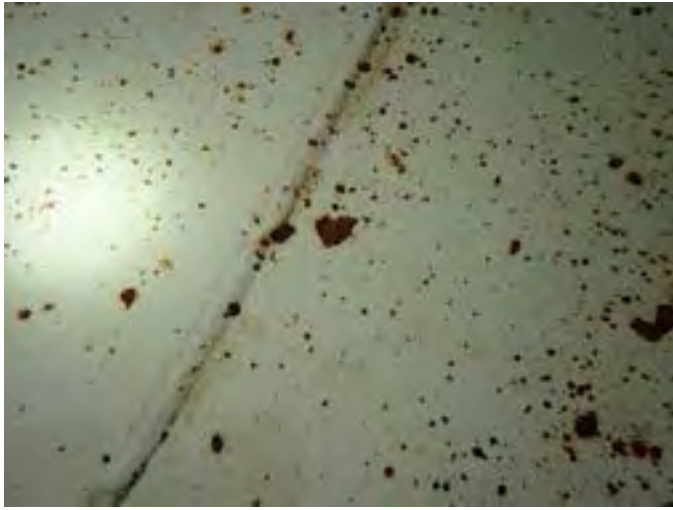
43 *Floor Having Coating Loss, Exposed Steel And Corrosion*

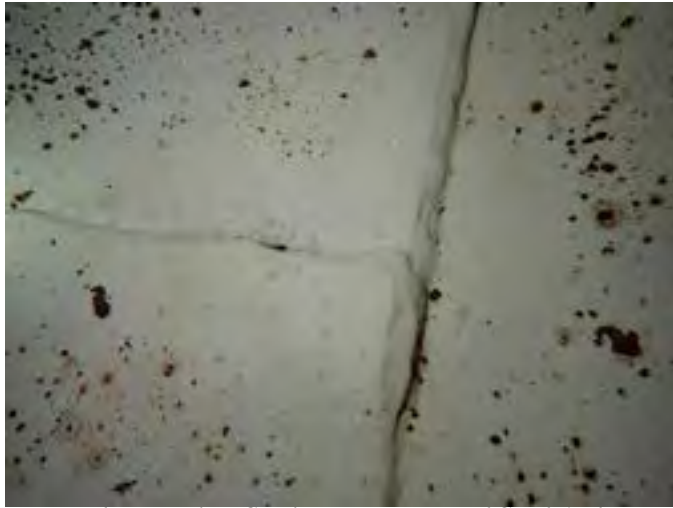
45 *Floor Having Coating Loss, Exposed Steel And Corrosion*

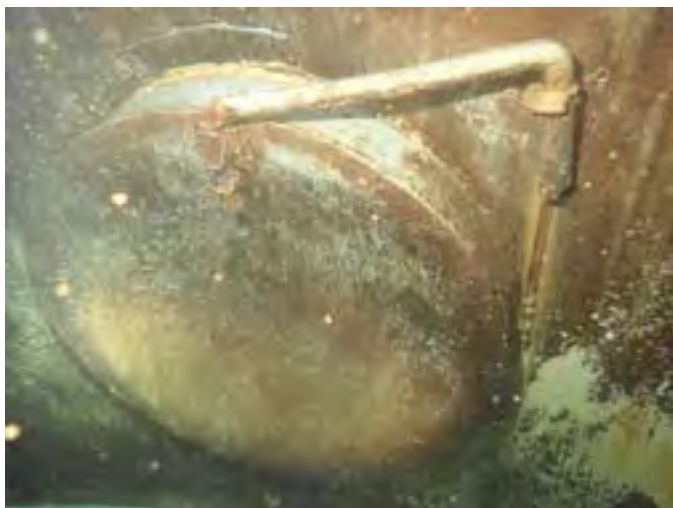
47 *Manway Having Coating Loss, Exposed Steel And Corrosion*

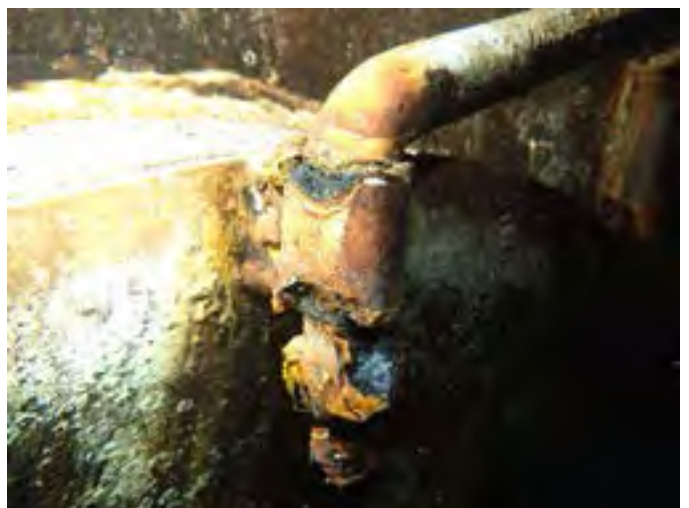
48 *Manway Davit Hinge Assembly Exposed Steel, Corrosion And Deterioration Of The Steel*

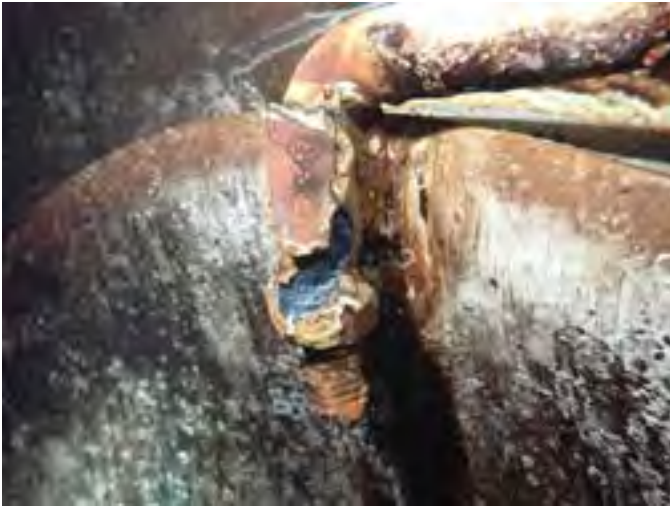
49 *Manway Davit Hinge Assembly Exposed Steel, Corrosion And Deterioration Of The Steel*

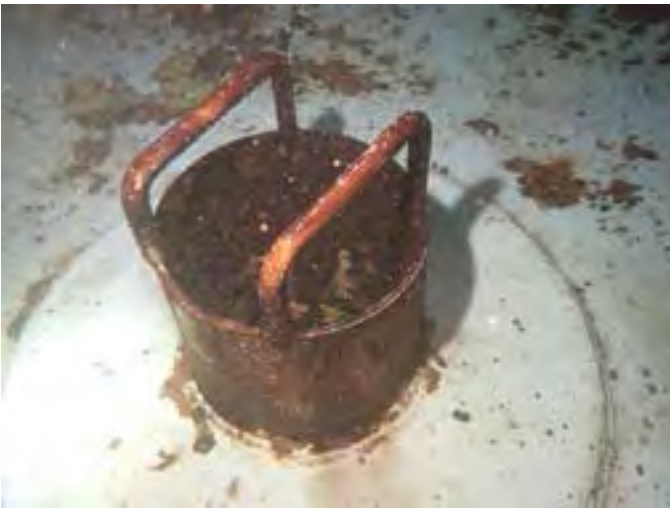
51 *Removable Slit Stop Riser Having Exposed Steel And Corrosion*

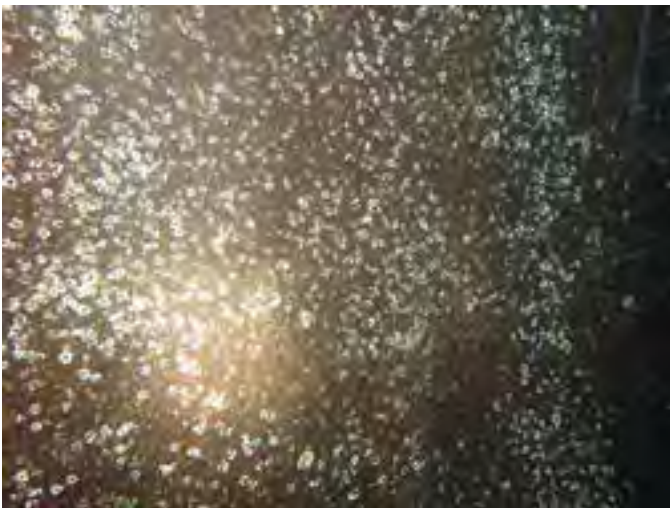
53 *Interior Wall Having Coating Fatigue, Exposed Steel And Corrosion*

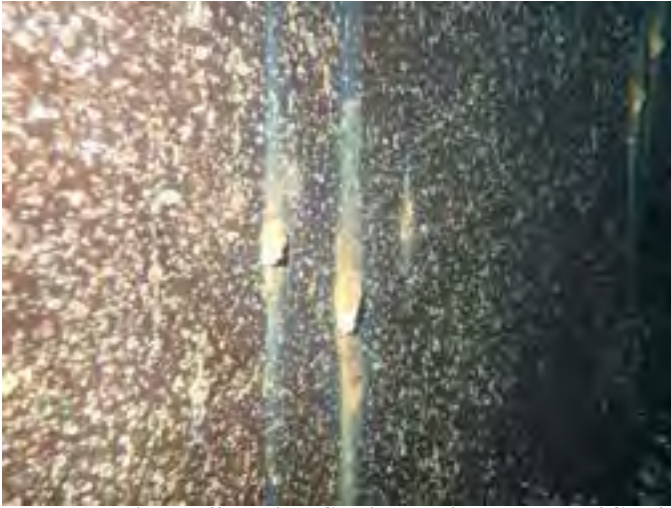
57 *Interior Wall Having Coating Fatigue, Exposed Steel And Corrosion*

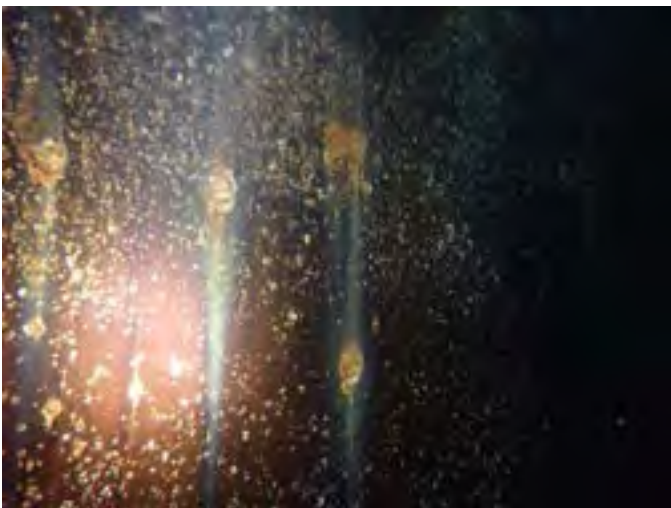
59 *Interior Wall Having Coating Fatigue, Exposed Steel And Corrosion*

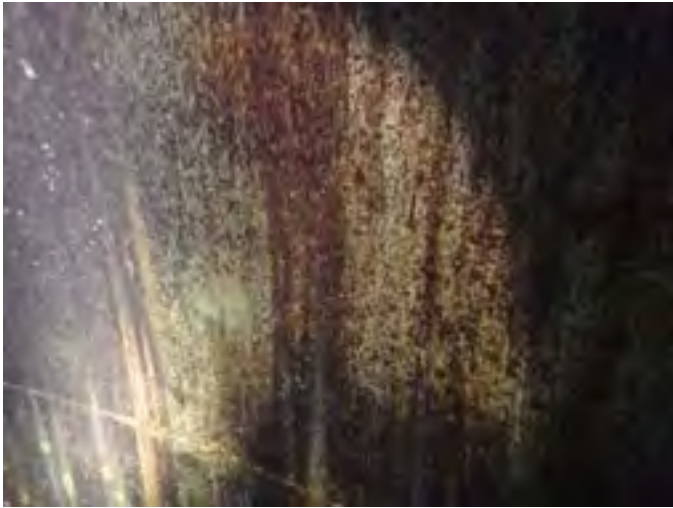
61 *Interior Wall Having Coating Fatigue, Exposed Steel And Corrosion*

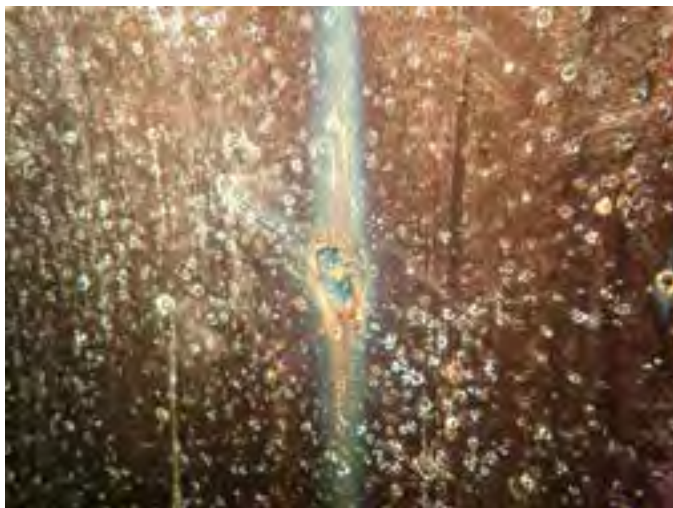
65 *Interior Wall Having Pitting Of The Steel*

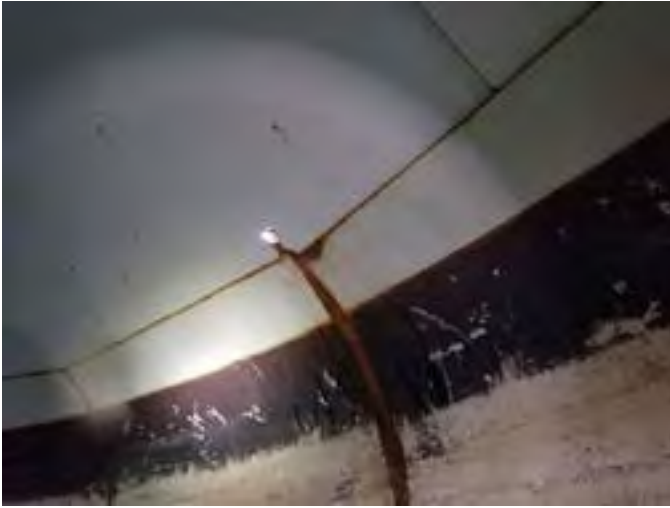
Decline (thinning) of the coating film thickness has resulted in surface corrosion to show through the coating throughout approximately 40% of these surfaces, while adhesion loss of the protective coating throughout approximately 5% of these surfaces has resulted in exposure of the underlying steel.

No obvious fatigue (pitting) of the steel panels was evident within these areas of steel exposure rather mild corrosion exists at this time.

67 *Overhead Having Exposed Steel, Corrosion And An Open Rigging Hole Penetration*

RECOMMENDATION(S): It is our recommendation to abrasive blast the interior overhead panels to white or near white metal. We recommend applying a protective coating to the interior overhead panels using a protective coating formulated for immersion (wet contact) and having an A.N.S.I./N.S.F. 61 approval for use in structures containing potable water. We recommend this protective coating be applied in accordance with the product manufacturer's surface preparation and application recommendations in an effort to halt corrosion, prevent fatigue/deterioration of the steel and to provide good protection for the steel overhead panels.

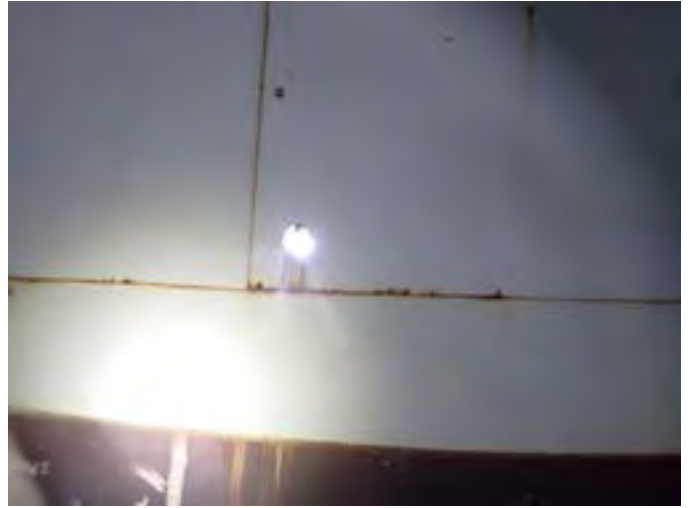
68 *Overhead Having Exposed Steel, Corrosion And An Open Rigging Hole Penetration*

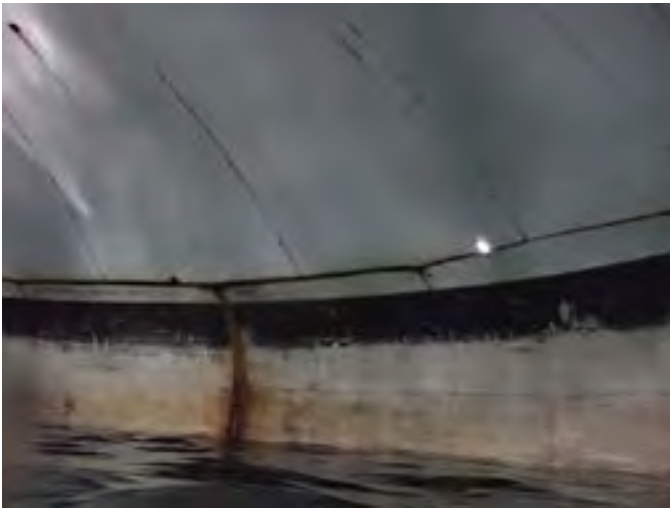
69 *Overhead Having Exposed Steel, Corrosion And An Open Rigging Hole Penetration*

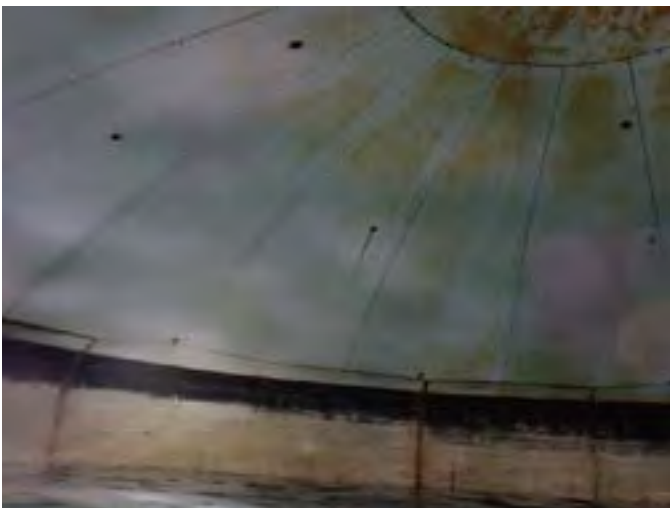
71 *Overhead Having Surface Corrosion And Exposed Steel*

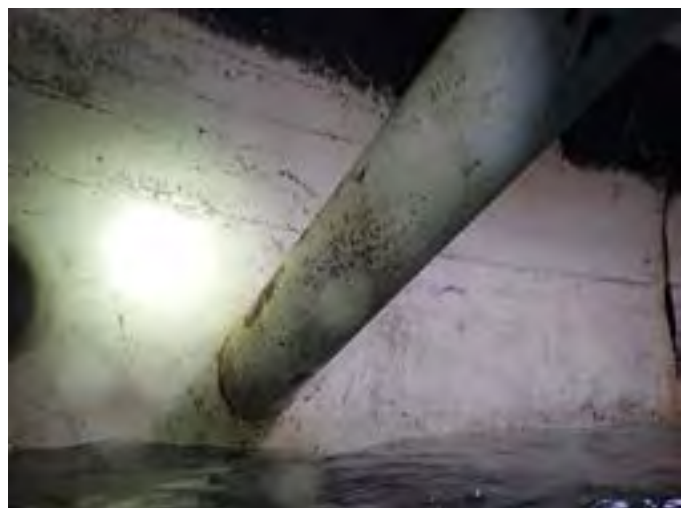
The protective coating on this steel pipe appeared to have been applied uniformly and was found having mostly good adhesion value at this time. Adhesion loss of the coating was observed throughout approximately 20% of these surfaces, resulting in exposure of the underlying steel. No obvious fatigue/deterioration of the steel was evident within these areas of exposure, rather mild corrosion exists at this time.

72 *Overflow Pipe Having Exposed Steel And Corrosion*

RECOMMENDATION(S): It is our recommendation to abrasive blast the interior overflow pipe to white or near white metal. We recommend then applying a protective coating to the pipe using a protective coating formulated for immersion (wet contact) and having an A.N.S.I./N.S.F. 61 approval for use in structures containing potable water. We recommend this protective coating be applied in accordance with the product manufacturer’s surface preparation and application recommendations in an effort to halt corrosion, prevent fatigue/deterioration of the steel and to provide good protection for this steel pipe.

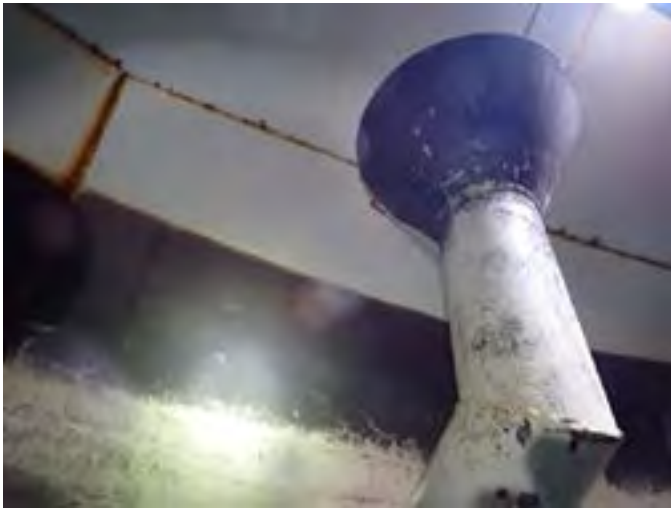
73 *Overflow Pipe Having Exposed Steel And Corrosion*
