Preliminary Engineering Report

Wellsburg Municipal Water Study
Village of Wellsburg, Chemung County, New York

February 2021
Revised July 2023

HUNT 2678-009

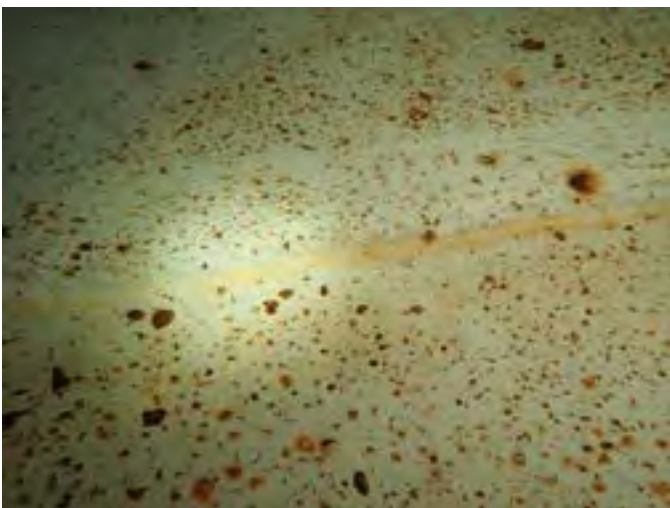
41 *Floor Having Coating Loss, Exposed Steel And Corrosion*

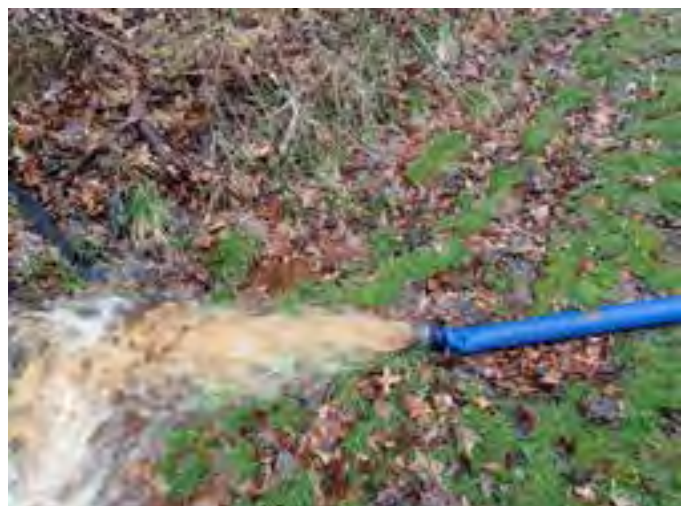
90 *Discharge From Cleaning*

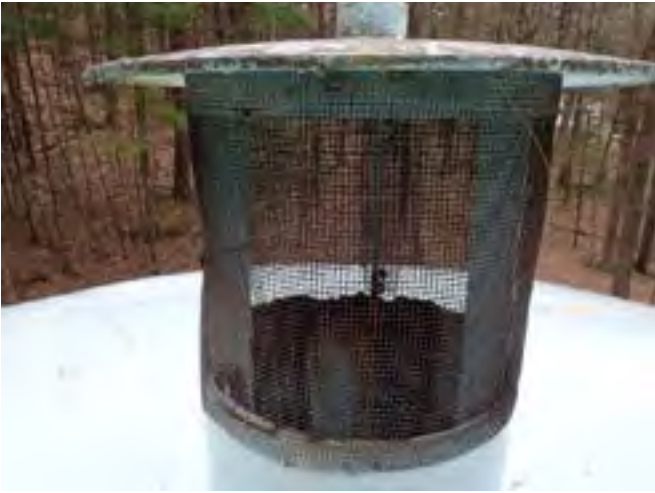
37 *8-Mesh Screen*

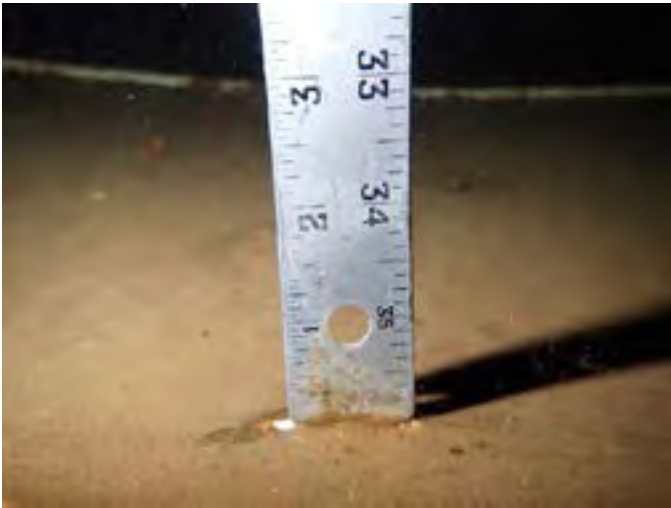
39 *Layer Of Precipitate*

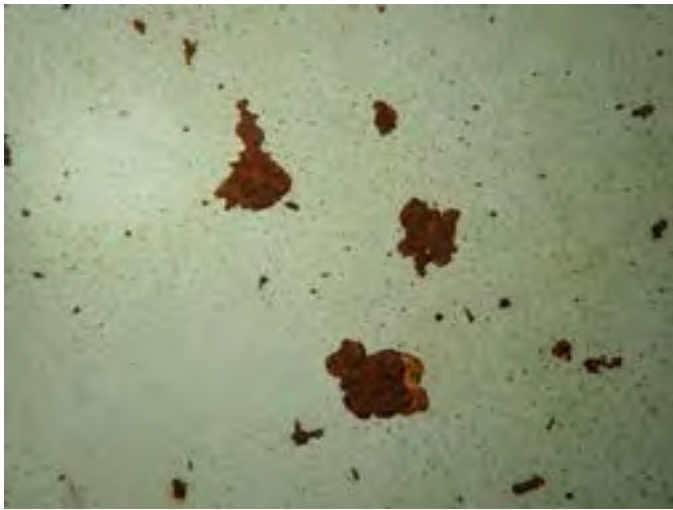
43 *Floor Having Coating Loss, Exposed Steel And Corrosion*

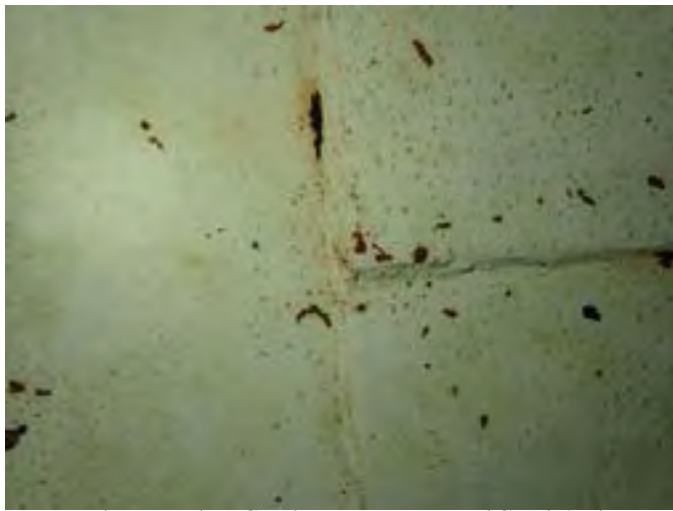
45 *Floor Having Coating Loss, Exposed Steel And Corrosion*

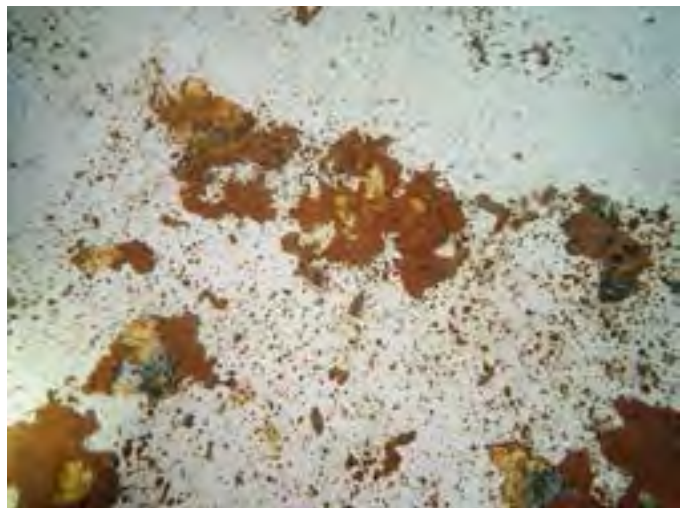
40 *Floor Having Coating Loss, Exposed Steel And Corrosion*

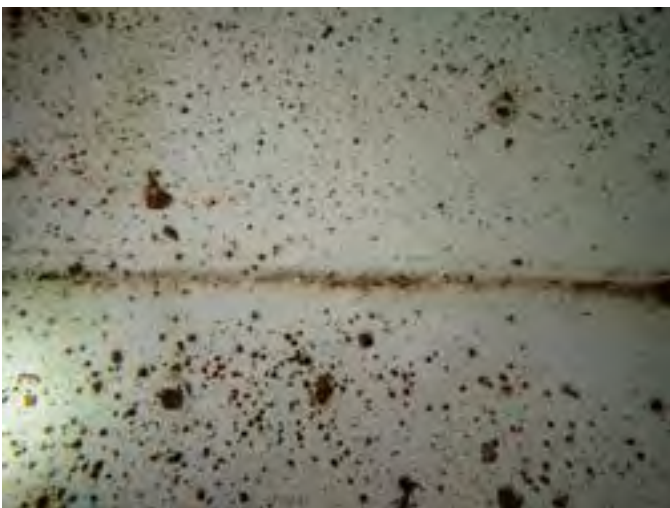
41 *Floor Having Coating Loss, Exposed Steel And Corrosion*

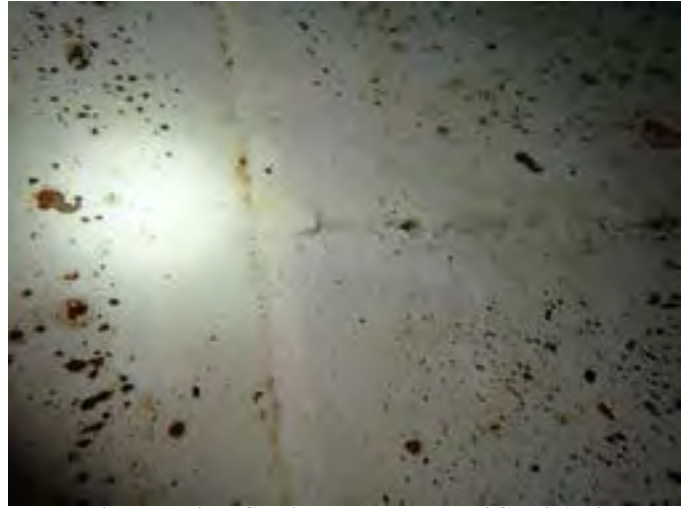
46 *Floor Having Coating Loss, Exposed Steel And Corrosion*

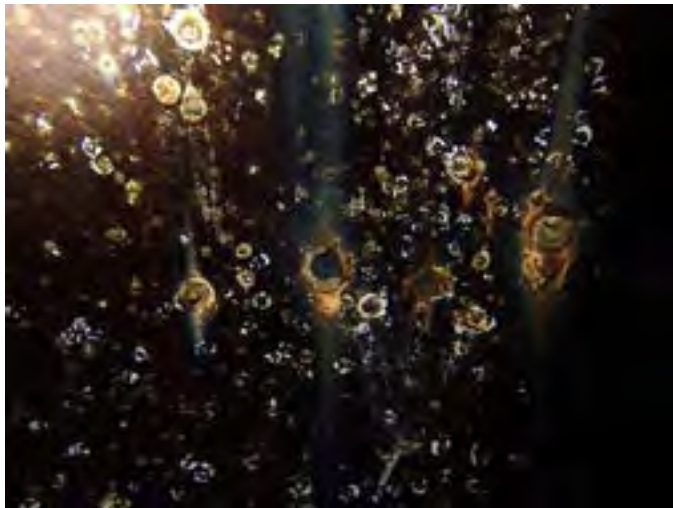
63 *Interior Wall Having Pitting Of The Steel*
